Rockfalls at Stevns Klint

Landslide hazard assessment based on photogrammetrical
supported geological analysis of the limestone cliff
Stevns Klint in eastern Denmark

Stig A. Schack Pedersen

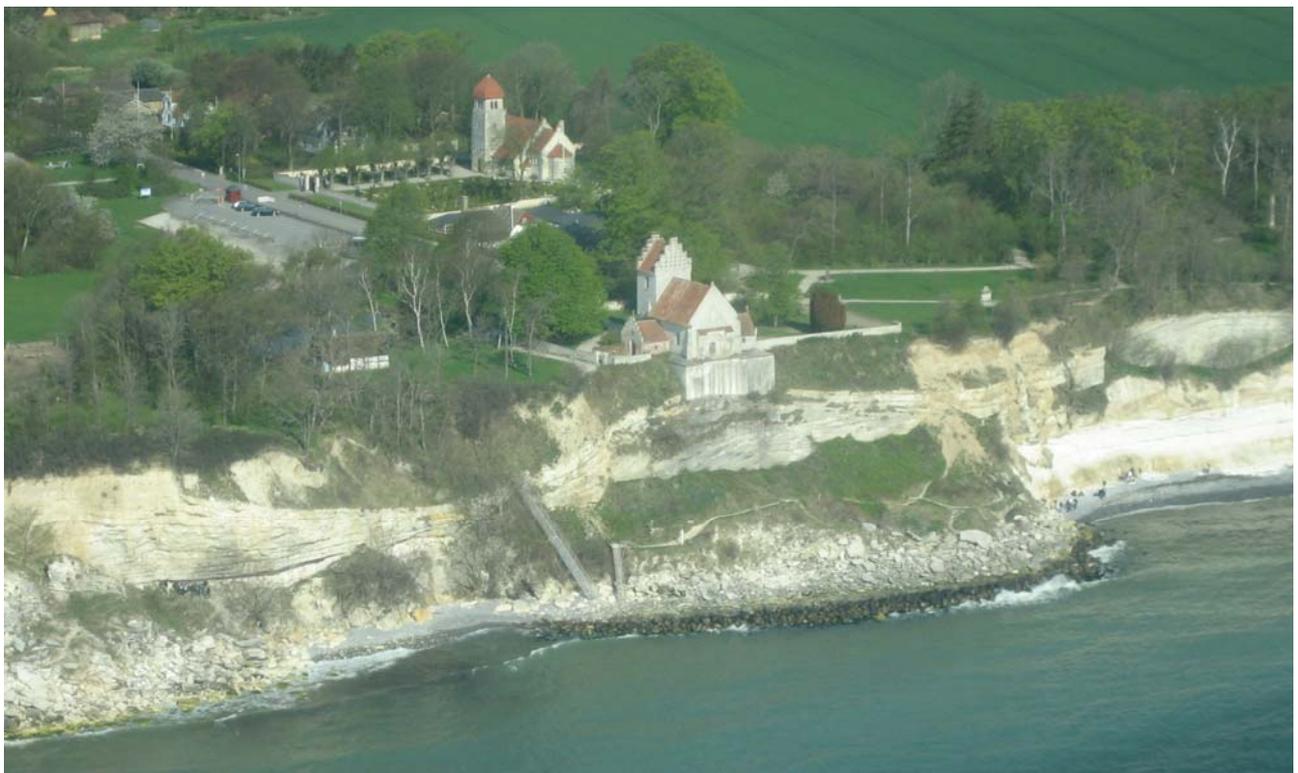
The rockfall type at Stevns Klint which involves the largest volumes is classified as cliff-slide (Fig. 5). Prior to a cliff-slide a whole section of the chalk was eroded away to create an undercutting below the limestone resulting in a considerable overhang. The size of the overhang is about 10–12 m and the thickness of the limestone and till in the overhang is about 15–18 m. The landslide at Højerup old church is regarded as representing such a slide (Figs 6, 7). The map in Fig. 7 shows the extent of this landslide, which prograded several tens of meters out into the sea. Today a coast protection with erratic blocks secures the survival of the remaining part of church for more than hundred years (Fig. 6).

Figure 6. *The landslide at Højerup old church. The top of the landslide body is c. 15 m a.s.l. and the toe of the slide is protected against erosion with blocks and boulders. The new church in Højerup was built in 1913 due to the local fear for destruction of the old church by a landslide.*

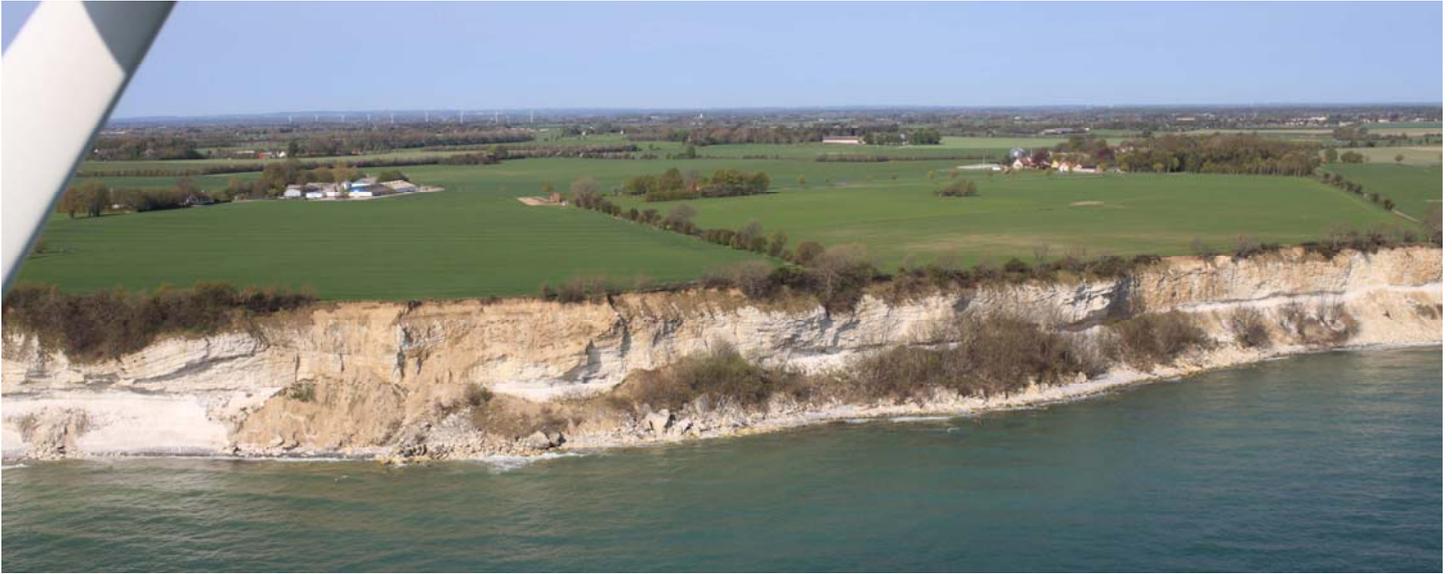
Two other significant examples of cliff-slide are found north of Stevns Fyr at the locality indicated as Tommestrup (no. 13 in Fig. 1) (Fig. 8) and in the inner part of Harvig (no. 7 in Fig. 1) (Fig. 9). At both sites these landslides will serve as coastal protection for about half a century.

Figure 8. *An example of a cliff-slide with preserved vegetation on top of the landslide. In the left side of the air-photo a recent rockfall is recognisable. Locality Tommestrup no. 13 in Fig. 1.*

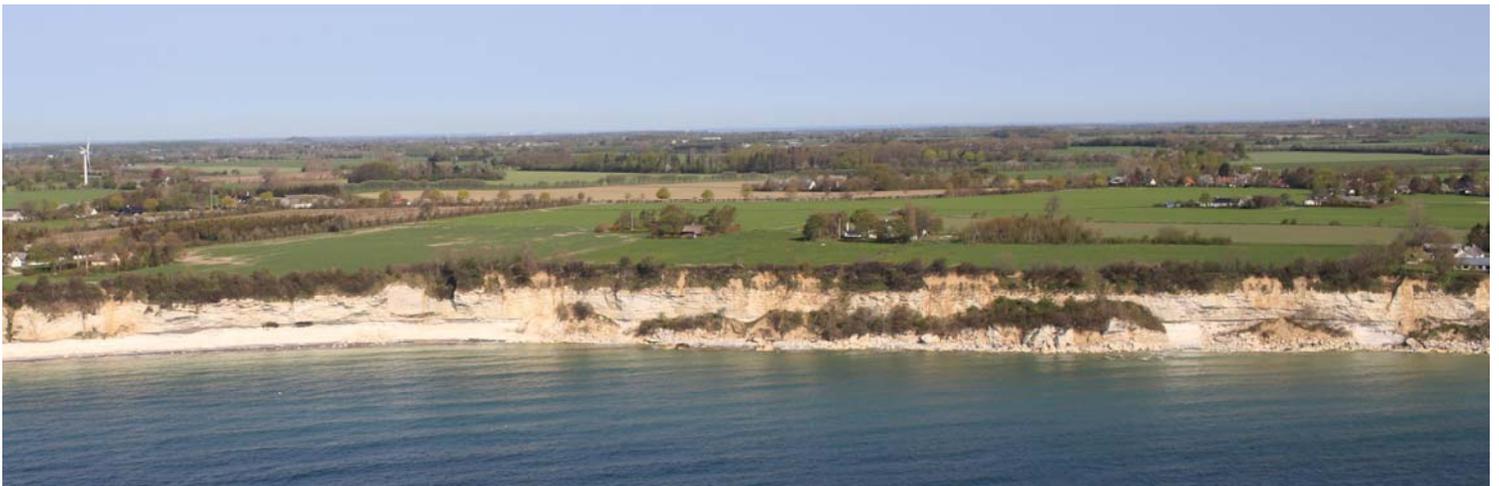
Figure 9. *The cliff-slide in the inner part of Harvig (Loc. 7 in Fig. 1). The measured length of the slide along the coast is 90 m and the thickness of the displaced stratigraphy is 12 m which corresponds well with the thickness of the limestone and till in the cliff. The width of the surface in the slide is 7-10 m which consequently corresponds to the depth of undercutting below the overhang.*

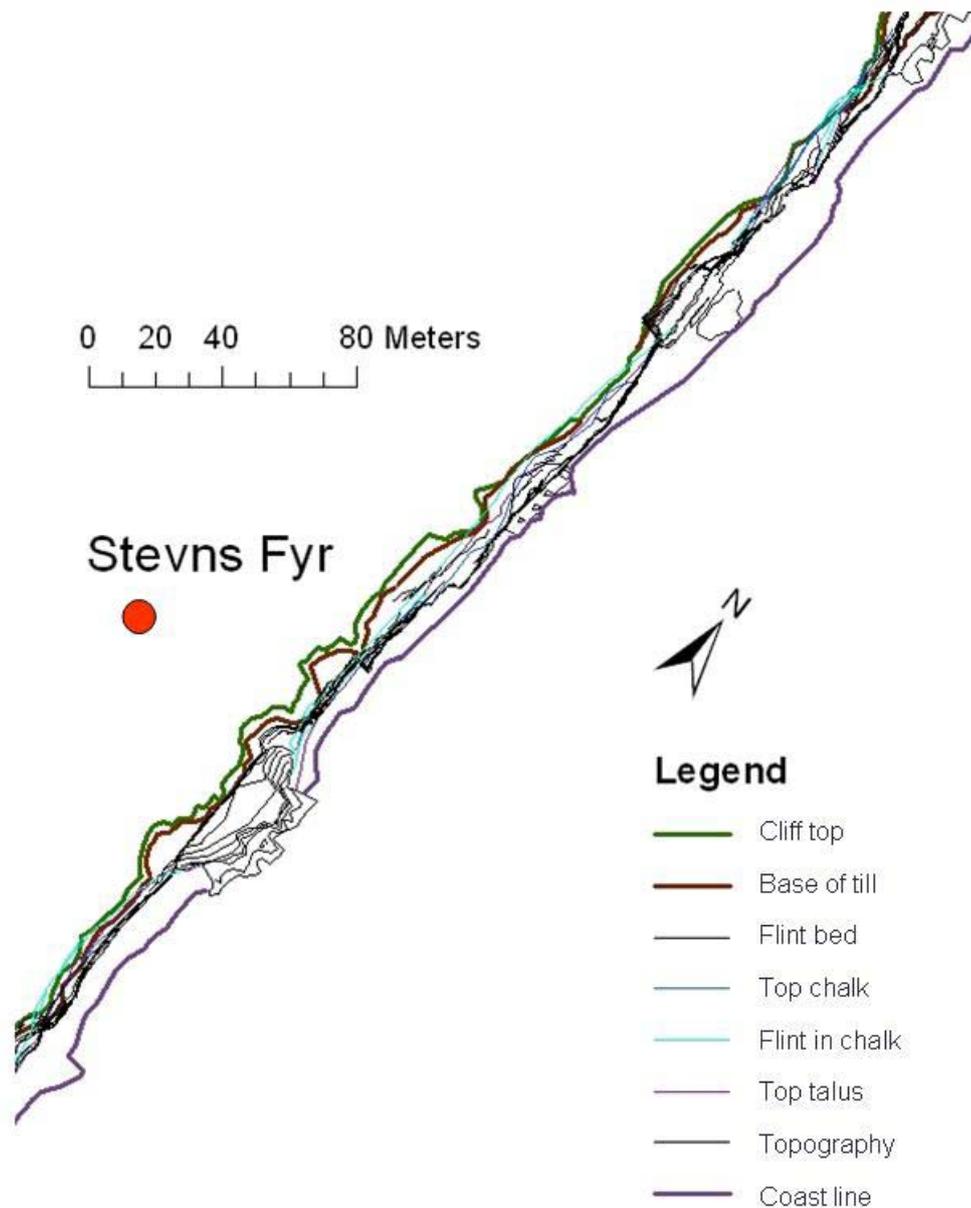
One of the best examples of a cliff-fall is seen below the Stevns Fyr lighthouse (Loc. 12 in fig. 1). Here a rectangular part of the cliff has dropped directly to the beach (Fig. 11, 12). The thickness of the bryozoan limestone in the cliff section is about 22 m, whereas the thickness of the displaced block is only 12–14 m. This discrepancy is explained by former excavation in an old limestone quarry, which has removed c. 10 m of the limestone. The relation between limestone thickness and overhang is thus in the order of 3 to 2, which corresponds to the average measurements of rockfalls along the cliff.

Figure 11. Photogrammetric contour map of the area at Stevns Fyr (lighthouse). The cliff-fall is located immediately southeast of the lighthouse. The topographic contours outlining the cliff-fall have intervals of 2.5 m. The steep and squared walls of the cliff-fall can easily be seen as well as the flat top at a height of 12.5 m. Note the rectangular outline of the old limestone quarries on top of the cliff. Note also the size of the overhang north of the cliff-fall, which is given by the distance between the thin blue lines (top chalk and flint in chalk) and the black lines (traces of flint bands in limestone). The overhang amounts to 8–9 m, which is close to the maximum value of overhangs along the cliff. Explanations to the contour lines are given in Fig. 7.

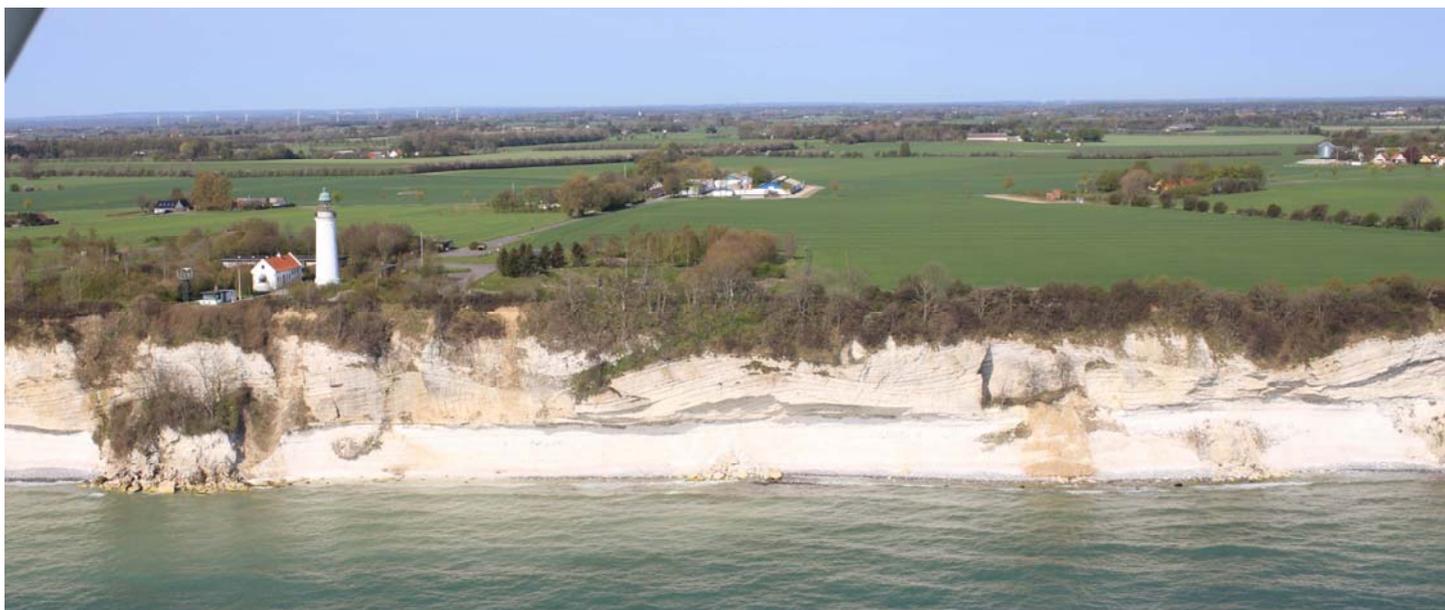
Figure 12. Photo of the cliff-fall and the large overhang at Stevns Fyr. The lighthouse is located at the highest point along Stevns Klint, 41.5 m a.s.l. Below and north of the lighthouse the rectangular shaped small limestone quarries can be seen. Note that under the substantial overhang a small pile of blocks indicate a rock-bedding exfoliation of the roof below the overhang. This type of erosion contributes to the decrease in the thickness of the overhang, which decreases its strength and thus increases its tendency of a cliff-fall (or cliff-slide).

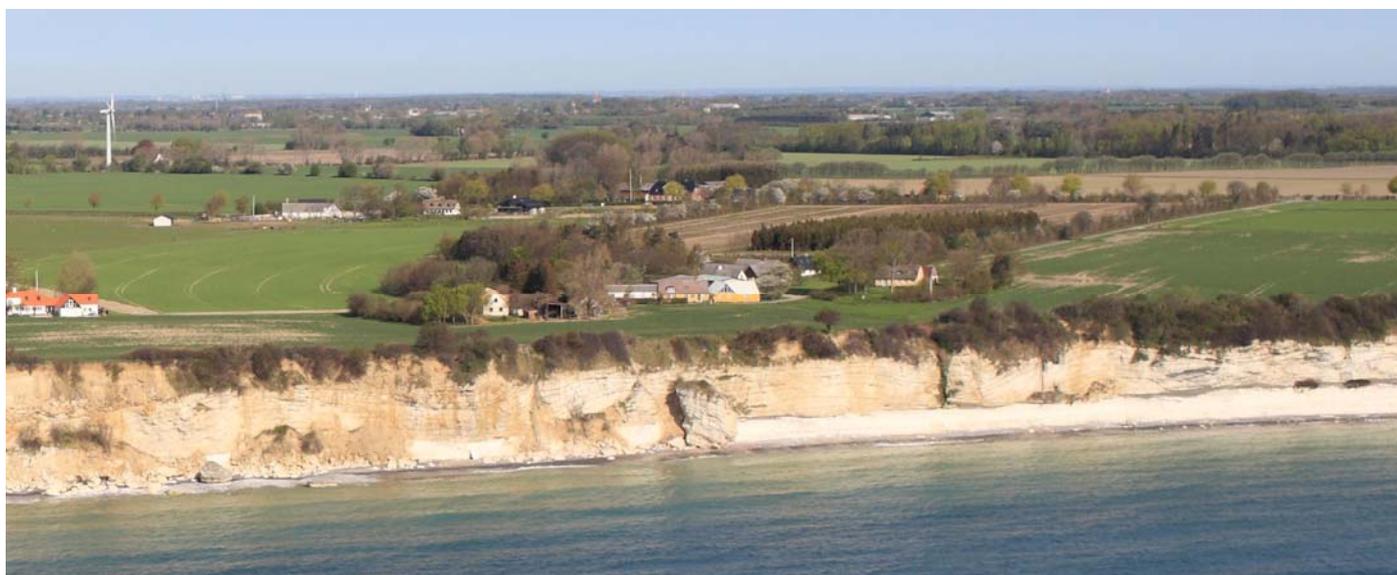
Figure 13. An additional example of cliff-fall from the inner part of Lille Hedding Vig (Loc. 4 in fig. 1). The cliff-fall is seen just below the yellow house, and its dimension of 1200 m³ corresponds well with the general magnitude of cliff-falls.

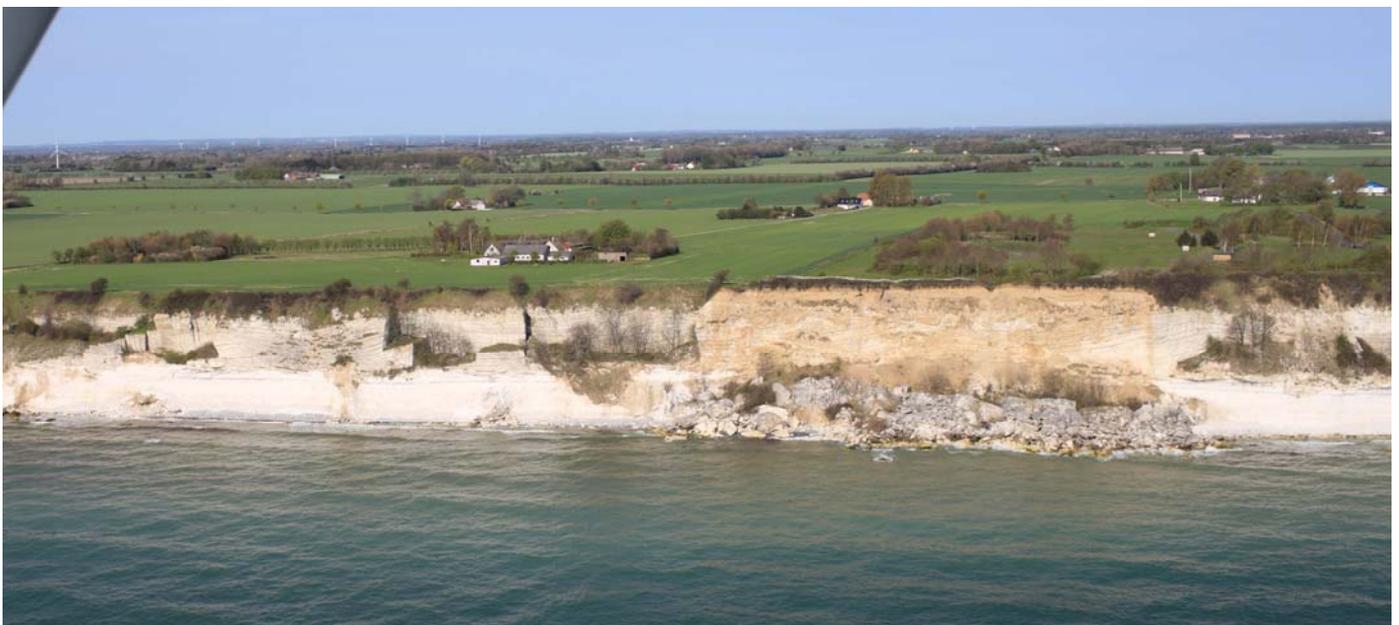
In general the rockfalls leaves a concave escarpment in the cliff and the aggradation of debris results in a cone expanding out into the sea. In Fig. 15 an example of one of the larger rockfall is shown. This rockfall is situated c. 200 m south of Stevns Fyr. The top of the cliff is here 38 m a.s.l., and the uppermost 4 m comprises at till bed. The base of the overhang is situated in 13,5 m a.s.l., and the extension of the debris reached 60 m from the cliff surface.

Figure 15. *The large rockfall c. 200 km south of Stevns Fyr. Note the 3–4 m thick till unit at the top of the cliff. The clay content in the till contributed to a mixed rockfall development.*

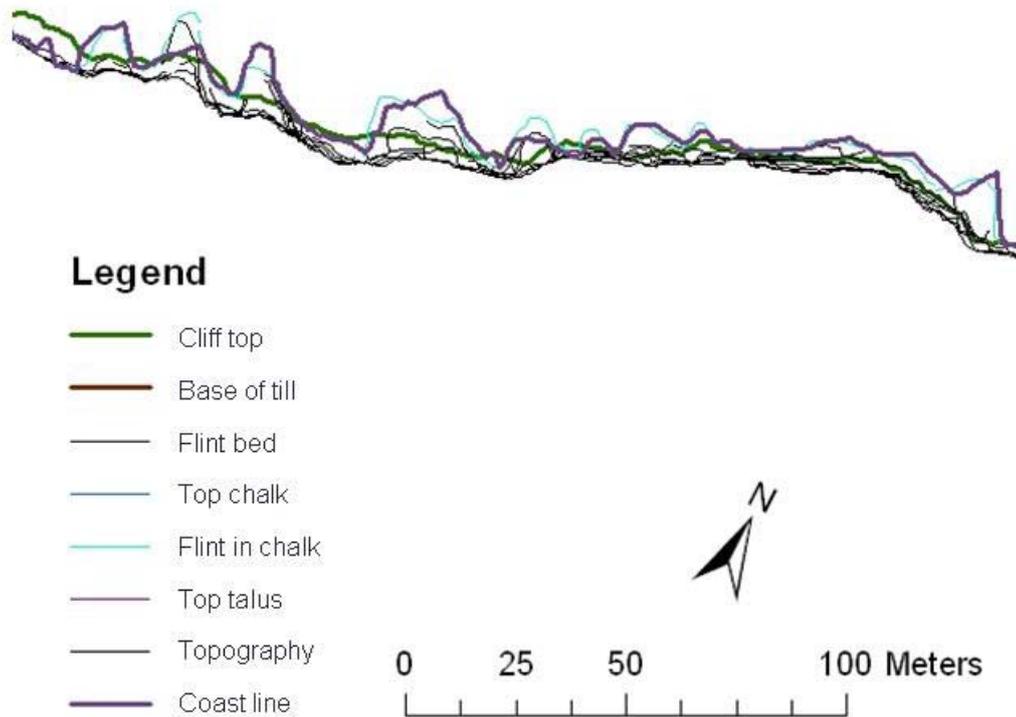
Figure 17. *Photogrammetric contour map of the coastline east of Boesdal. The extension of the wave eroded caves is indicated by the tracing of the Rødvig Formation and underlying chalk marked by blue lines on the map. Note the group of thin black lines are tracings of flint bands in the limestone which represent the surface of overhanging cliff.*

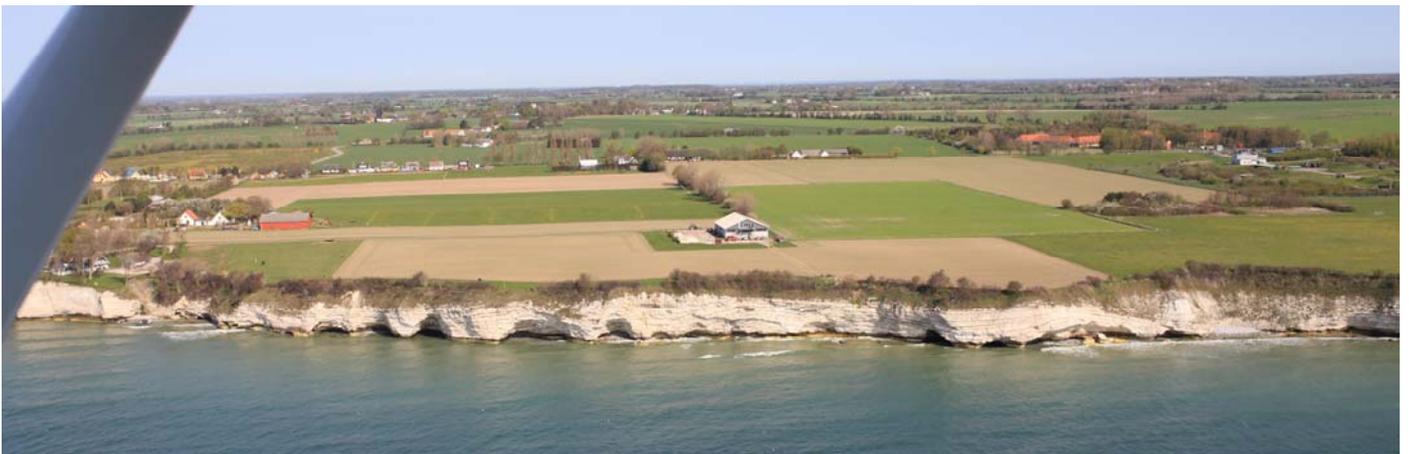
Figure 18. *The coastline east of Boesdal is characterised by breakers erosion of caves. Note the rock-bedding exfoliation blocks present at the shoreline.*

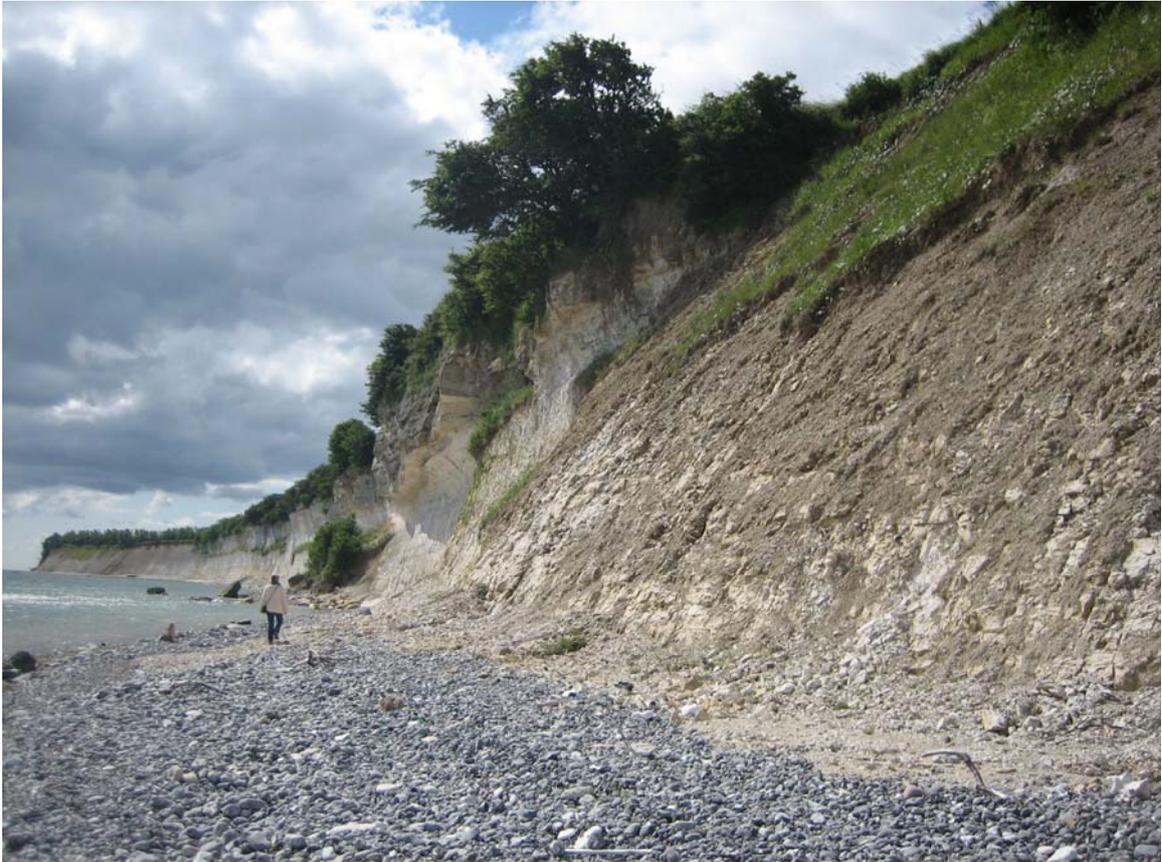
Figure 20. *The general debris shedding generates small talus cones along the toe of the cliff at Stevns Klint. The photo shows the cliff section north of Holtug (Loc. 21 in Fig. 1). Note the characteristic composition of flint cobbles and stones on the foreshore.*

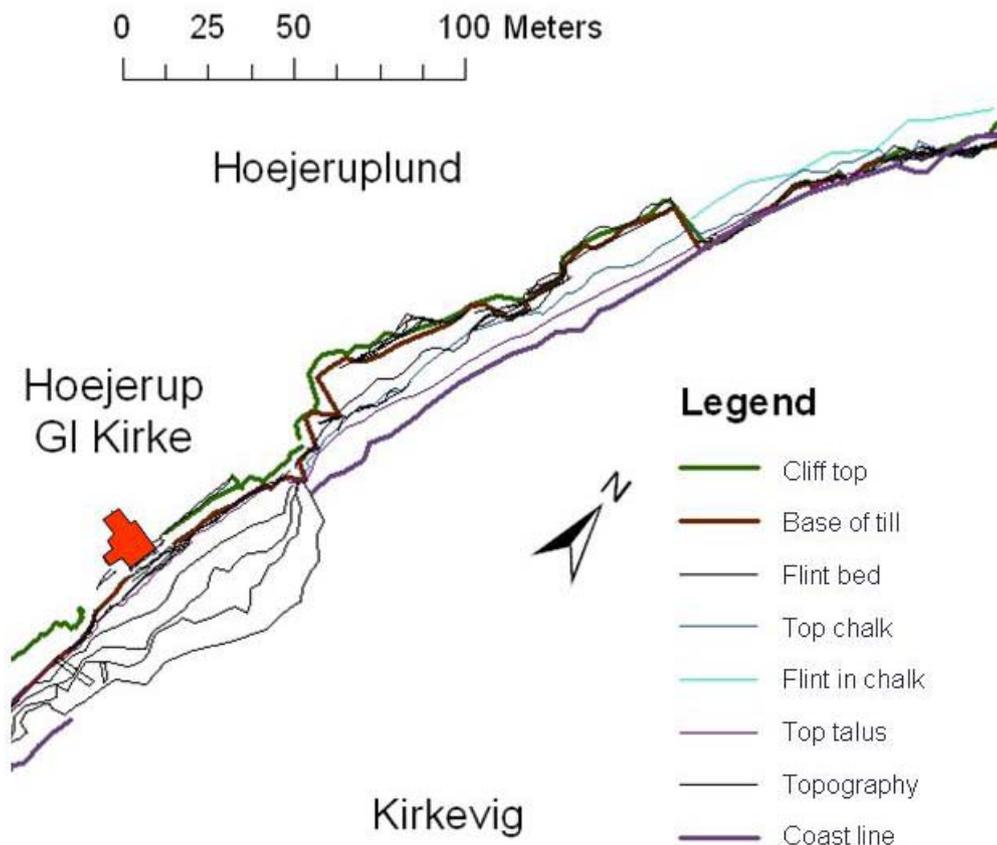
Figure 23. Photogrammetric contour map of the coastline north of Højerup old church. The overhang north of the Højeruplund limestone quarry amounts to 7–8 m. Here an overhang prone to collapse will be created within the next 25–50 years.

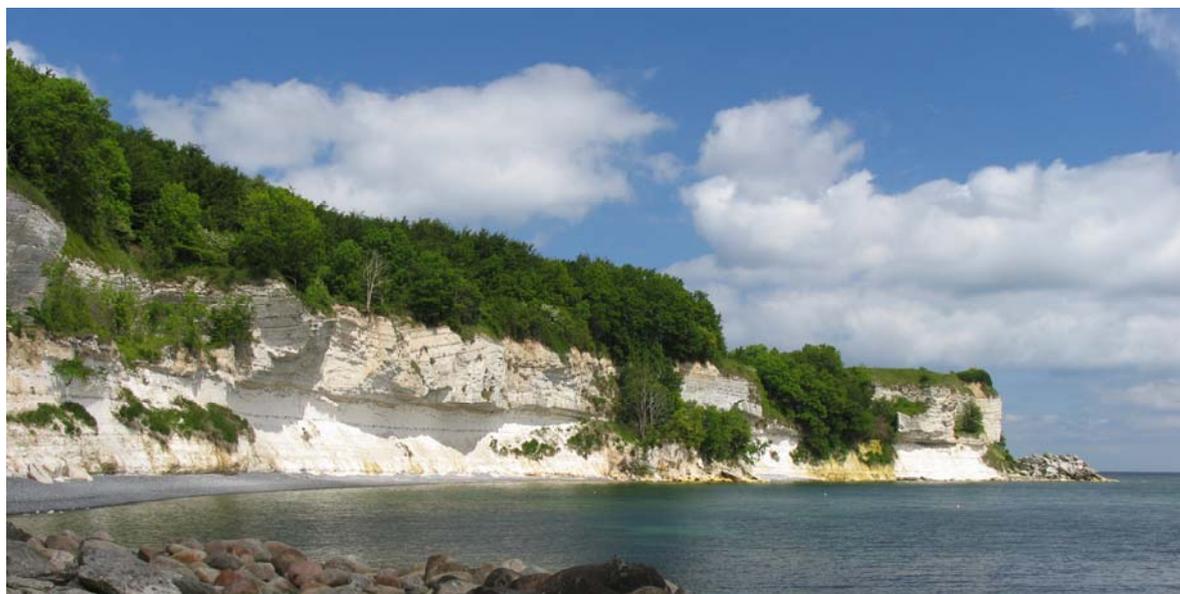
Figure 24. *The coastline north of Højerup old church. In the left side of the picture the traces of the limestone quarry at Højeruplund can be seen. The cliff is exposed to erosion and a hazardous overhang will probably be created within the next 50 years. Photo M. Binderup 2010.*
