Test grid established for the EU-project PROTECT at cliffed terrains in Denmark, England and France

Technical progress report for the 1st years
project period of Partner 4 in PROTECT,
EU-Contract EVK3-CT-2000-00029

Stig A. Schack Pedersen, Ingelise Møller
and Lasse Gudmunsson

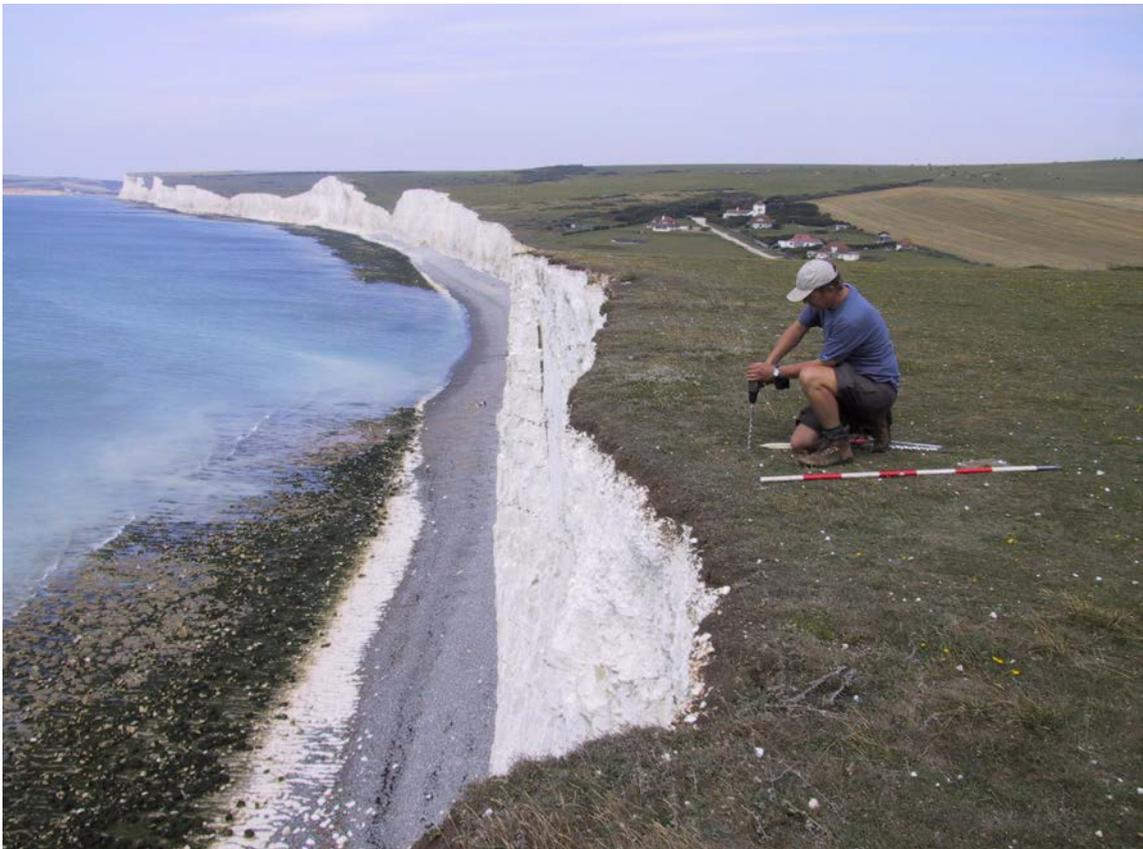
Figure 1. *Establishment of a grid point in the Birling Gab, Eastbourne, test site. First a drill hole was prepared for hammering a wood peg into the ground, which hampered the hammering activity to avoid cliff collapse initiated by hammering along the edge of the cliff. On top of the peg a nail marks the precise position of the point.*

For testing the dislocations in the terrain a grid has been established at each research field. The grid consists of a number of fix points marked with wooden pegs hammered down in a small drill hole into the chalky soil. On top of the pegs, marked with red colour, a small nail marks the precise position of the grid point. Subsequent the grid points have been measured with Leica electronic total station (TC600, theodolite) with reflection prism distance calibration. In addition to the grid points a number of established fix points have been identified and measured.

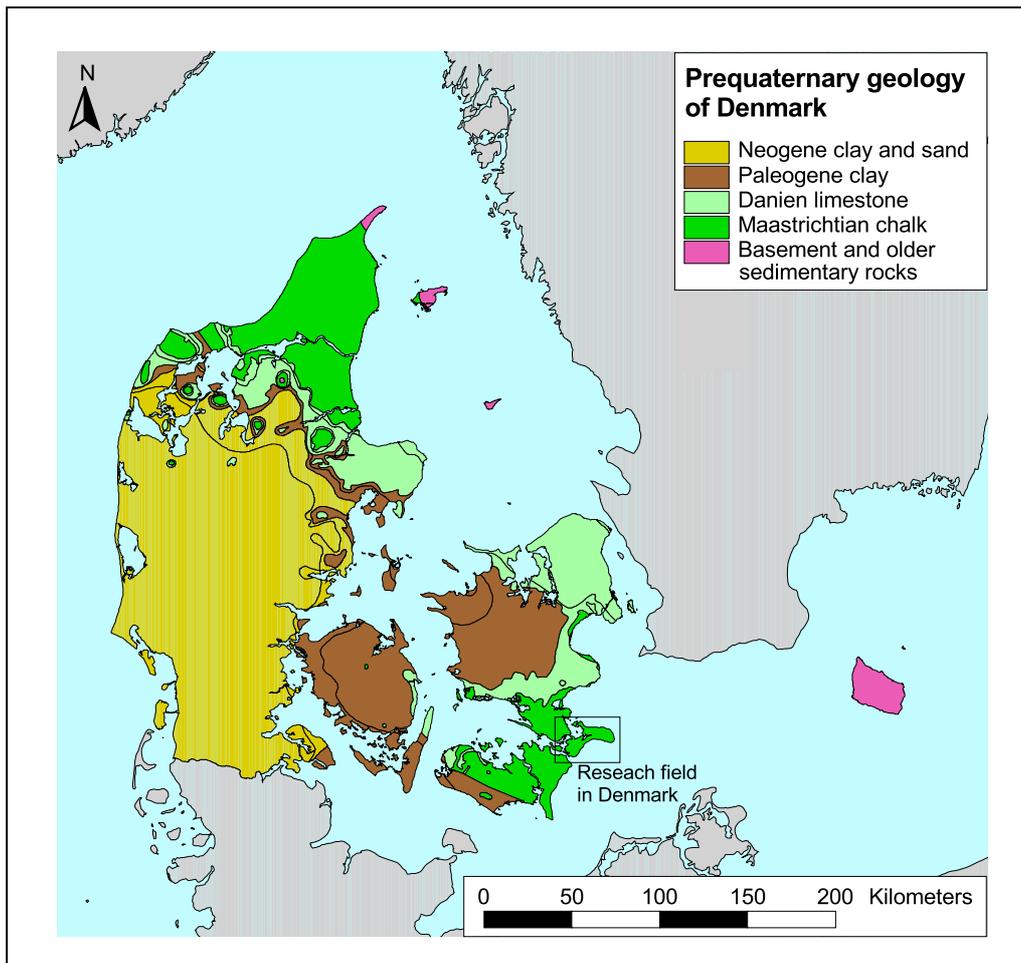
Figure 2. Geological map of Denmark which shows the distribution of chalk and the location of the Danish research field.

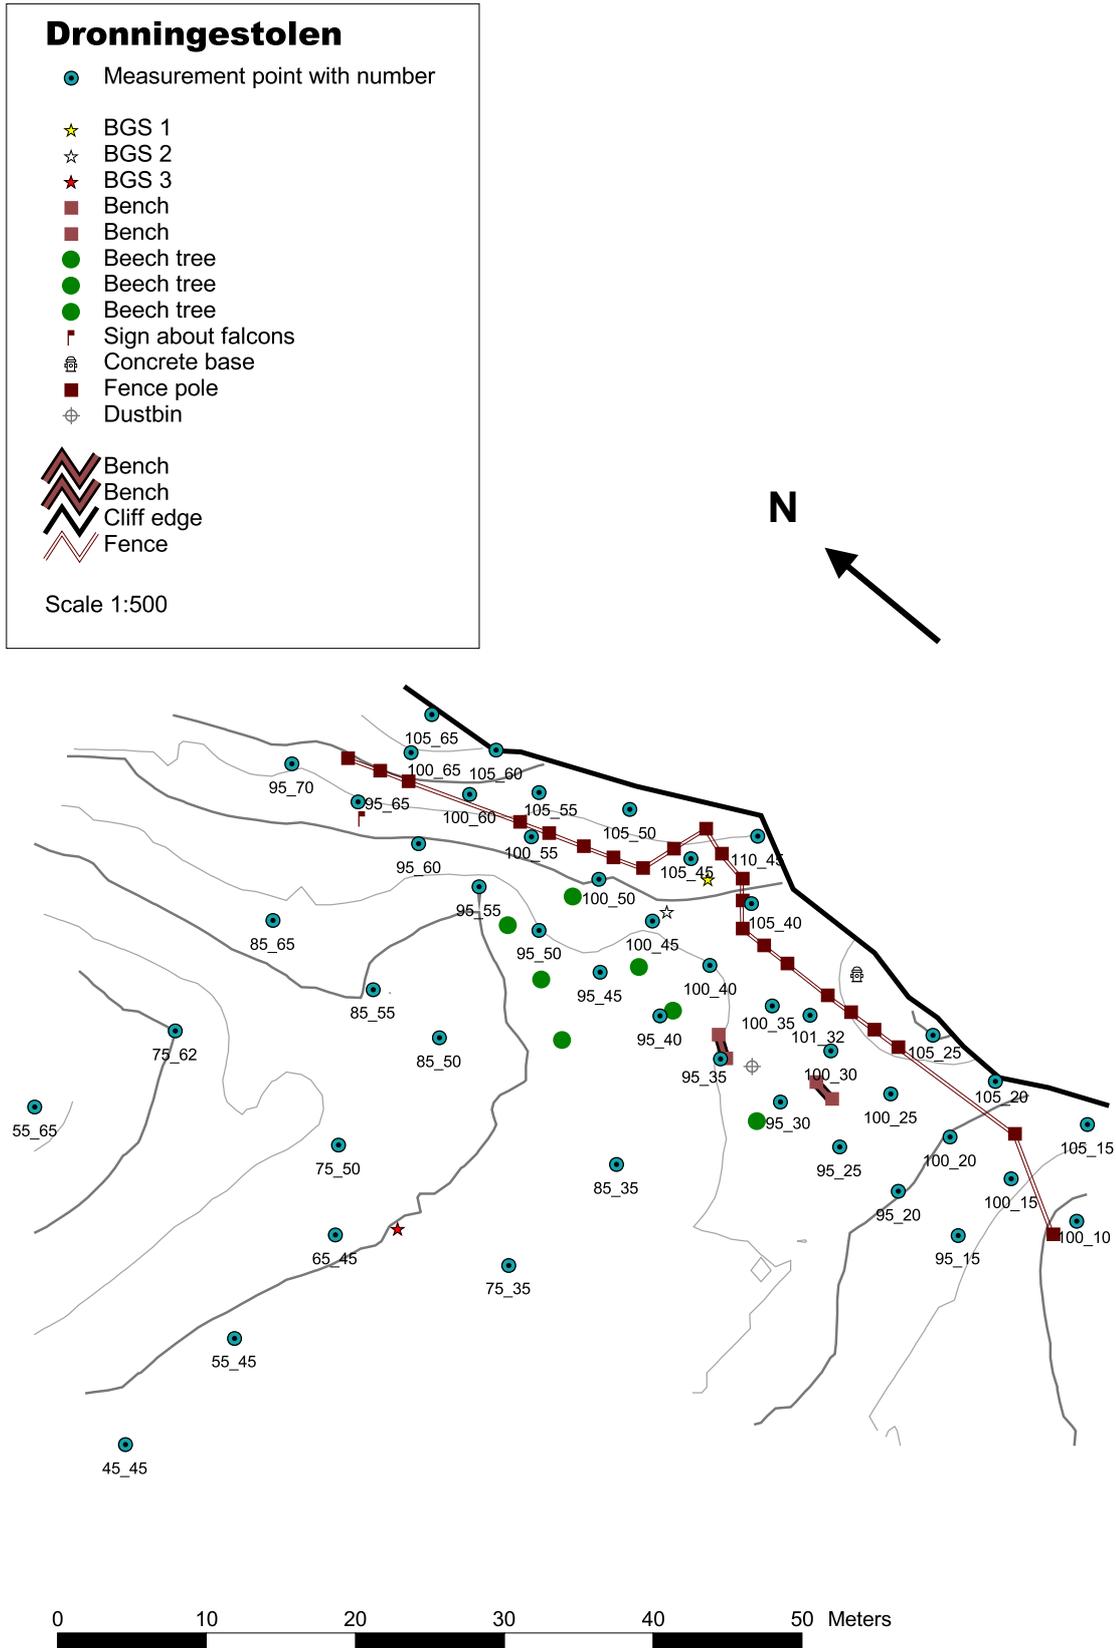
Figure 4. *The test grid established at Dronningestolen, Møns Klint.*

This grid is situated on the highest cliff of Møn's Klint c. 130 m above sea level (Fig. 3). The field is situated in a public forest area managed by the Agency of Natural Preservation and Forestry, Ministry of the Environment. Only 100 m away from the grid the last hazardous rock fall took place in 1994, which killed one person. The grid is vulnerable to public traffic and icy ground in the winter time (Fig. 5 and 6). Some of the grid pegs are difficult to find in the summer time due to the forest vegetation.

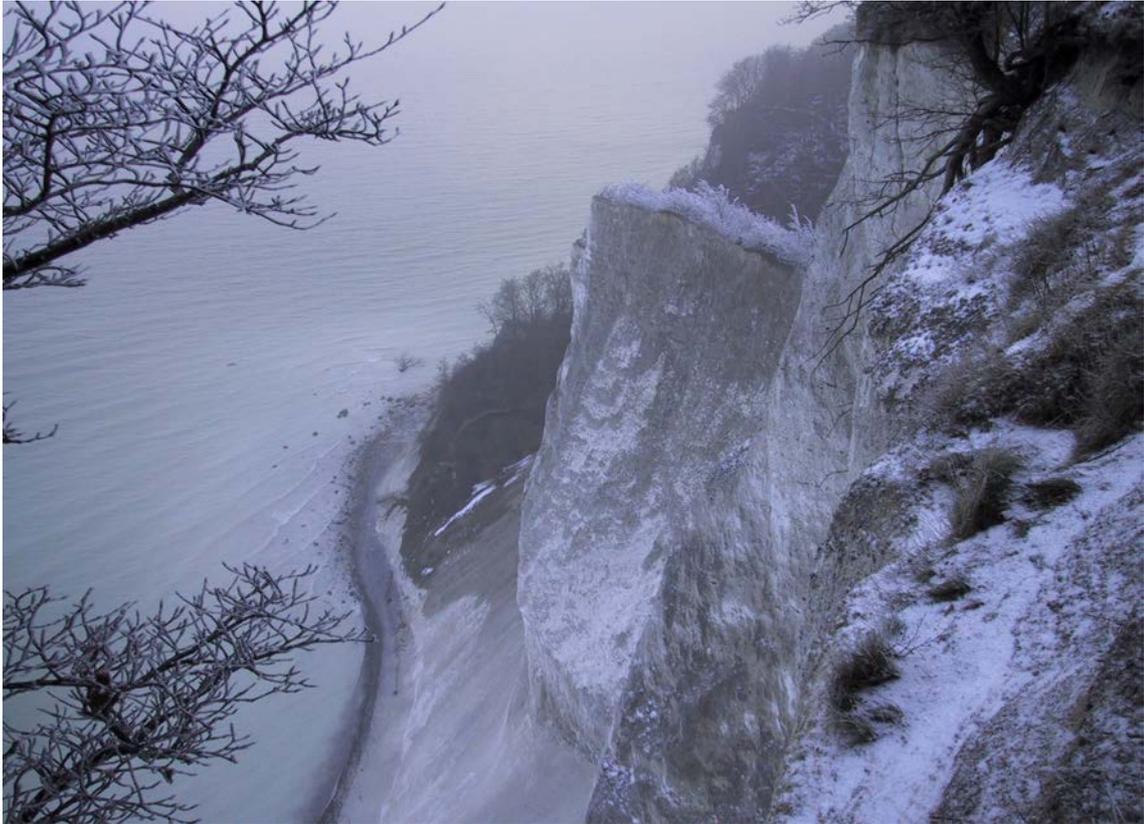
Figure 5. *View from the Dronningestolen towards the beach in January 2002 .*

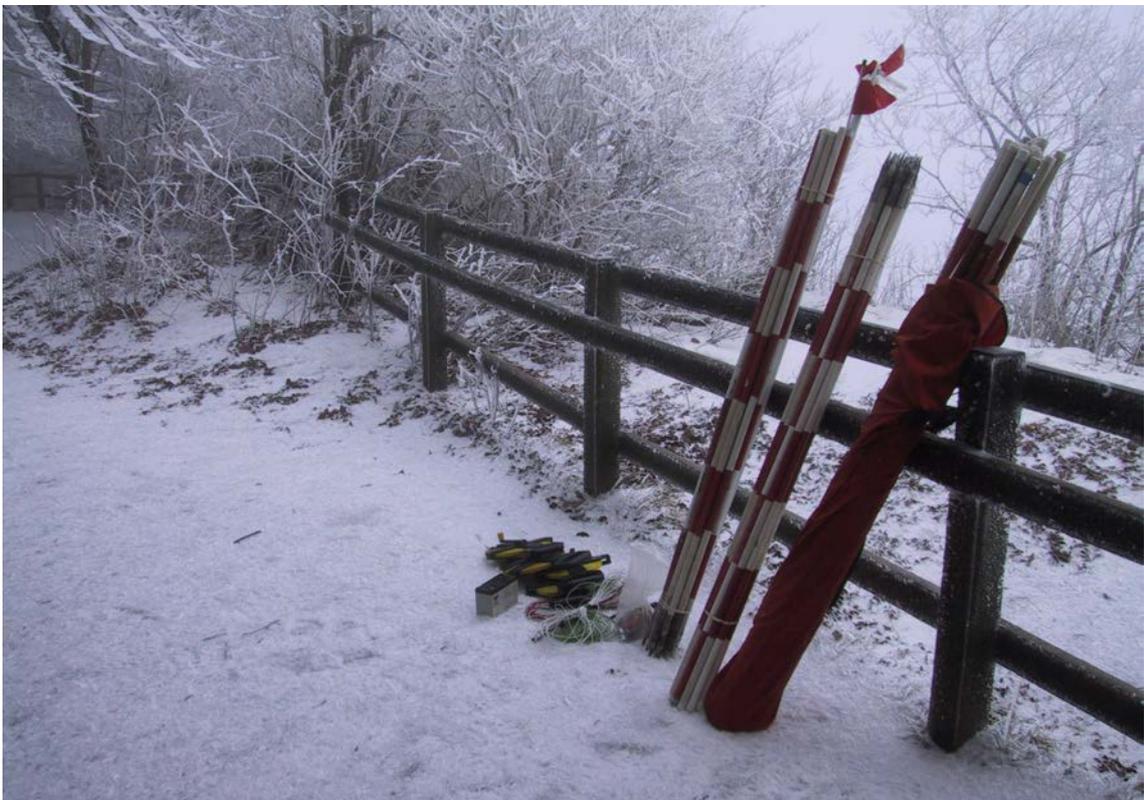
Figure 6. *Icy ground on the test site of Dronningestolen a winter day in January.*

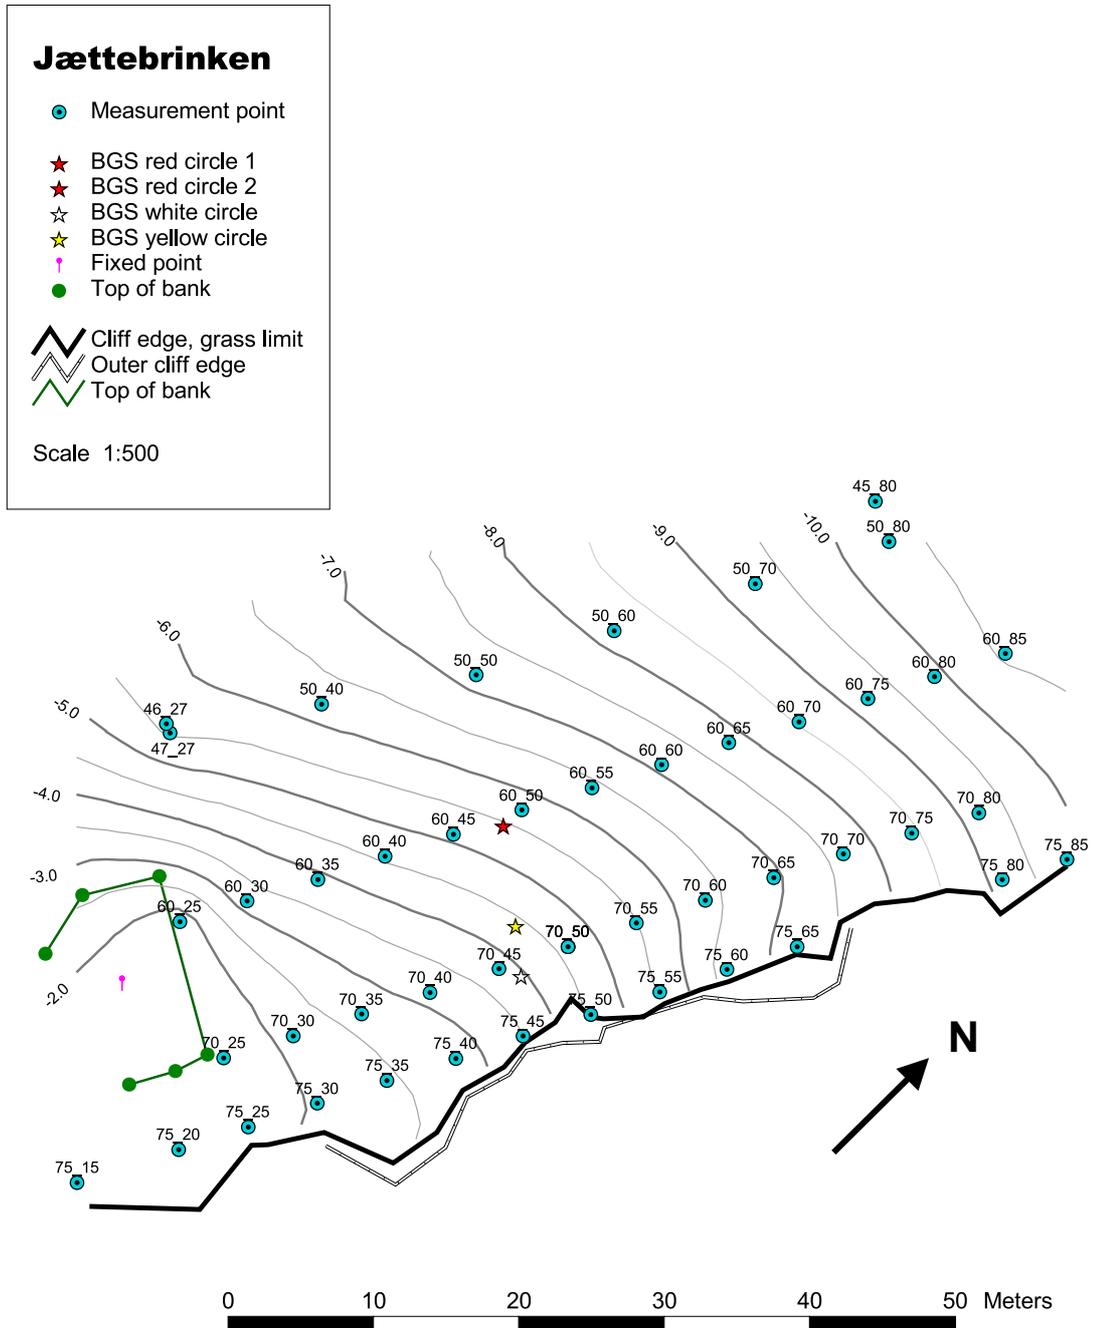
Figure 7. The test grid established at Jättebrinken, Møns Klint.

This grid is established in a grass field on top of the only 25–30 m high vertical cliff Jättebrinken on the southern part of Møns Klint (Fig. 7). The field is private owned and permission for access has been given by the local count of Klintholm. The field is well protected and easy accessible. A small landslide affected the cliff 100 m north of the grid in the end of February this year.

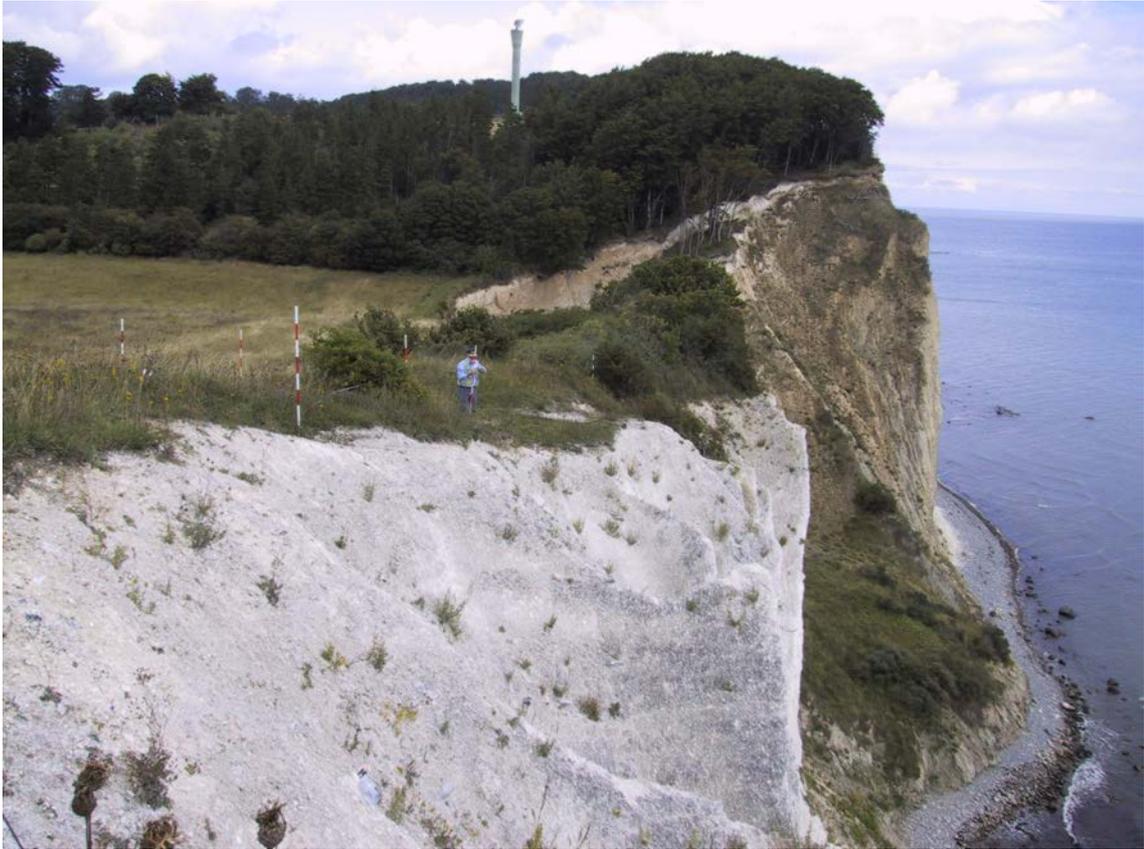
Figure 8. *The Jättebrinken test site, southern part of Møns Klint, September 2001.*

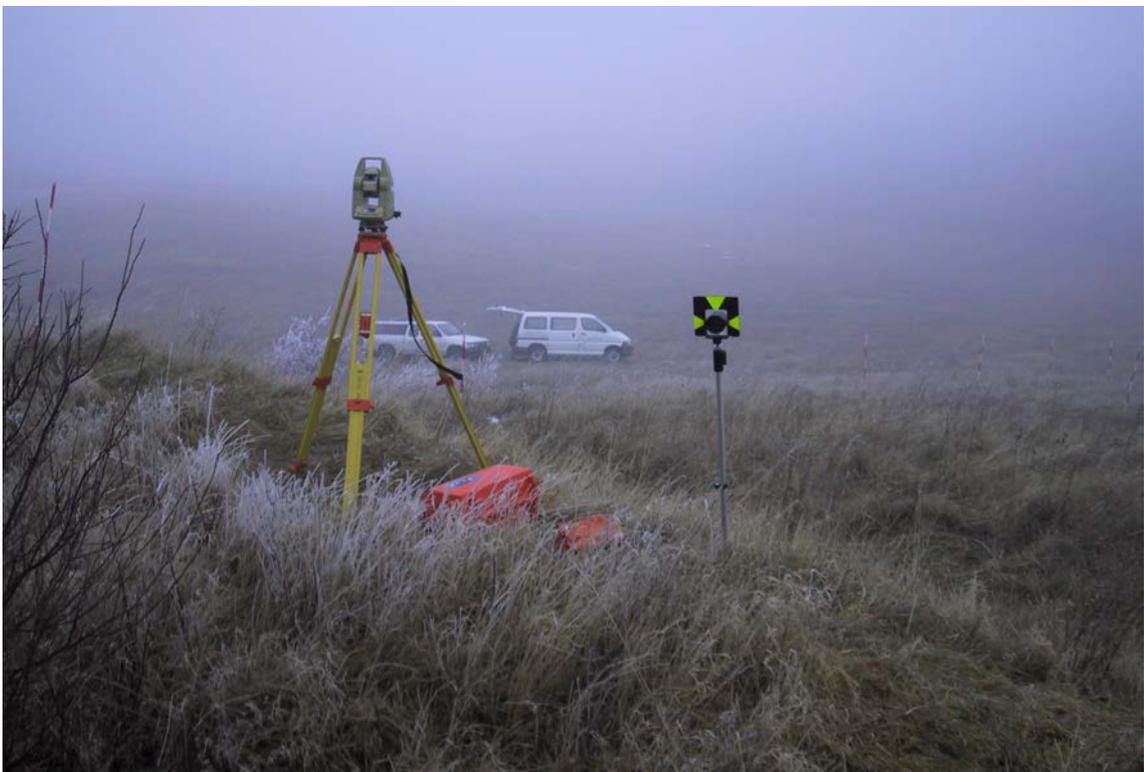
Figure 9. *The Leica electronic total station and reflection prism applied for the grid measurements.*

The Leica total station has a standard mode accuracy on 3 mm +3 ppm (=3mm/km).

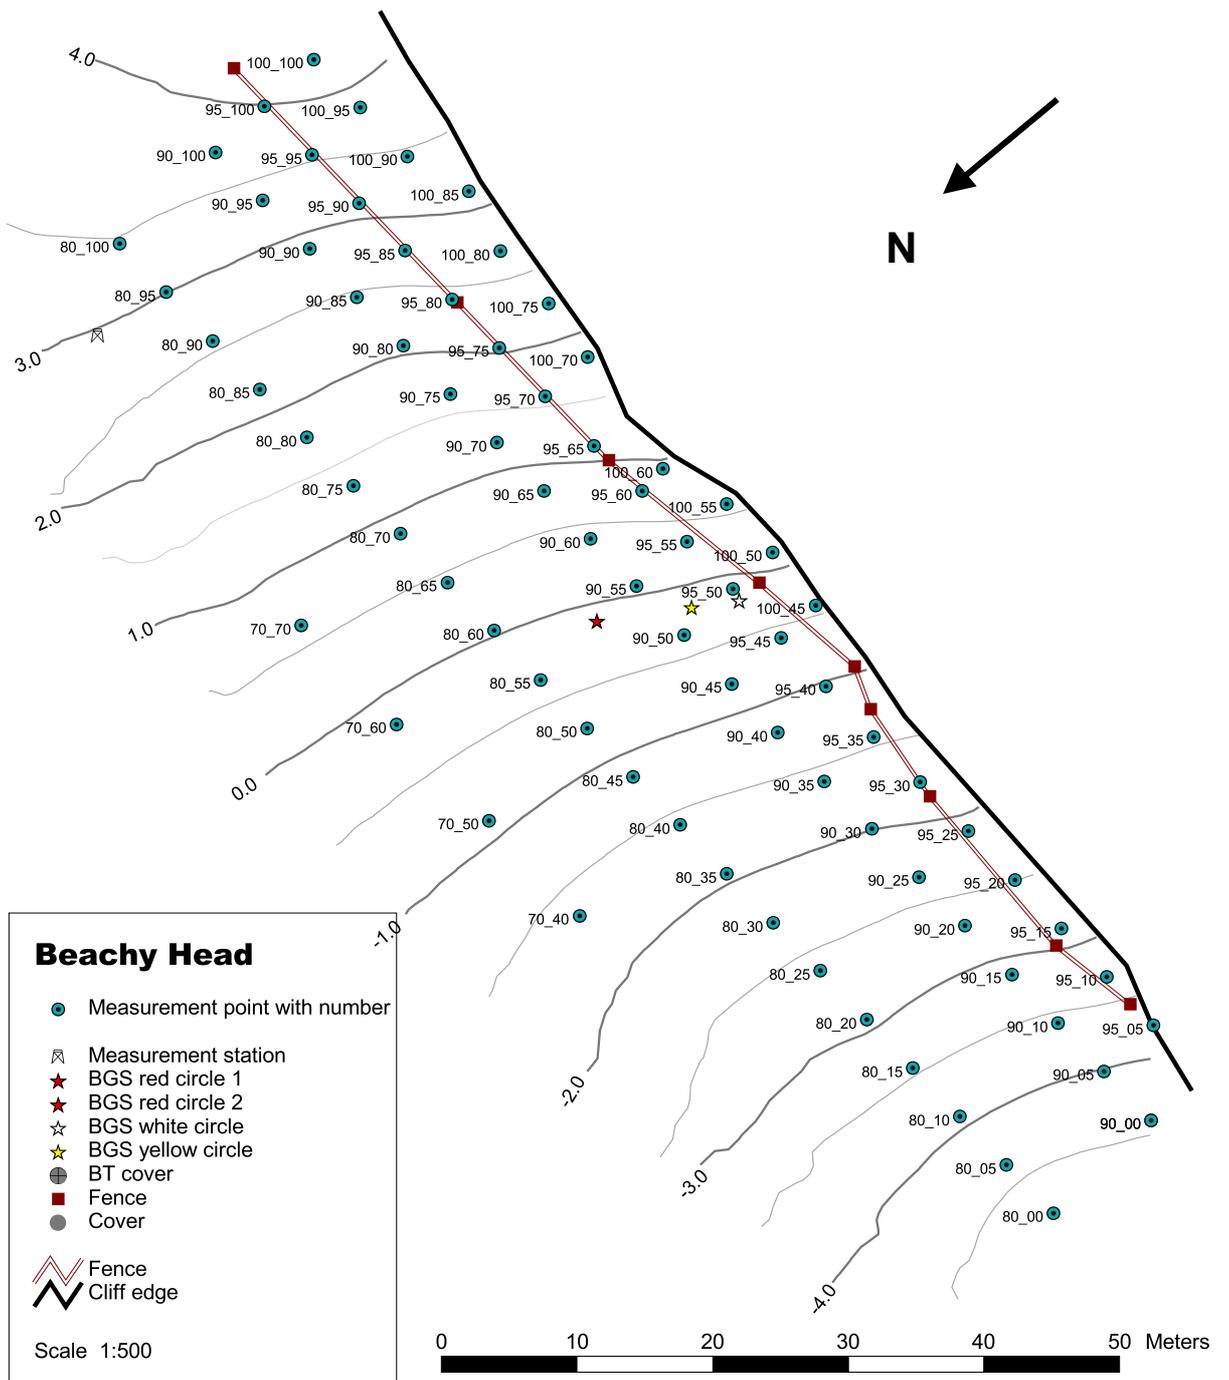
Figure 11. *The test grid established at Beachy Head.*

The grid at Beachy Head is established in a public grass field west of Eastbourne, very close to the site where a rock fall took place two years ago near the light house at the sea point of Beachy Head (Figs 11, 12 and 13). The field is managed by the local county of Eastbourne and permission for access has been given by the local ranger. The grid is vulnerable to public traffic, but no grid points has been damaged until now. However, a reference point 100 m away from the cliff edge has been destroyed by the grass cutter machine.

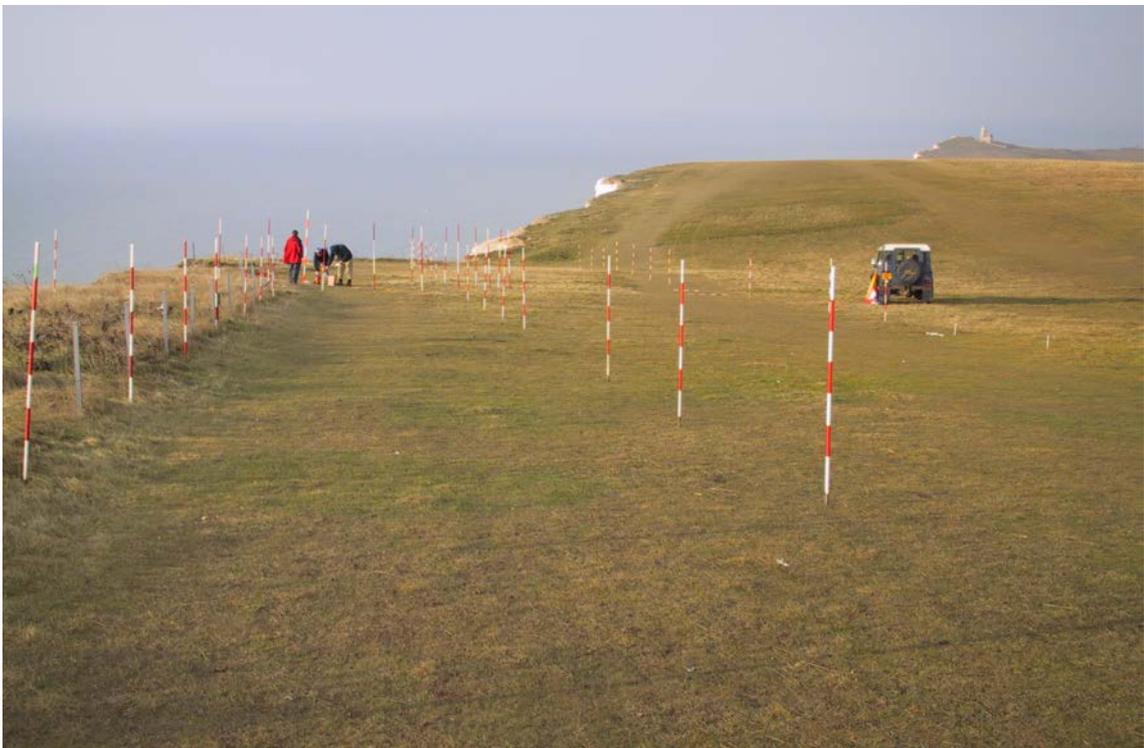
Figure 13. *The field above the chalk cliff at Beachy Head, where the test grid is established. Note the field team carrying out the azimuthal resistivity measurements.*

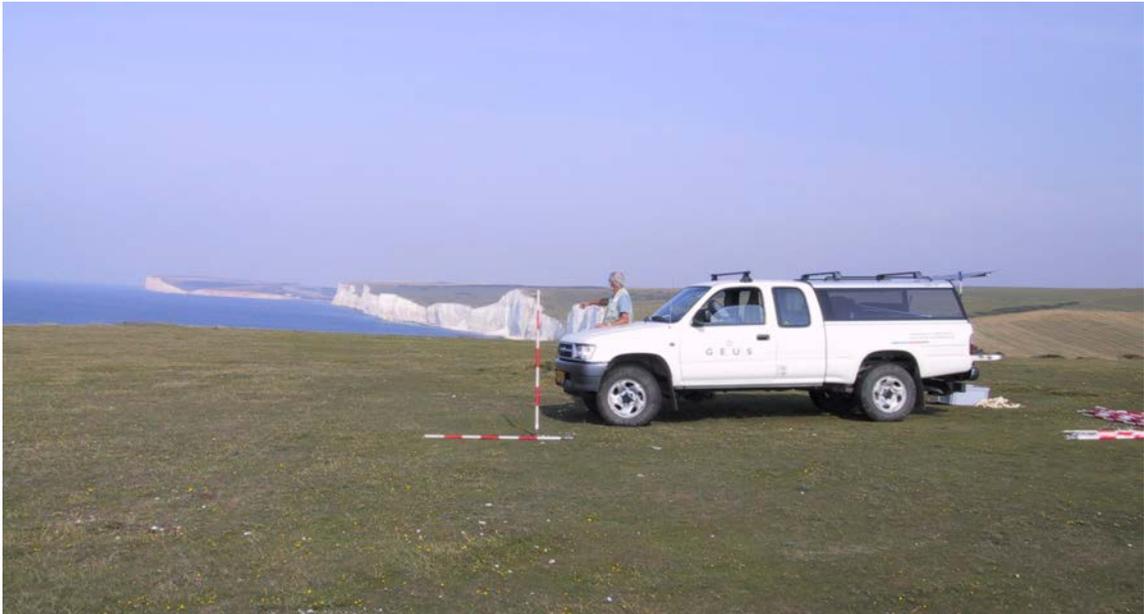
Figure 14. *The test site at Birling Gap looking towards the Seven Sisters to the west.*

The grid is established in a public grass field at the cliff top above the local pub and parking area of Birling Gab (Fig. 14, 15 and 16). The field is managed by the National Trust and permission for access has been given by the local ranger. A major fault zone is crossing the grid and it is expected that dislocation of the surface will be related to this tectonic feature.

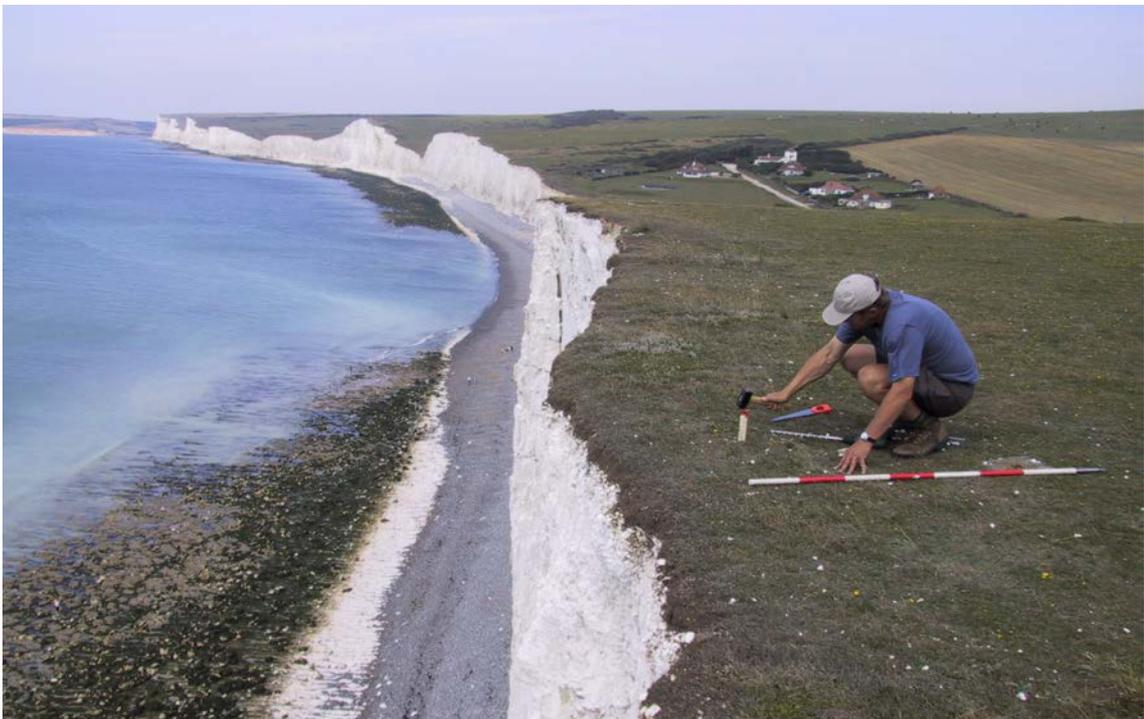
Figure 15. *The emplacement of one of the wood pegs, which mark the grid points in the test grid, September 2001.*

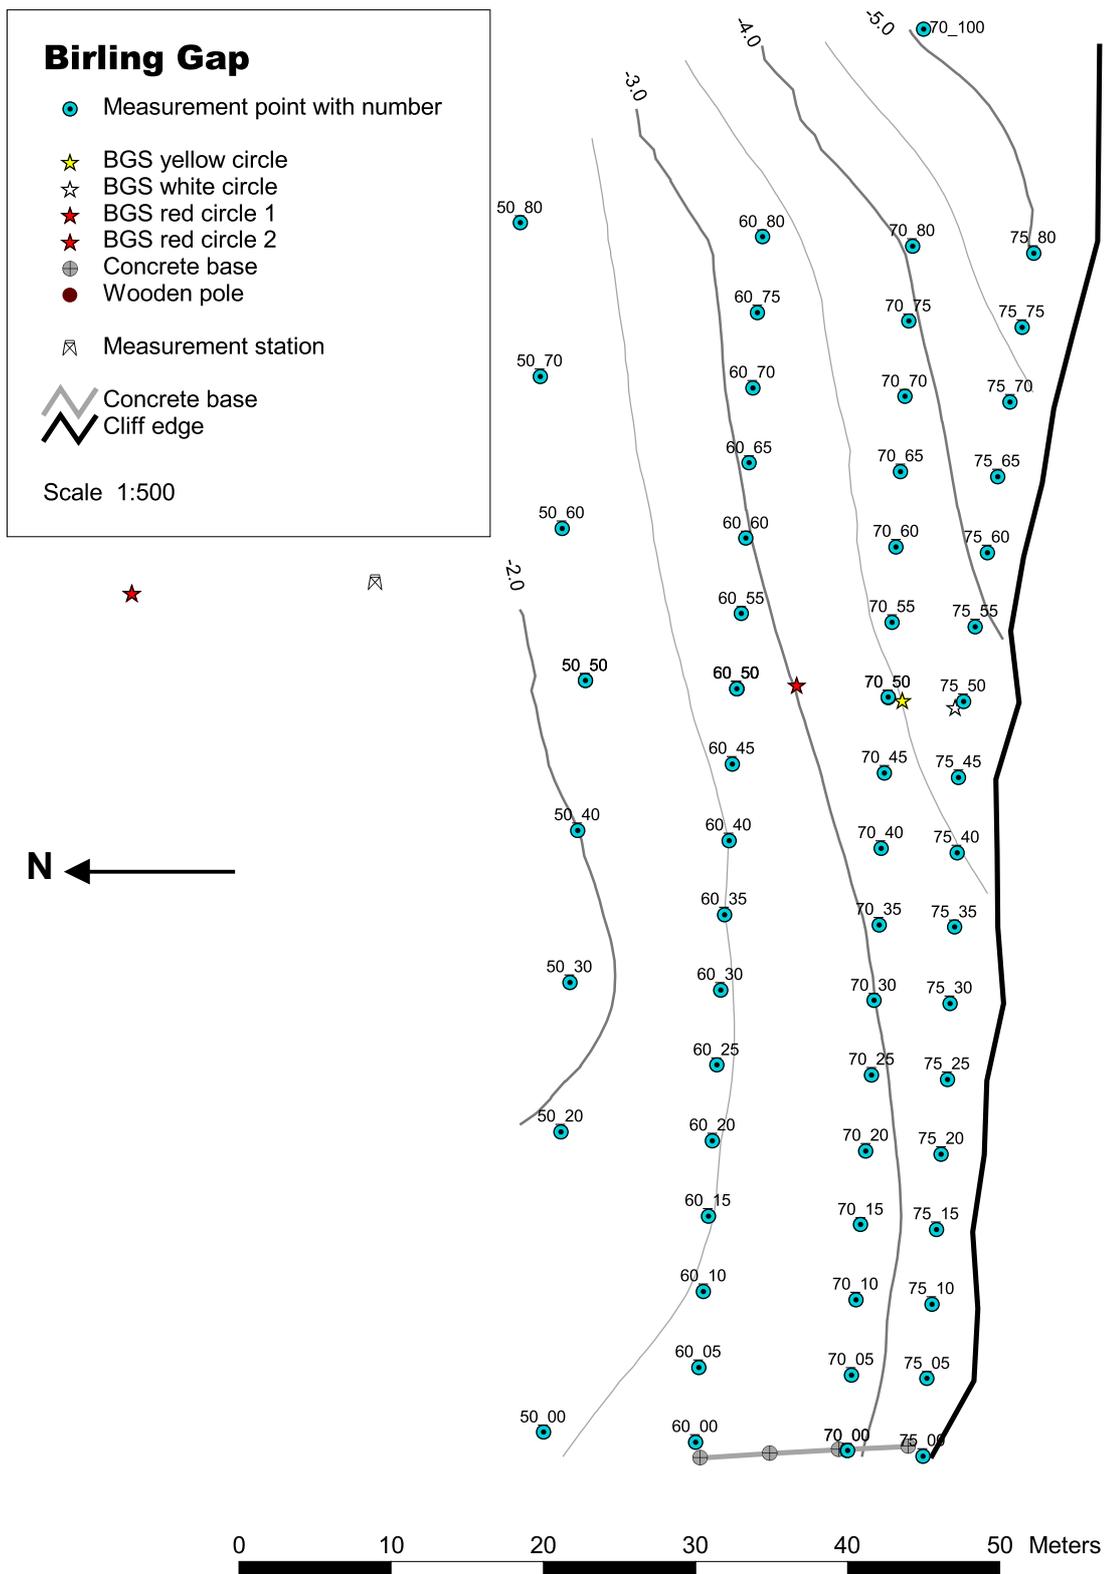
Figure 16. *The test grid established at Birling Gap.*

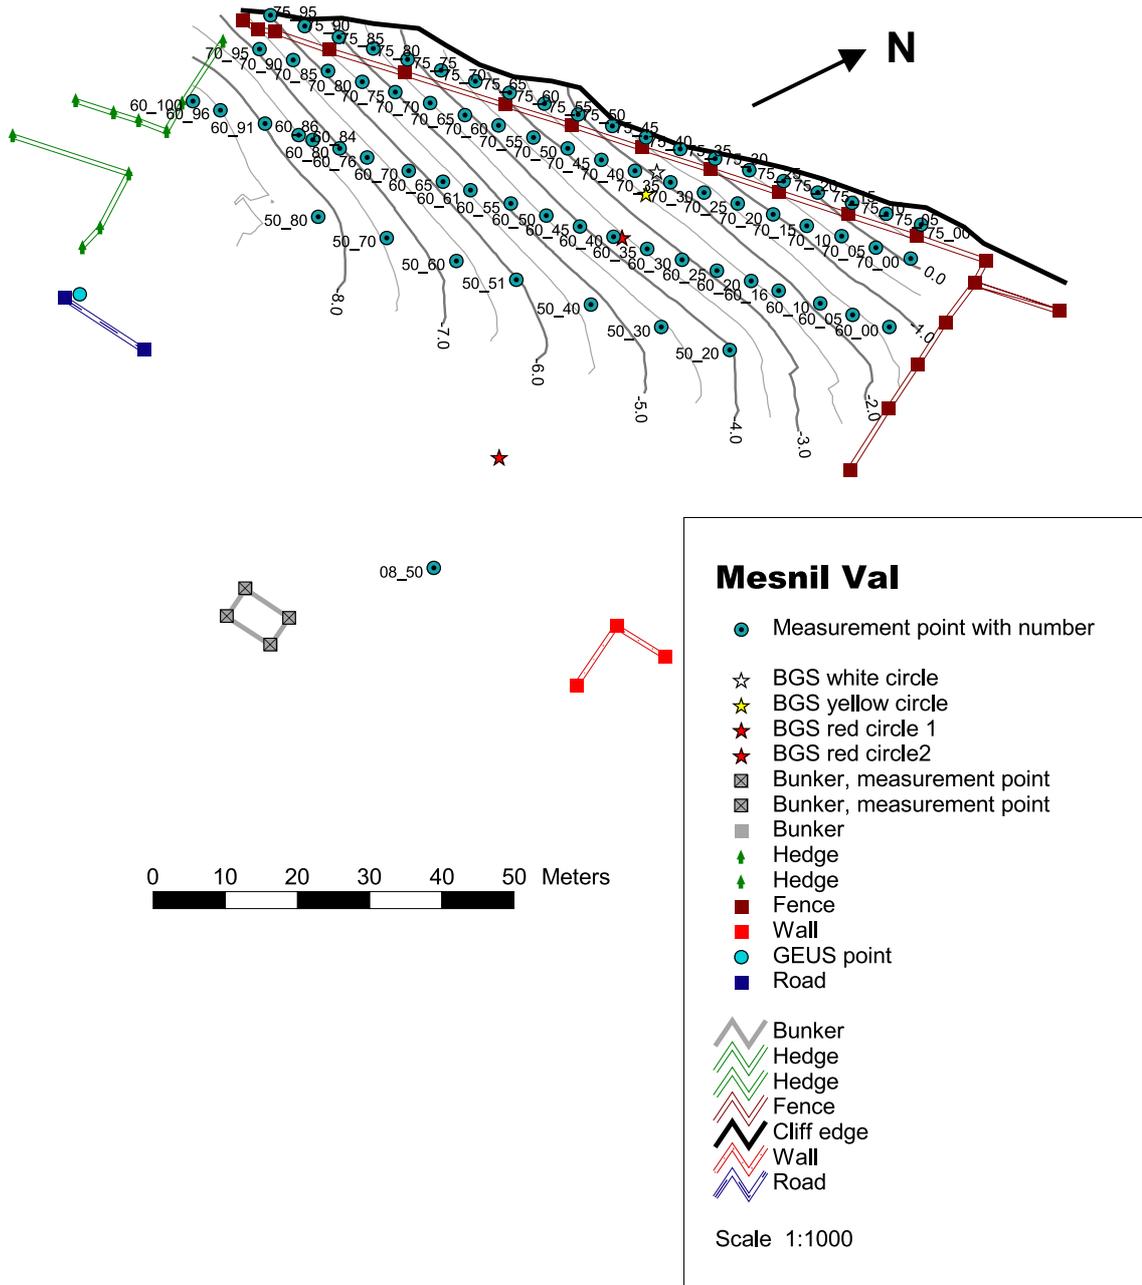
Figure 18. *The test grid established at Mesnil-Val.*

The grid is established in a local private hay field east of the local village Mesnil-Val. The established grid has suffered minor destruction during the activities of organising and putting up the sensors and equipment for the acoustic measurements. This part of the grid was subsequent re-established with new grid points in January 2002.

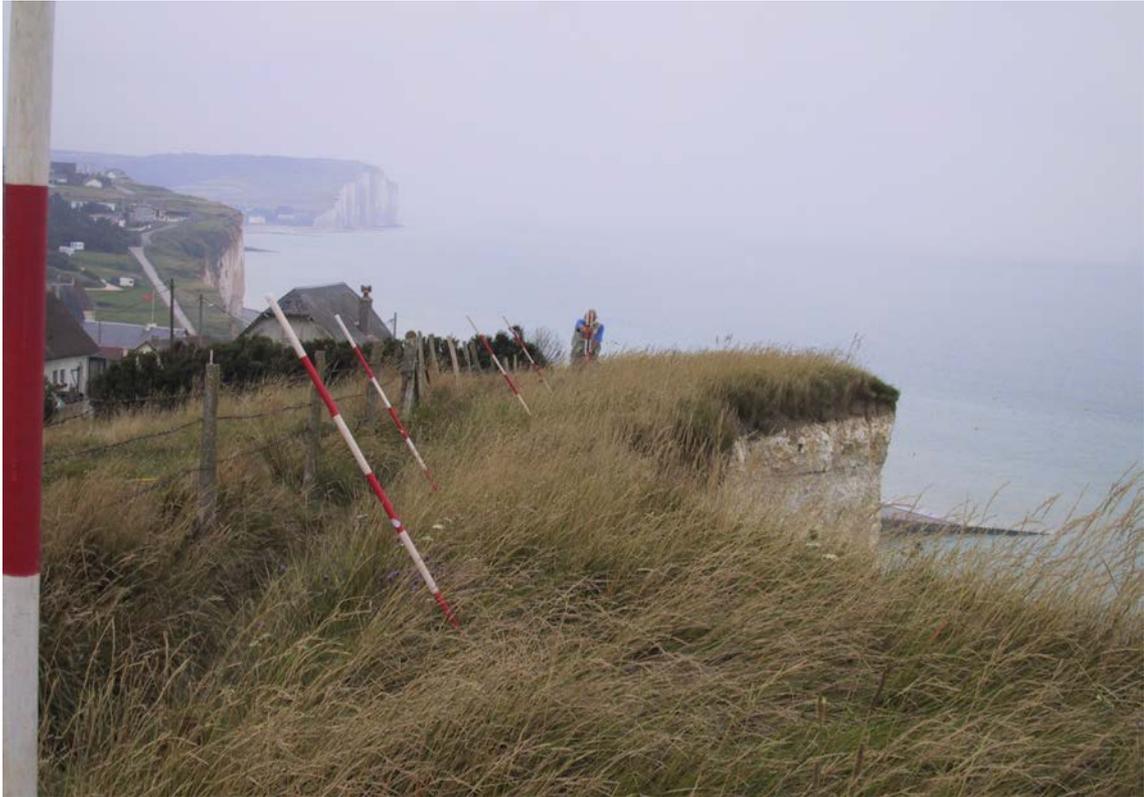
Figure 19. *The grid line at the outer edge of the Mesnil-Val test field.*

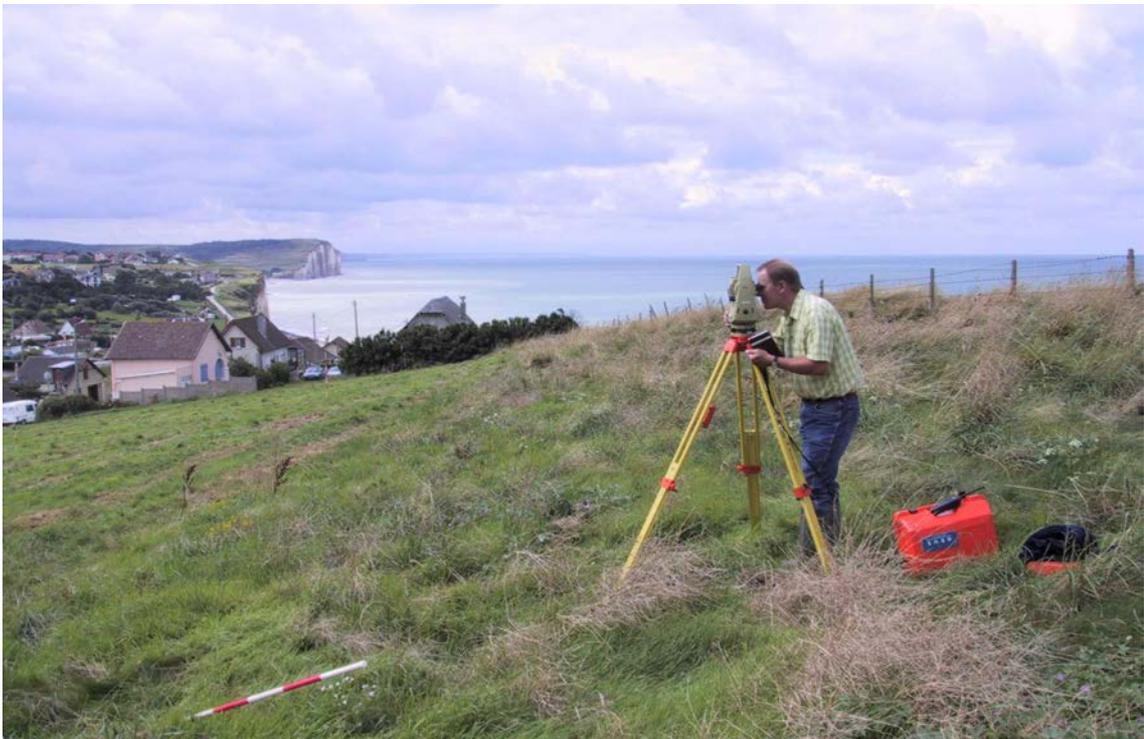
Figure 20. *Measurements carried out with the Leica total station at the Mesnil-Val site.*

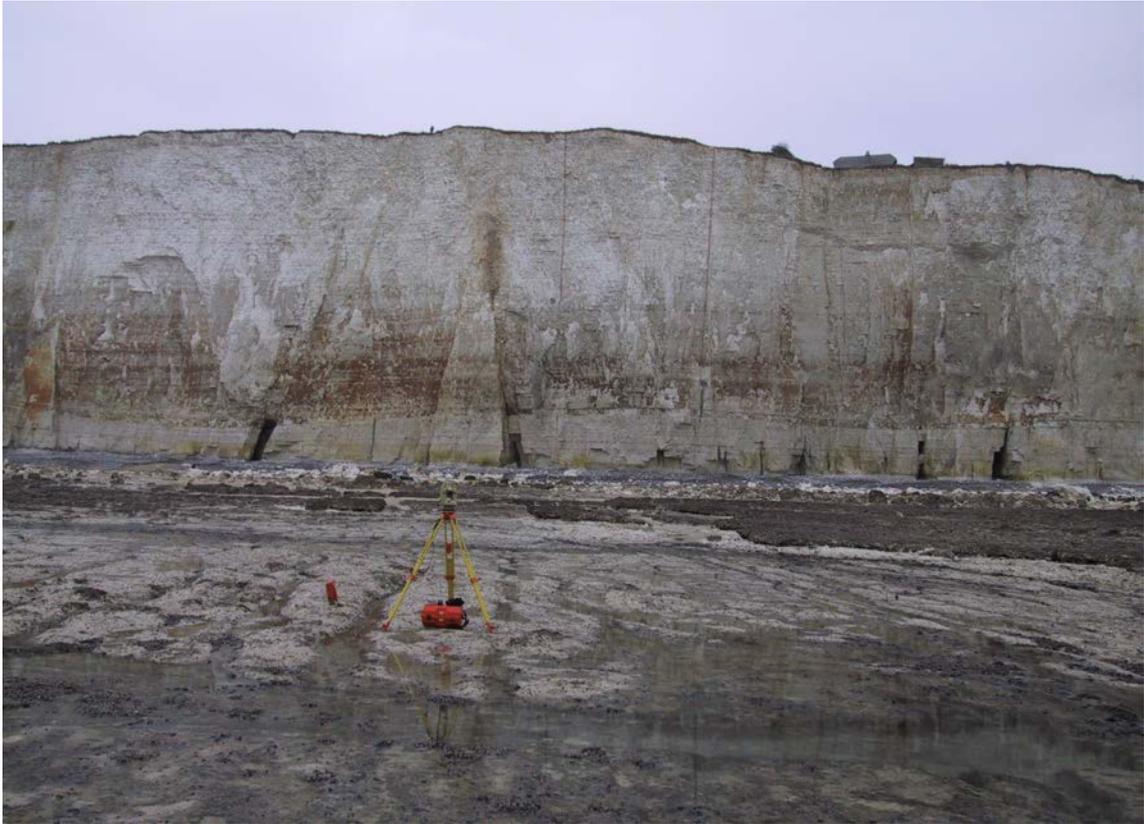
Figure 21. *The steep cliff section below the Mesnil-Val test site seen from the tidal flat at low tide.*

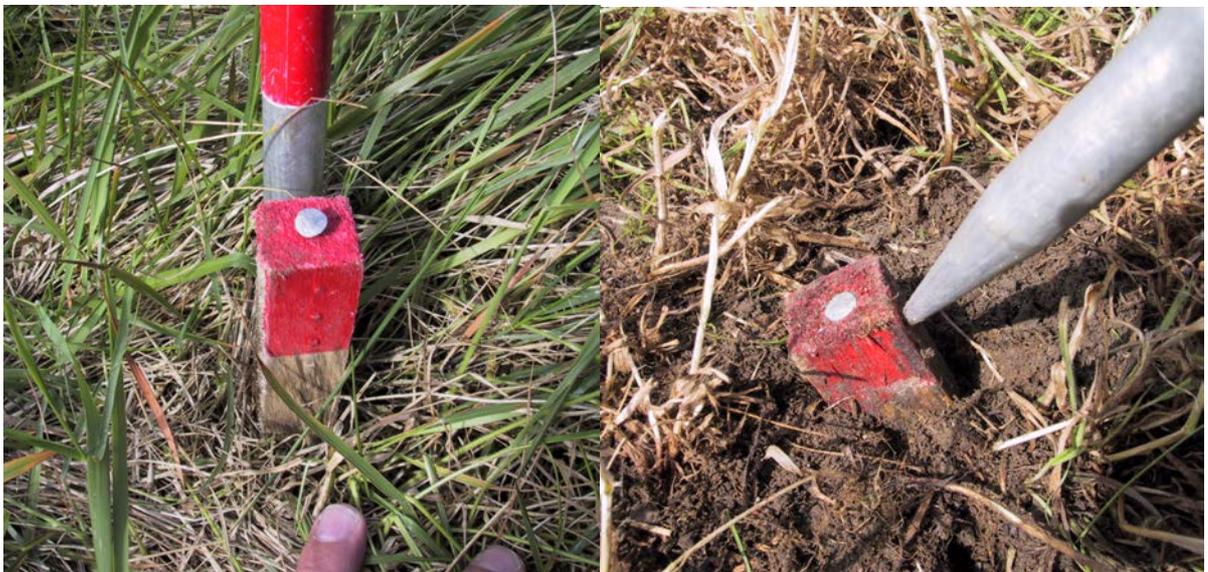
Figure 22. *Grid point established in the test grid consists of a wooden peg about 30 to 50 cm long (left) hammered into the chalky ground. In part of the Mesnil-Val grid the points were destroyed during the constructional work related to the establishment of the acoustic sensors (right), and these point had to be re-established subsequently.*

Finally a number of accidental small disturbances may occur. Naturally larger damage of grid points by machinery etc. can easily be recognised (Fig. 22). However, smaller distortions due to animal activities and passing pedestrians or even vehicles may occur without being noted by the measuring team. A few points are excluded in the calculation of standard deviation due to the suspicion of this type of error.

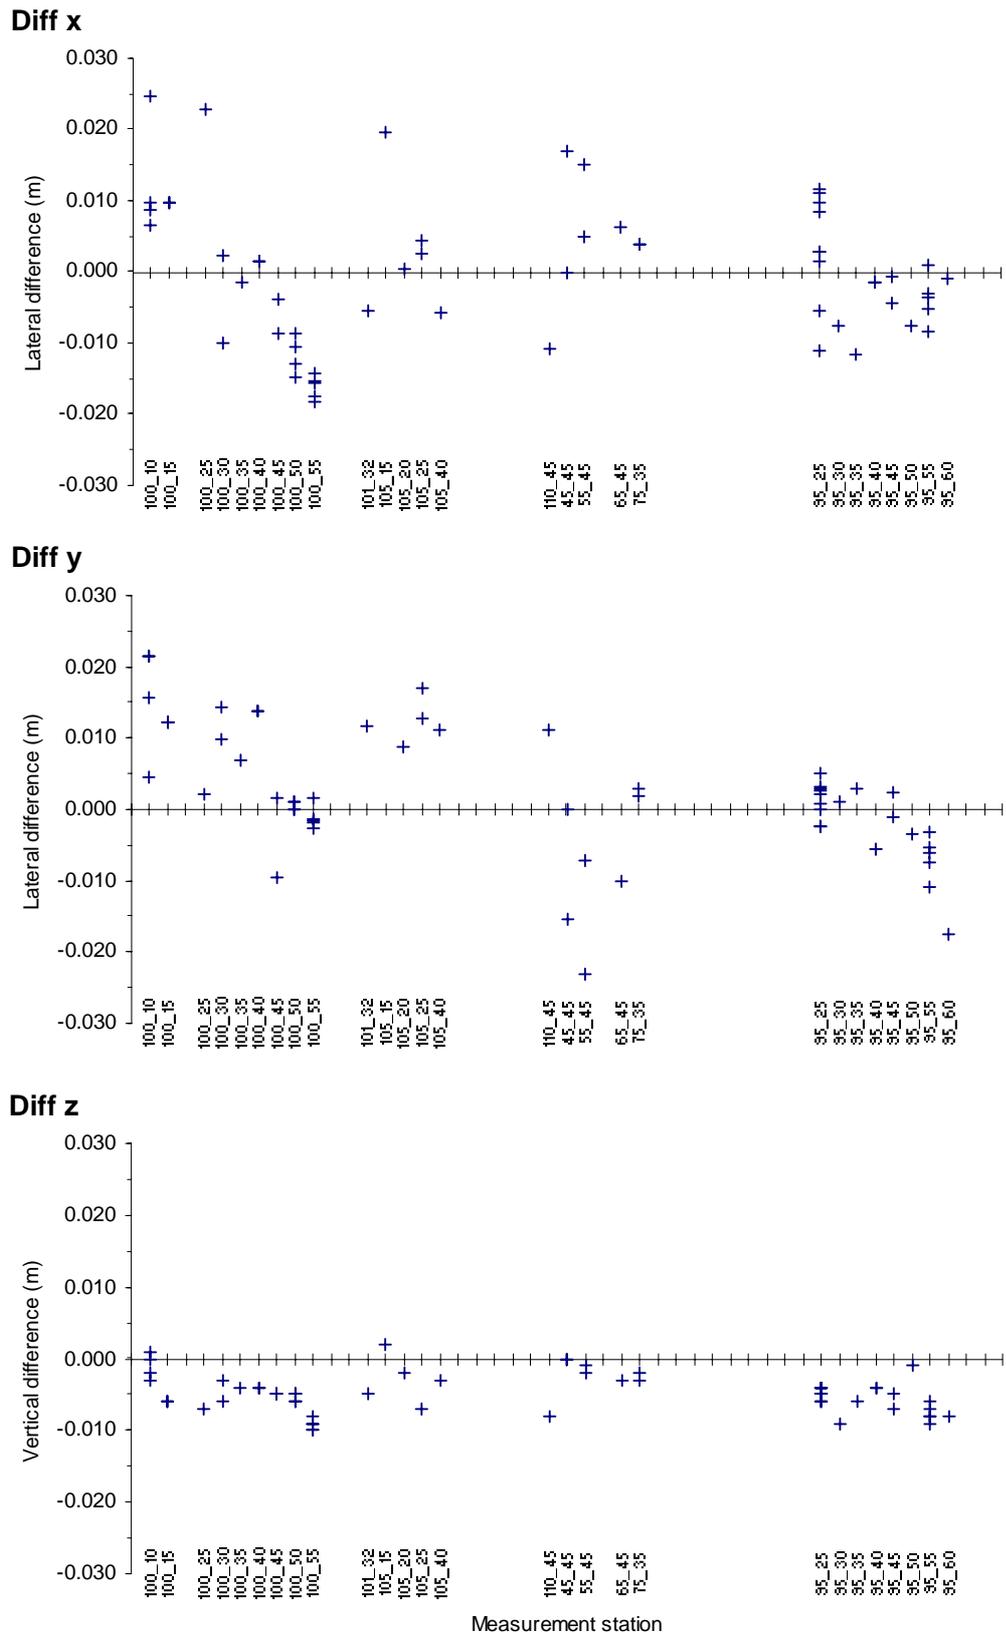
Figure 23. *Dronningstolen, difference between May 2001 and September 2001*
