Test grid established for the EU-project PROTECT at cliffed terrains in Denmark, England and France

Technical progress report for the 1st years
project period of Partner 4 in PROTECT,
EU-Contract EVK3-CT-2000-00029

Stig A. Schack Pedersen, Ingelise Møller
and Lasse Gudmunsson

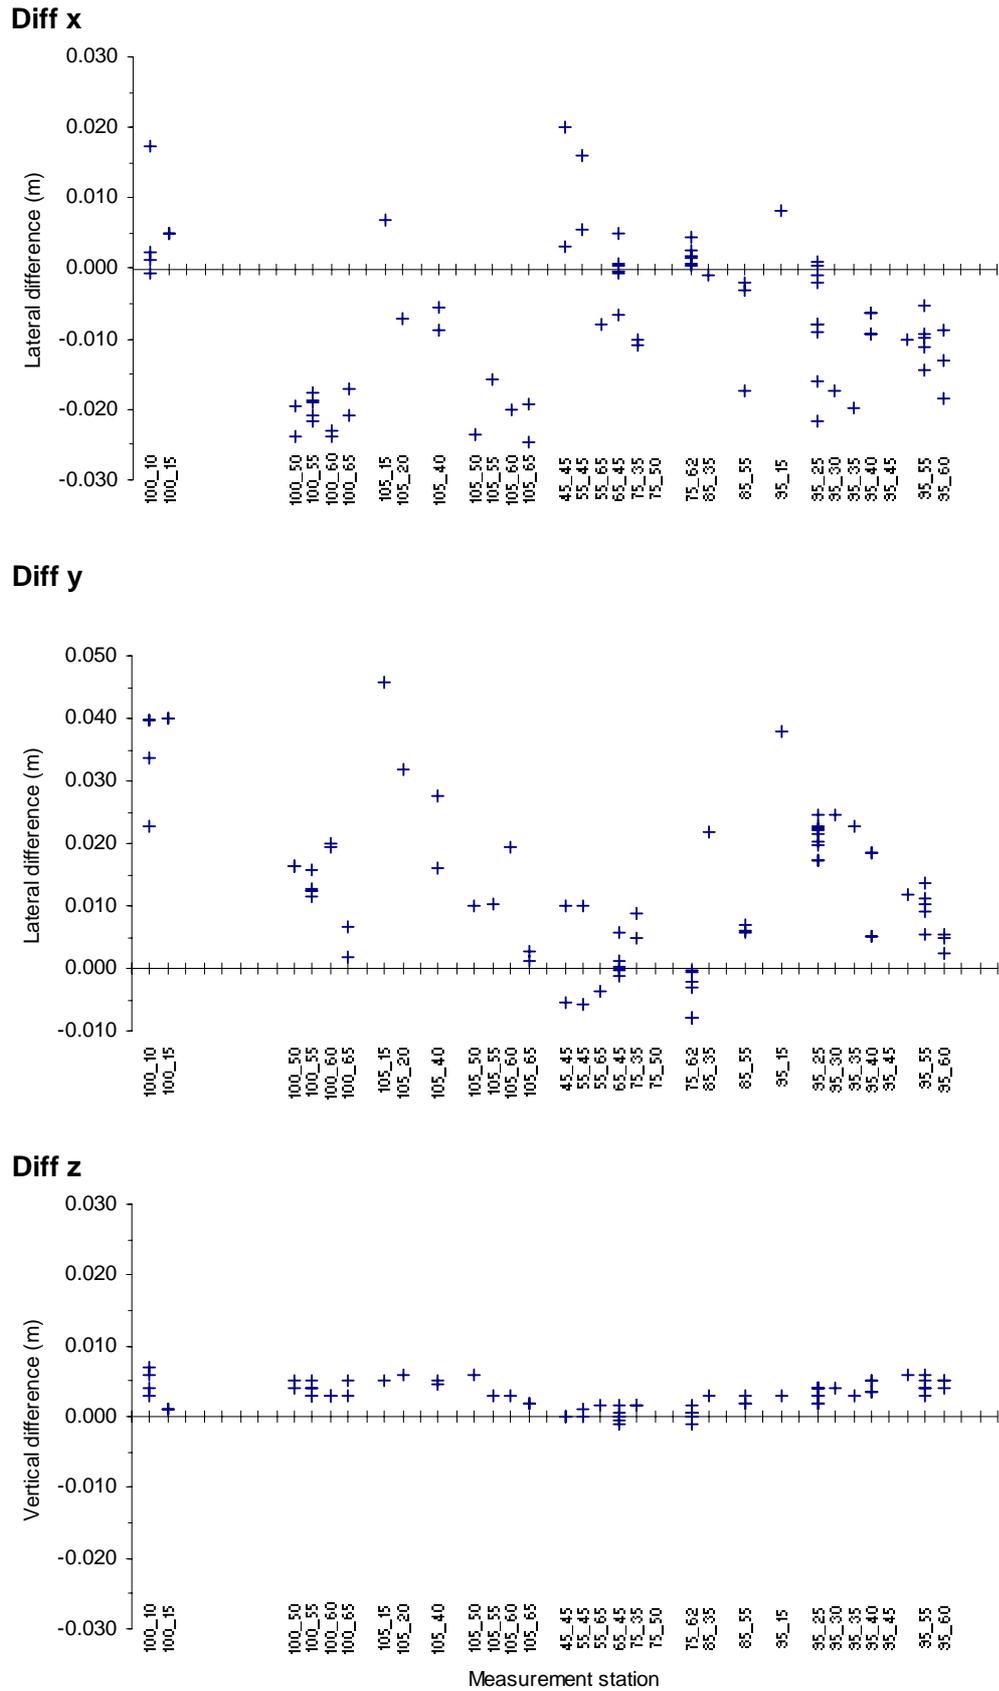
Figure 24. *Dronningestolen, difference between May 2001 and January 2002.*

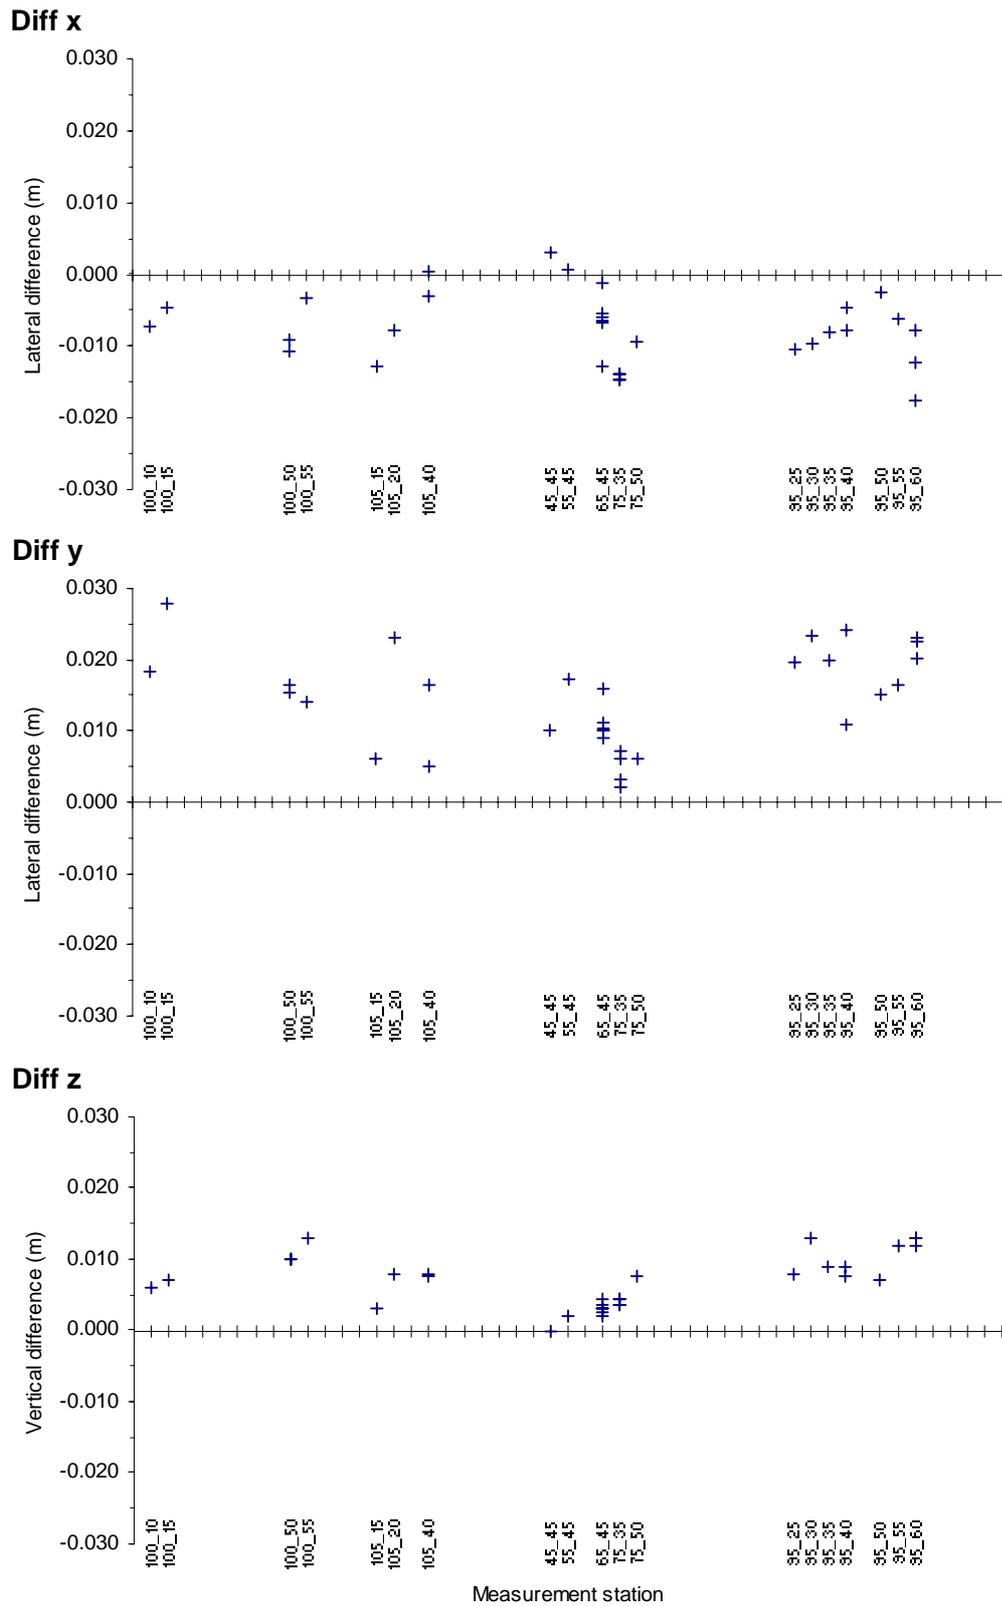
Figure 25. *Dronningstolen, difference between September 2001 and January 2002.*

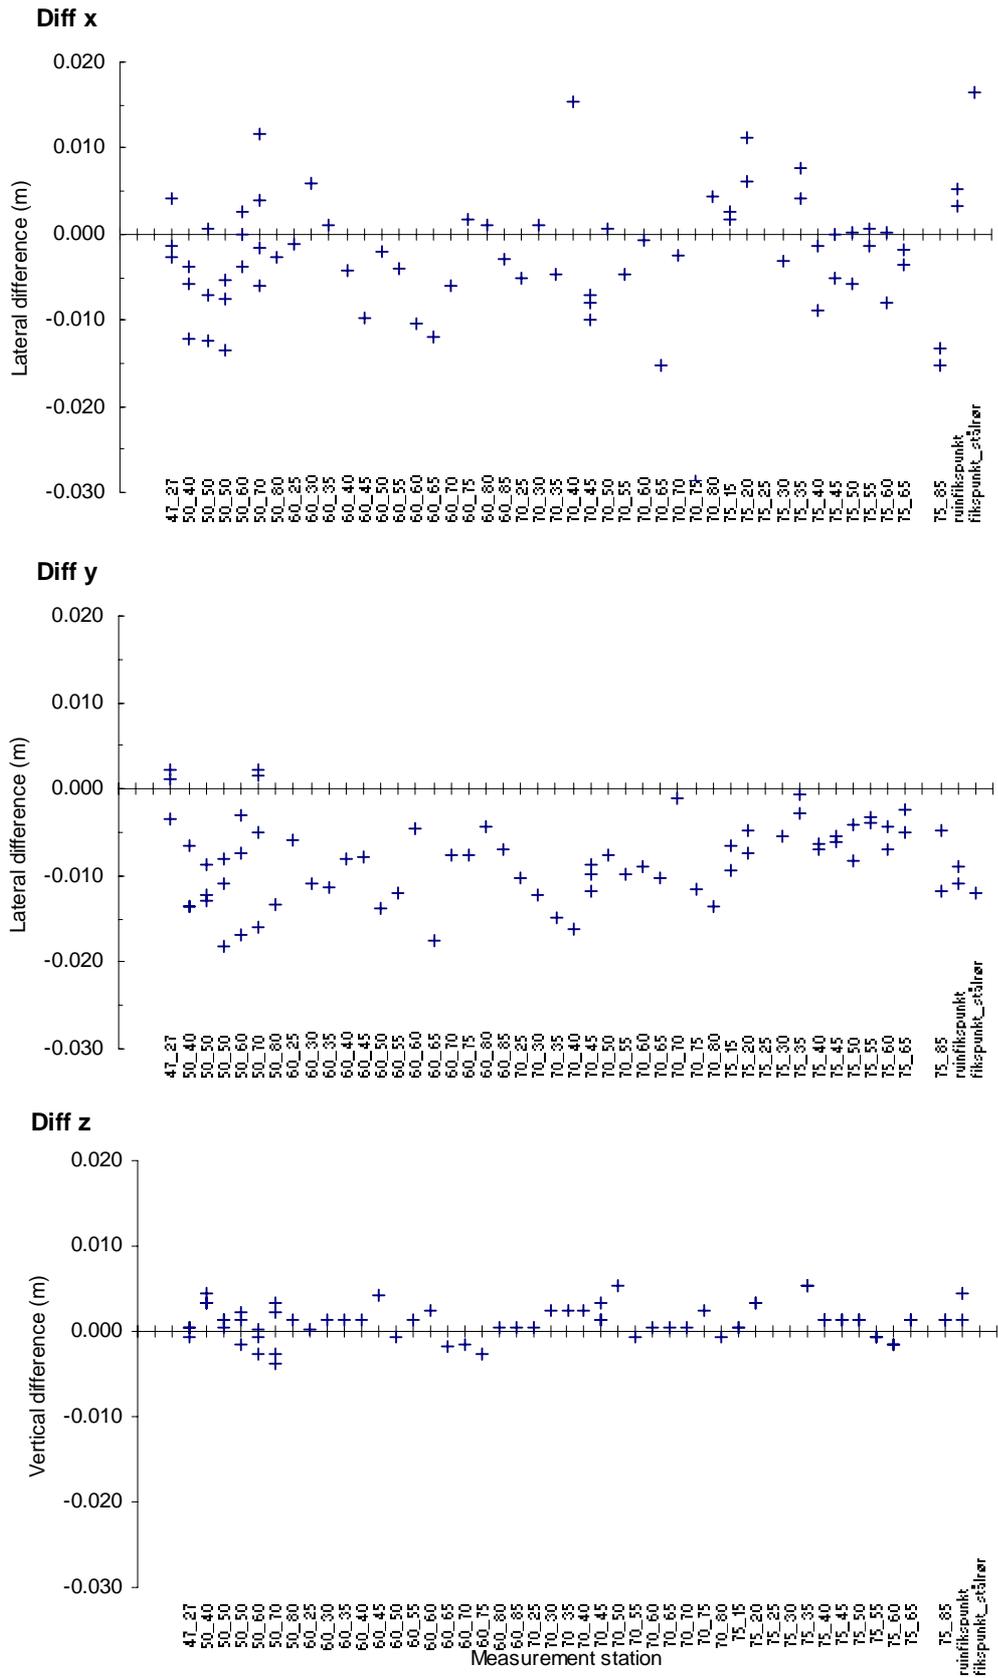
Figure 26. Jättebrinken, difference between September 2001 and January 2002.

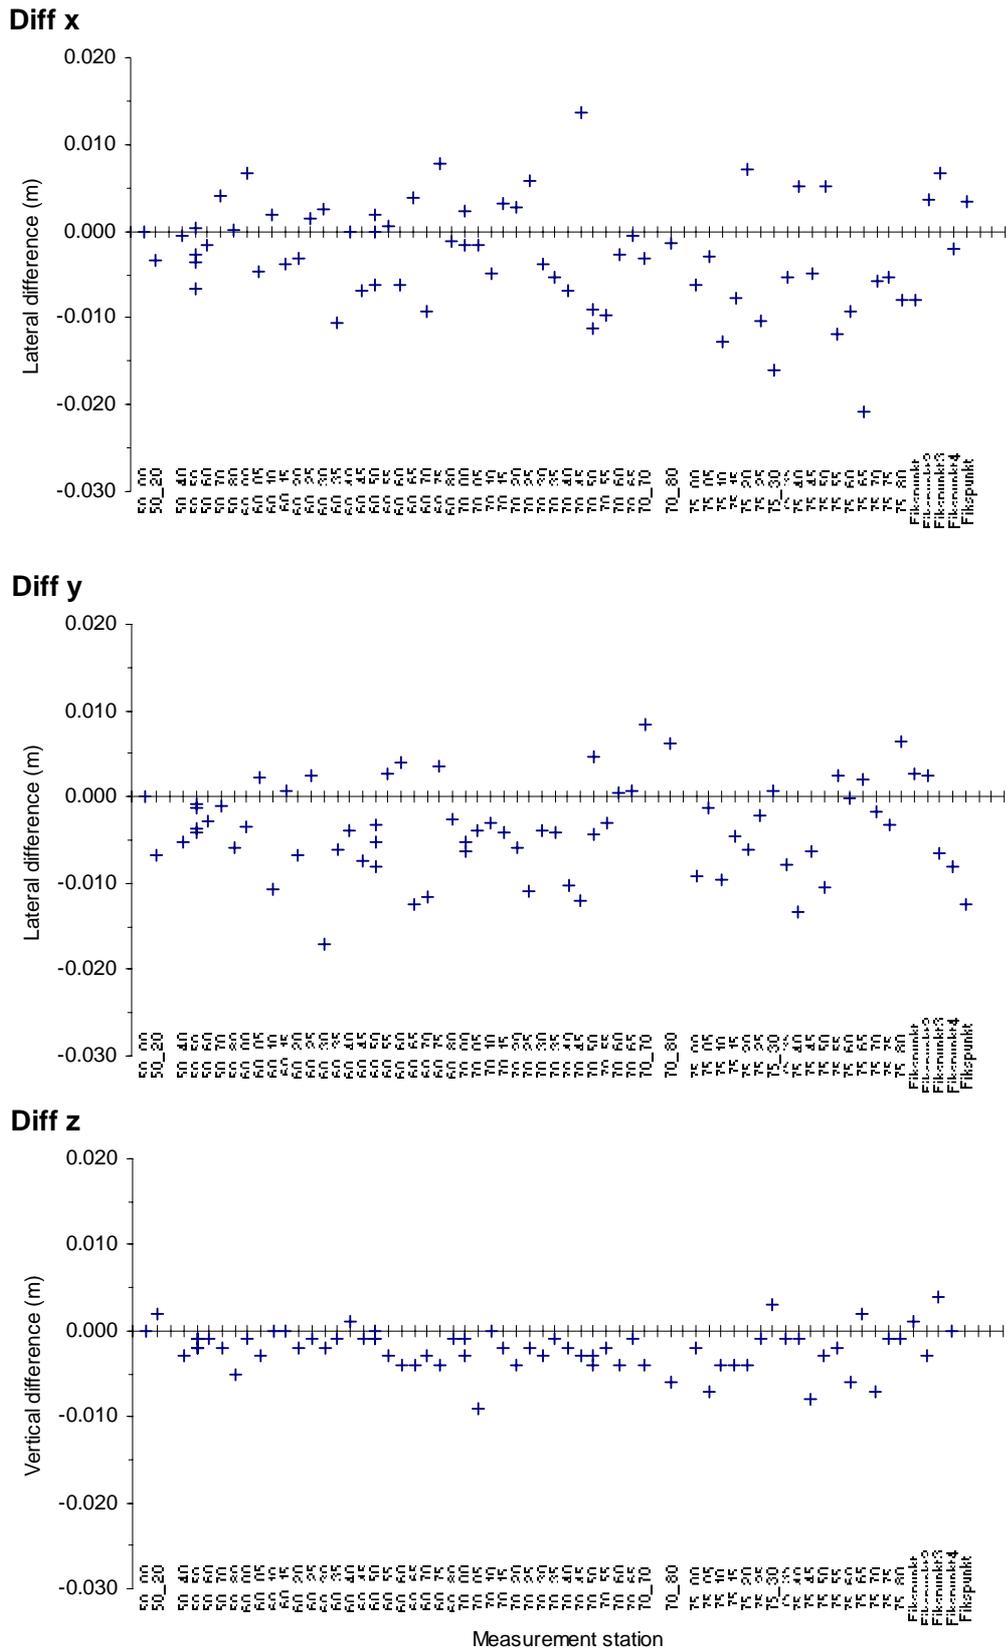
Figure 28. *Birling Gap, difference between September 2001 and January 2002.*

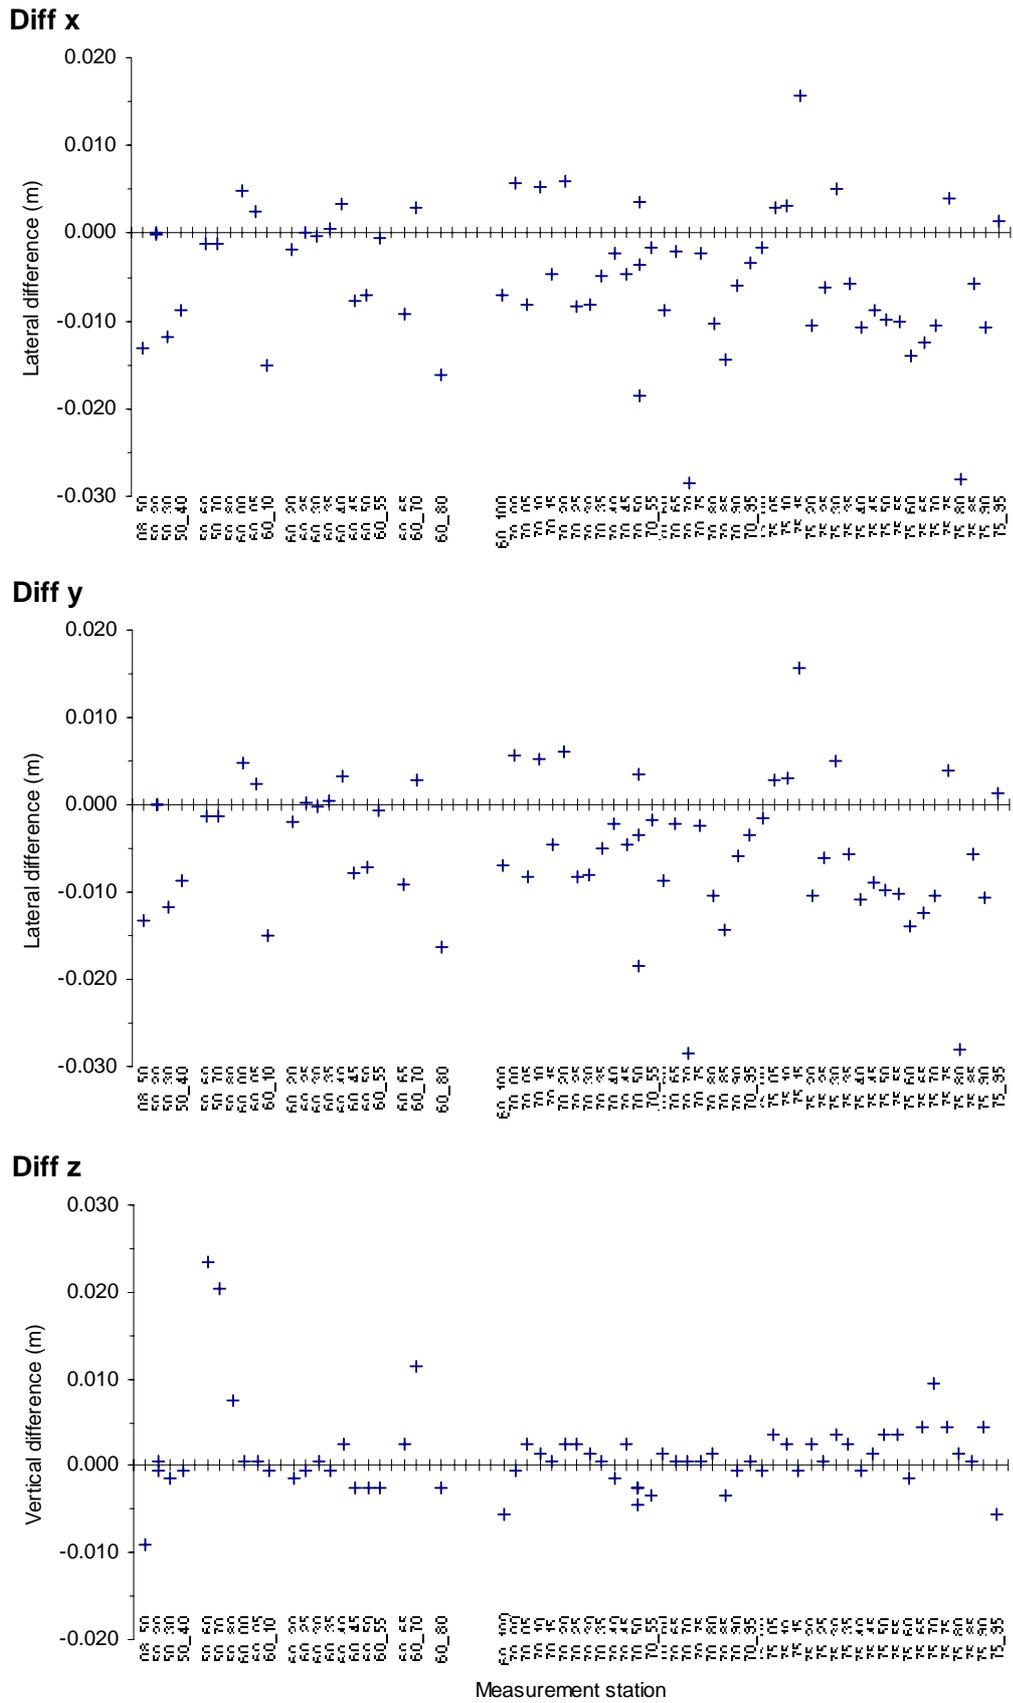
Figure 29. *Mesnil-Val, difference between September 2001 and January 2000.*
