Glaciological observations at the Qorlortorsuaq glacial lake, S-Greenland

Potential hazard and water ressource assessment

Christoph Mayer

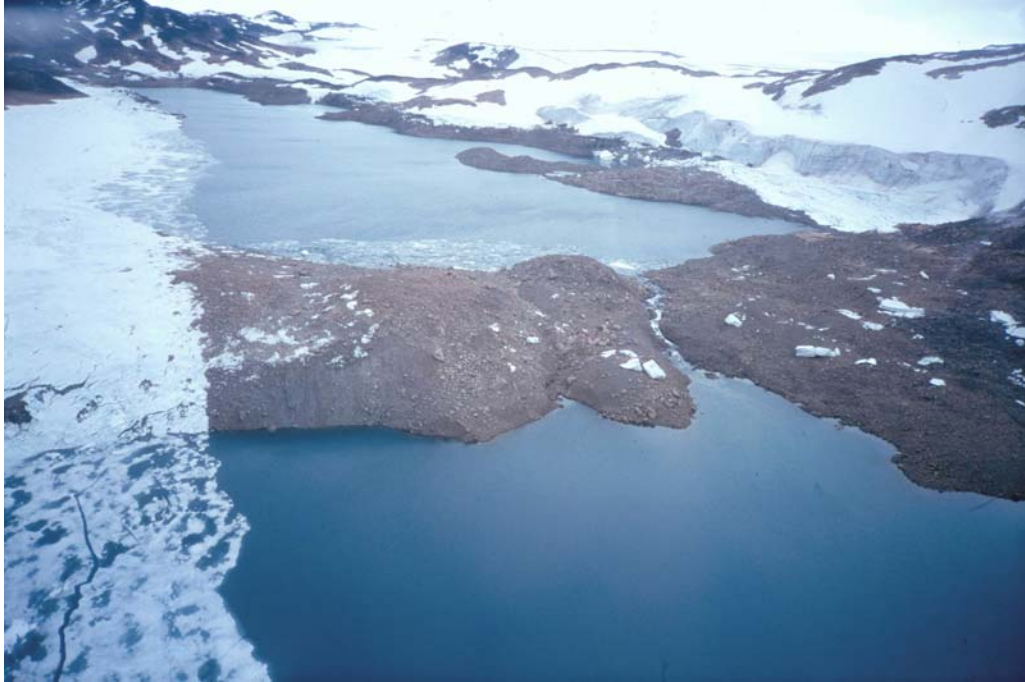
Fig. 3: Aerial view of the lake after the outbreak. The moraine ridge in the image centre now divides the lake in two parts, with a difference in water surface level of about 12 m. On the left of the image, snow and ice which covered this part of the lake earlier is now draped over the andscape. On the southern waterside (here the upper right shore) the old lake level is visible as the boundary line between ice and bare rock

At the time of the visit, the former lake basin basically was divided into two lakes (Figs. 2 and 3). The level of the larger, main lake is now 27 m below the old lake level. The uppermost part of the old lake, close to the ice margin of the ice cap, is divided into several smaller ponds, which are situated a few metres higher than the main lake (Fig. 4). The front of the ice cap in this area is about 1.2 km wide.

From the analysis of pictures taken during the visit it can be concluded that the smaller ones of the new lakes, bordering the glacier dam, is roughly 12 m below the main lake. The difference in lake levels can clearly be recognised along the small stream in Fig. 3. The height difference between this lake and the deepest part of the glacier gully therefore is about 10m. As can be seen from Fig. 5, there is a small cascade at the entrance of the gully, where the water plunges down over a still glaciated bed. If there is no bedrock or morainic threshold below the ice, the lake level of the smaller lake potentially could reduce another ten metres, due to further basal erosion/melting of the ice bed.

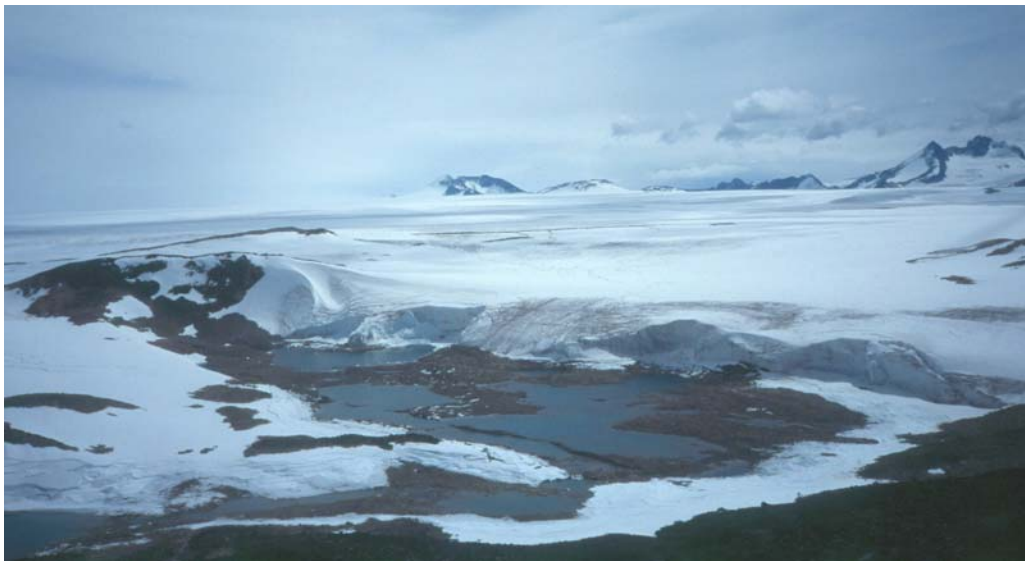
Fig. 4: Upper part of the former lake which now consists of a number of small ponds. The ice front adjacent to the ponds represents the main input region from the upstream ice cap.

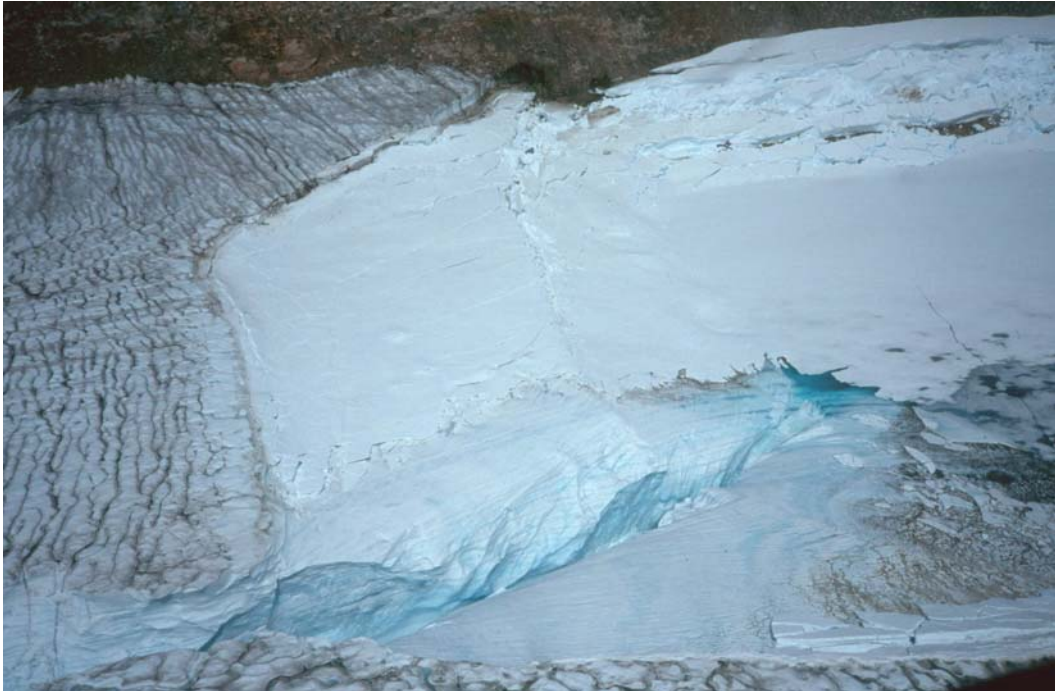
Fig. 5: The uppermost part of the gully, with the small cascade at its beginning. The lake bottom in this area still consists of glacier ice. In the left part of the image the change in surface conditions between last years lake extent and the recently flooded glacier surface is easily distinguishable.

The water depth of the first 100-200 m of the lake at the glacier margin seemed to be only a few metres (smooth white area in Fig. 5). This indicates that the melting of the glacier through lake water was only very gradual.

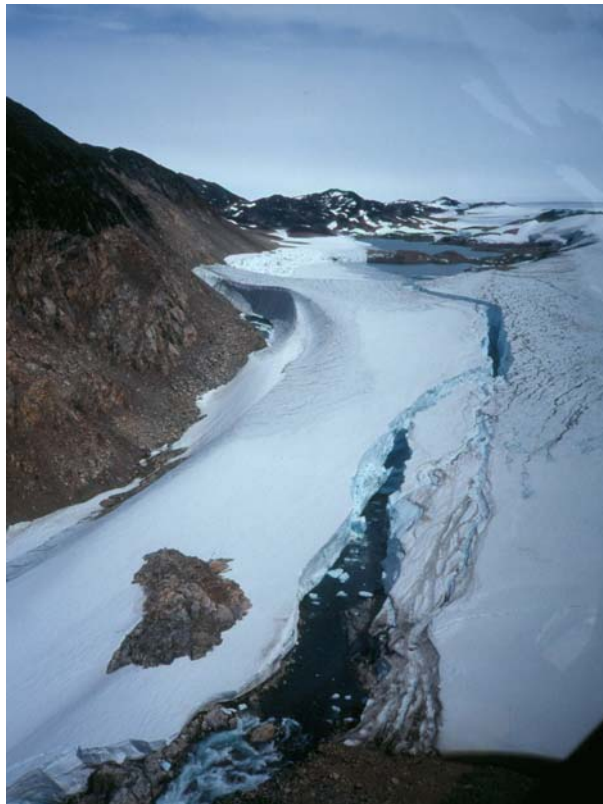
Fig. 6: Gully through the damming local glacier. The nunatak to the lower left was used as reference point. The flooded area and the creation of erosion channels is detectable to the right of the gully. At the mountain side at the left, the trim line of the last maximum glaciation (end of 19th century) can be recognized.

Observed trim lines in the area show that during the last maximum ice extent, towards the end of the 19th century, the entire lake basin was filled with a glacier, which was up to 100 m higher than the modern glacier surface (Fig. 6). At that time this glacier drained into the Qorlortorsup tasia basin, as well as into the adjacent Sermeq kangigdleq. During the onset of the general retreat of ice masses in S-Greenland at the beginning of the last century, drainage through the wide gap in the mountain range into Sermeq kangigdleq led to a shut down of the Qorlortorsuaq tributary and a subsequent surface lowering in the recent lake area. As soon as the ice flow over the rock threshold into Sermeq kangigdleq, due to further melting and retreat, was considerably reduced, the lake generation began. This happened most probably during the first two decades of the last century. In 1942, the lake already was about 60% of its latest maximum size.

Very probably during the last days of June this year, the water started to drain over the glacier towards Qorlortorssup tasia. This first happened on a rather broad stretch of the glacier (approx. 100 m) as can be seen in Fig. 6. The water flow subsequently concentrated to a few erosion channels, which finally were united into one stream. It is believed that this process of stream concentration, where only minor amounts of water were involved, took only a few days, as the surface of the glacier consisted of soft firm. As soon as there was a considerable flow of water reached, the channel started to erode from the lowest point, where the stream flow was fastest. The concentration of water flow into one channel eventually reached the lake shore and further erosion/melting of the channel accelerated the process of a retrograde creation of the gully. At the time of the visit the gully stretched over the entire length of the glacier (Fig. 6) and the water at the lake margin plunged down into the gully already at the lake margin. From there it continued through the glacier with no large gradient of the stream bed. As the gully is only 10-15 m wide and it was created gradually, the drainage of the lake was temporally distributed over at least 10 to 14 days.

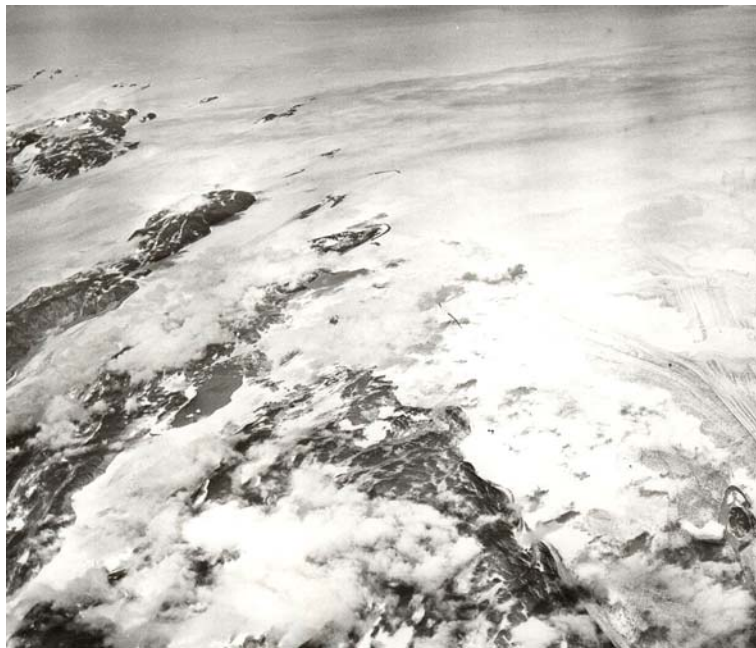
Fig. 7: Oblique aerial photograph from July 1942. The lake can be seen in the left middle part of the image. At that time it was clearly smaller than in 1985. A considerable part of the ice cap seen on the picture could potentially drain into the ice lake basin.
