# Installation of on-site stimulation set-ups within the Central Refueling Station at the Kluczewo Airfield, Poland

Deliverable D8

This report is a technical report of the deliverable D8 of the STRESOIL Project.

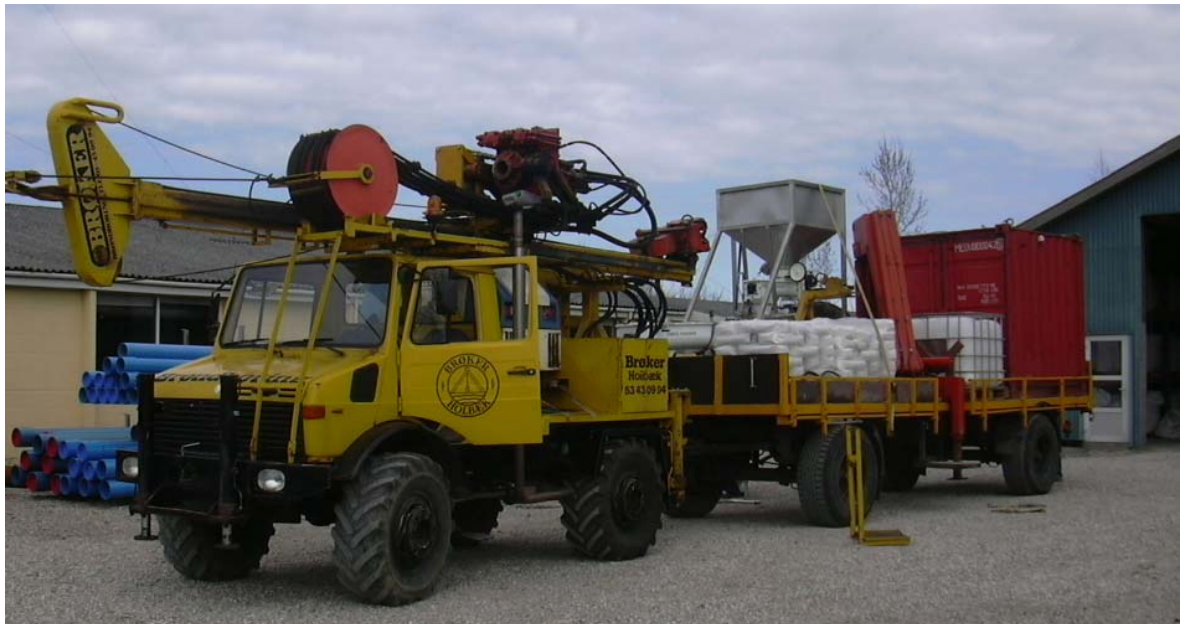
Figure 1. The reconstructed drilling rig.

The American subcontractor FrX has provided knowledge transfer on detailed construction principles of the drilling rig and mixing equipment to Broeker. During September 2004 to March 2005 Broeker designed, constructed and initially tested all new equipment for making hydraulic fractures on operational field scale. A drilling rig was rebuilt by replacing the drill head with a special hydraulic hammer, for hammering steel casing to target depth for establishing hydraulic fracture (Figure 1).

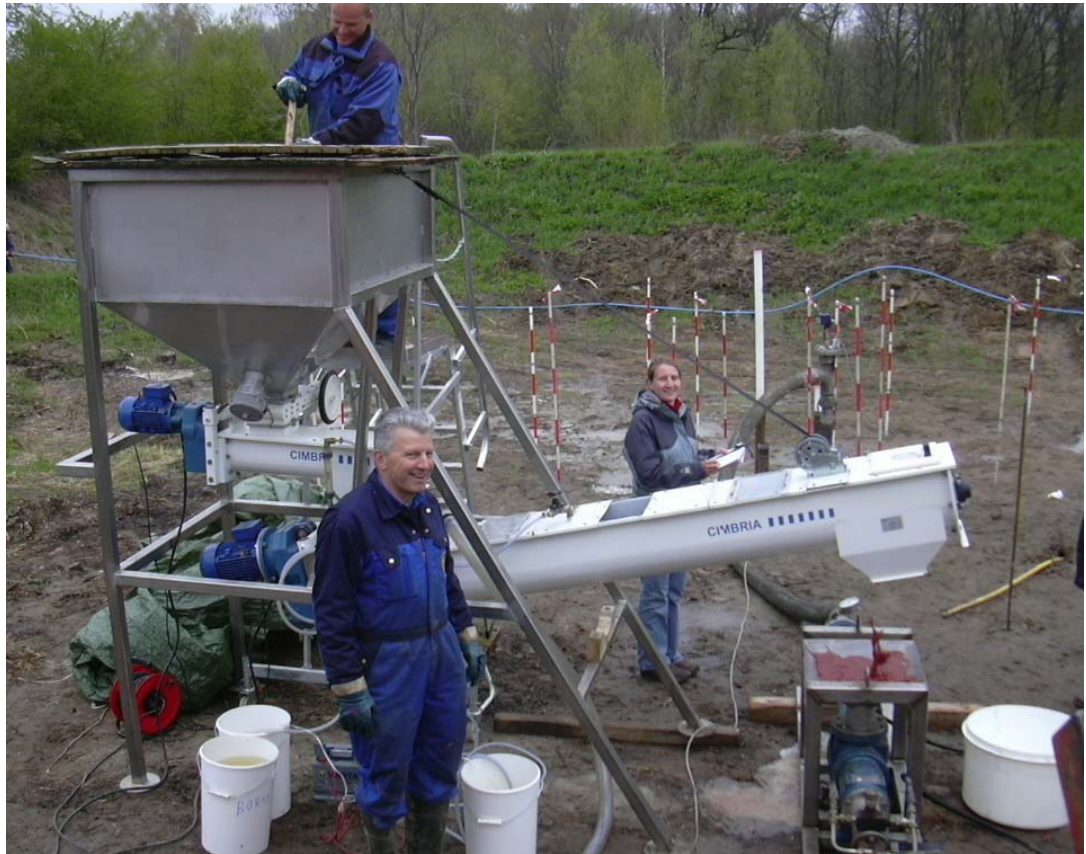
A slurry mixer was designed and built by Broeker. The mixing device consists of a mixing tower and a fully adjustable electrical feeding and mixing auger, and a number of small pumps for delivering different additives (guar, cross-linker and enzyme breaker) to the coloured sand materials (Figure 2). All materials are made of stainless steel. The mixing device was built in January 2005 and turned out to have an excellent ability to mix the fracturing fluid. The high viscosity slurry with up to 70 % sand was injected into the fracturing well using a hydraulic driven mono-pump with adjustable outlet.

Figure 2. Mixing equipment with tower for sand mixing at the left and in the middle a fully adjustable electrical feeding and mixing auger

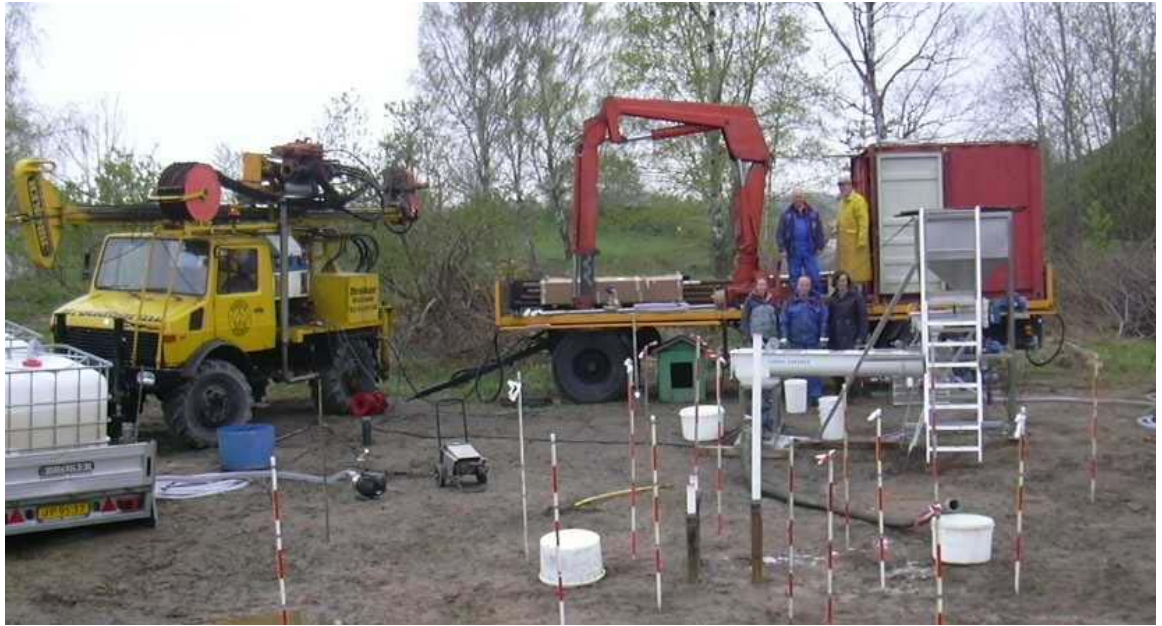
Fracture creation was monitored by two sets of measurements, pressure and uplift. Injection pressure was indicated by a gauge (0-10 bar) fixed to the discharge of the progressing cavity pump, and injection well head pressure was sensed by an electronic pressure transmitter (0-6 bar). The electronic signal was recorded by a data logger, which later was queried by a computer. Uplift was monitored by surveying with a Sokia auto level and a collection of graduated staffs that were driven a few centimetres into the ground and extended ~150 cm upwards (Figure 5a). Surface elevations were recorded before and after fracture creation at as many as 19 locations, which were distributed along six symmetrically placed rays that emanated from or near the injection well. The uplift array was oriented with north-south generally parallel to the long wall of the service building; a compass indicated this nominal north to be approximately N12°W.

Figure 5a. Survey measurements of terrain uplift during injection of hydraulic fractures in the subsurface

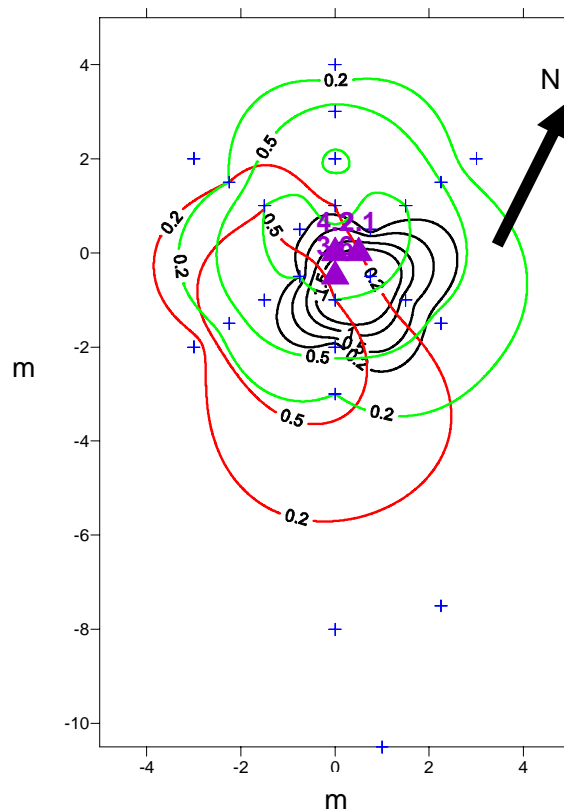
*Cell 1, C1-f1, Green Sand 4.2m bgs* – The fracture was created in Cell 1 at 4.2 m depth using 500kg of green sand and 550 liters of gel. The parent well was the first and north westernmost of the three fracturing wells installed in Cell 1. Uplift data are given in Appendix A. The pressure followed trends of typical horizontal fractures. A somewhat symmetric

and broad uplift pattern (Figure 6) was observed, with centre of uplift close to the position of the nucleation well.

Figure 6. Contoured uplift data of hydraulic fractures installed in Cell 1 (bioremediation). Green contours: green sand (4.2m); Red contours: red sand (3.6m); Black contours: white sand (2.1m). Blue crosses show the position of graduated staffs for surveying measurements. All contour levels are in cm.

*Cell 1, C1-f3, Red sand 3.6 m bgs* – The fracture was nucleated from a well installed at 3.6 m depth with 350kg red sand and 400 liters of gel. The uplift data are given in Appendix A. The magnitude of observed uplift data was relatively small but showed an oval shaped broad uplift feature with the long axis oriented NW-SE and centre of uplift placed 2-3 m to the south of the nucleation point.

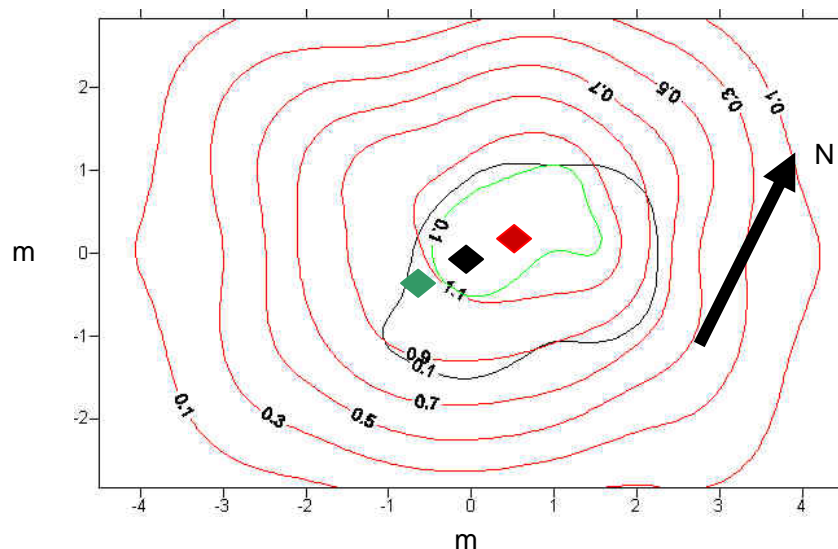
Figure 7. Contoured uplift data of each hydraulic fracture in Cell 2. Red contours: Green sand (4.5m) when injecting in well at (0,0); Black contours: red sand (3.5m); Green contours: white sand (2.5m). Contour levels are in cm.

*Cell 2, C2-f2, Green sand 4.5m bgs* – The fracture was created at 4.5m depth using 450kg of green sand and 500 litres of gel. Uplift data are given in Appendix A. The parent well was the north-easternmost of the three wells installed in Cell 2. The pressure followed trends of typical horizontal fractures. A somewhat symmetric and broad uplift pattern (Figure 7) was observed, with centre of uplift close to the position of the nucleation well.

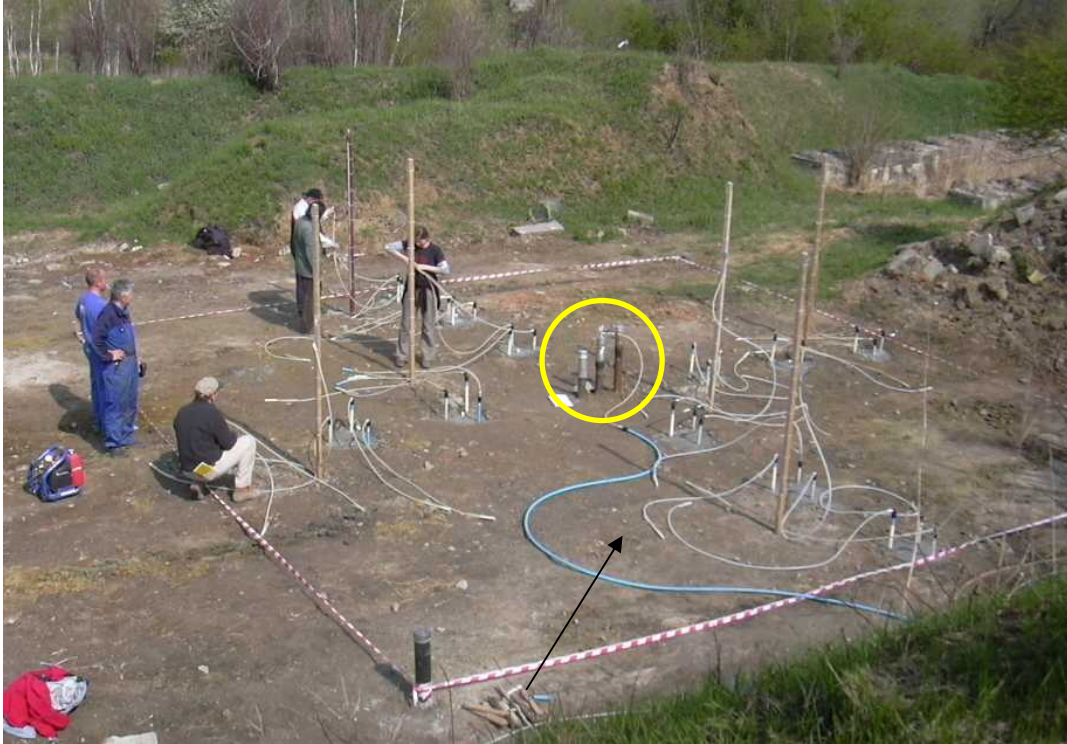
Figure 8. Field instrumentation of Cell 2 for pneumatic tests (see also Nilsson et al, 2006b). Yellow circle: Fracturing wells at 2.5 (left), 3.5 (mid) and 4.5m (right). All other white plastic pipes are monitoring wells for hydraulic testing. Arrow points to the North.

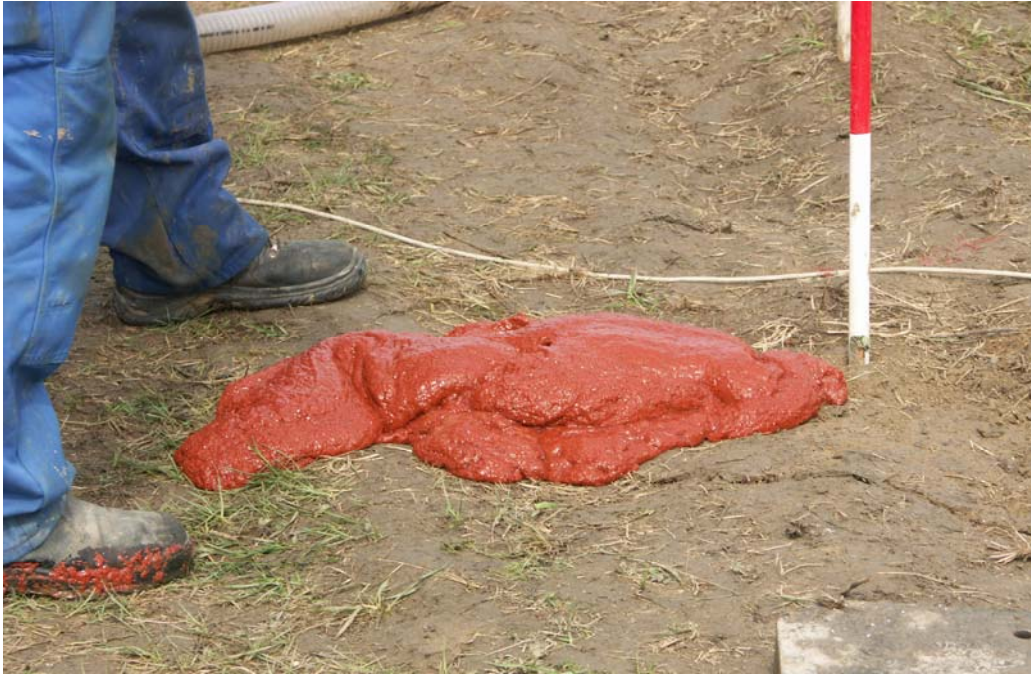
*Cell 4, C4-f3 or C, Red Sand 3.05m bgs* – The fracture was created from a well installed to a depth of 3.05 m bgs at a location 65 cm south of the well used to create the fracture 2 m bgs (1.25 m south of well to 5.2 m.) Three hundred kilograms of sand were transported in 400 litres of guar gel. The pressure log was consistent with the creation of a gently dipping or horizontal fracture. The increase of injection pressure after an initial breakdown can be attributed to the increased effective viscosity of the slurry and the resistance of flow offered by the fracture aperture. Symmetrical and broadly distributed uplift was noted. This fracture vented about six litres of slurry from a hole about 2 m west of the injection locations (Figure 9). The vent hole later proved to be an ancient and uncharted boring.

Figure 9. Venting of red coloured sand (Cell 4) due to shortcut via an ancient and uncharted boring in the subsurface constructed in the past by Russian military.

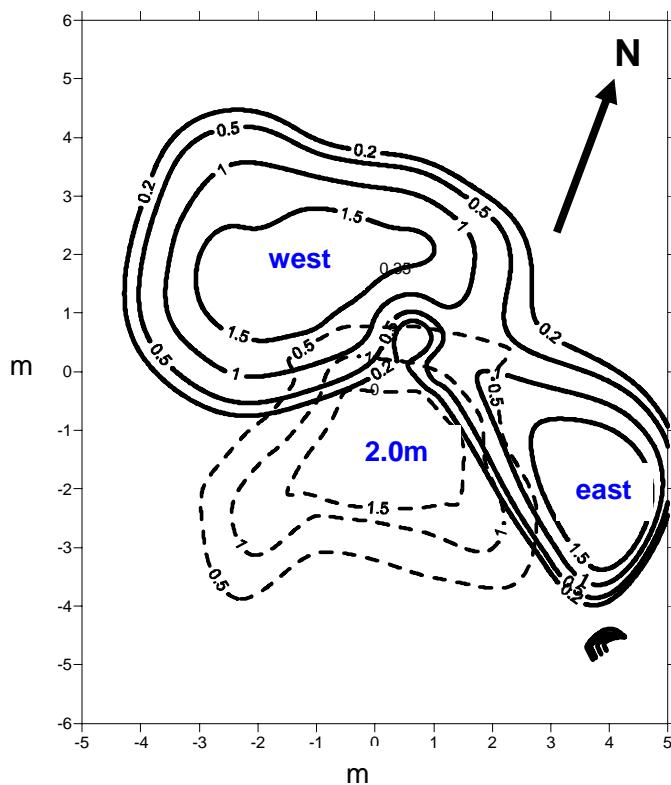
*Cell 4, C4-f6 and C4-f7, both White sand, 2.0m bgs* – The two fractures were individually installed at 2.0 m depth with a spacing of 2.5m between the locations. The drive points were dislodged 18cm to open an 8cm borehole. Each well was notched for 2 minutes with a single jet that was rotated only 60 degrees pointing against Well B (at 2 m depth, see Figure 10). A tee was installed on the injection line so that slurry could be injected simultaneously to each well. About 175 kg of white sand and 175 litres of gel was injected in each well. A broad uplift was observed with an overlap of C4-f2 and the combined C4-f6 and C4-f7 fractures (Figure 10).

Figure 10. Contoured uplift data from the installation of the 2.0m deep Mickey Mouse ear (solid contour lines) and the 2.0m deep fracture C4-f2 (dashed contours). “East”, “West” and “2.0m” indicates an approximate position of the three nucleation wells C4-f2, C4-f6 and C4-f7. Contour levels in cm.

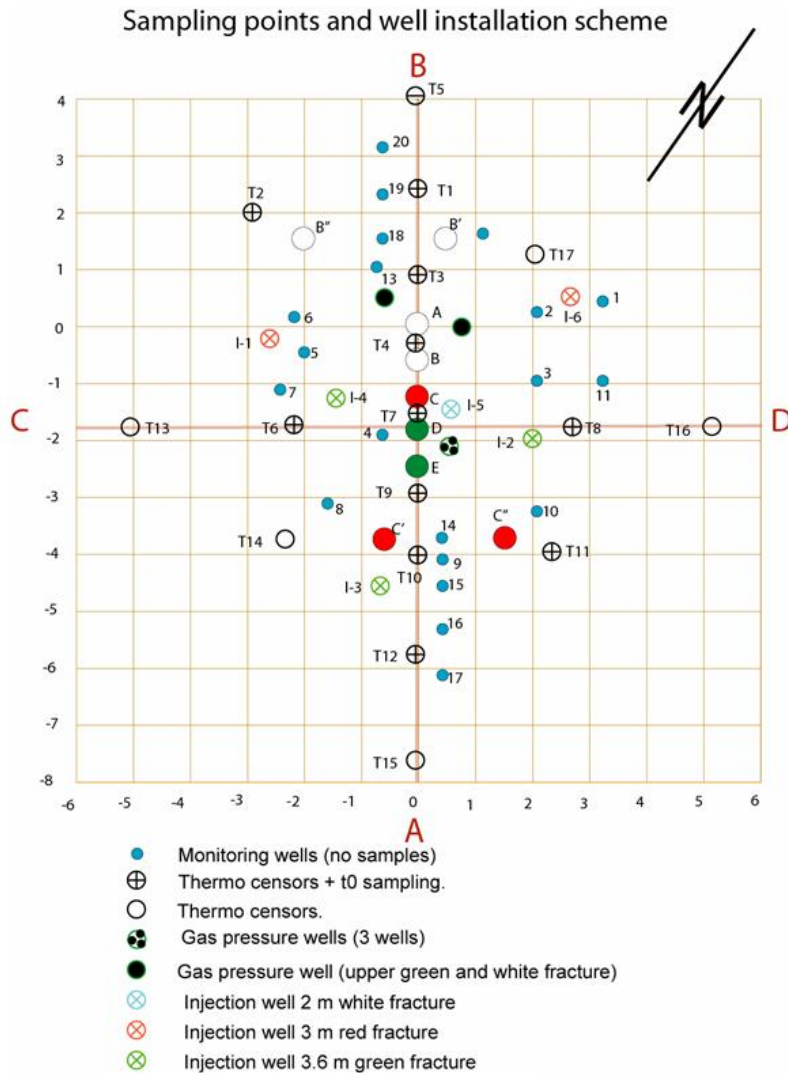
Figure 12. The location of sample wells (blue dots), thermo couple wells, injection wells and fracturing wells in Cell 4.

Location of sample borings in Cell 4 are shown in Figure 12 and the uplift patterns are shown in Figure 13.

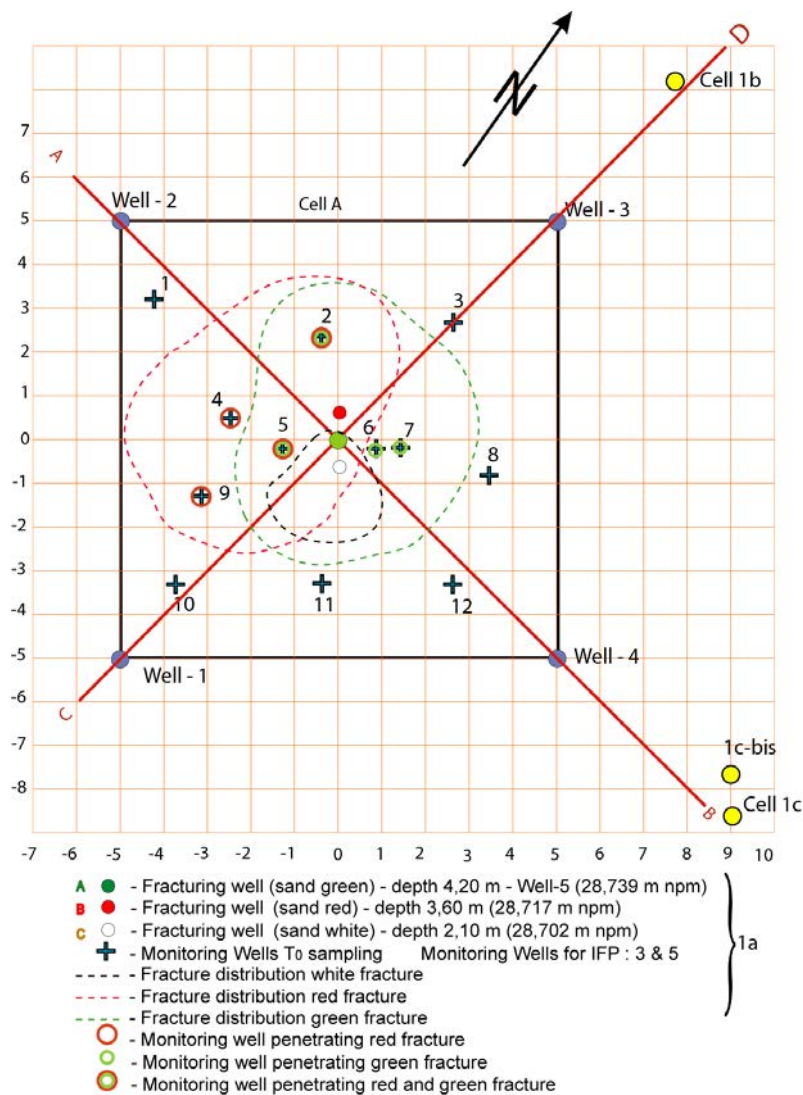
Figure 14. The location of T0 sample wells (blue dots), injection / extraction wells and fracturing wells in Cell 1. The cross sections AB and CD are shown in Figure 15.

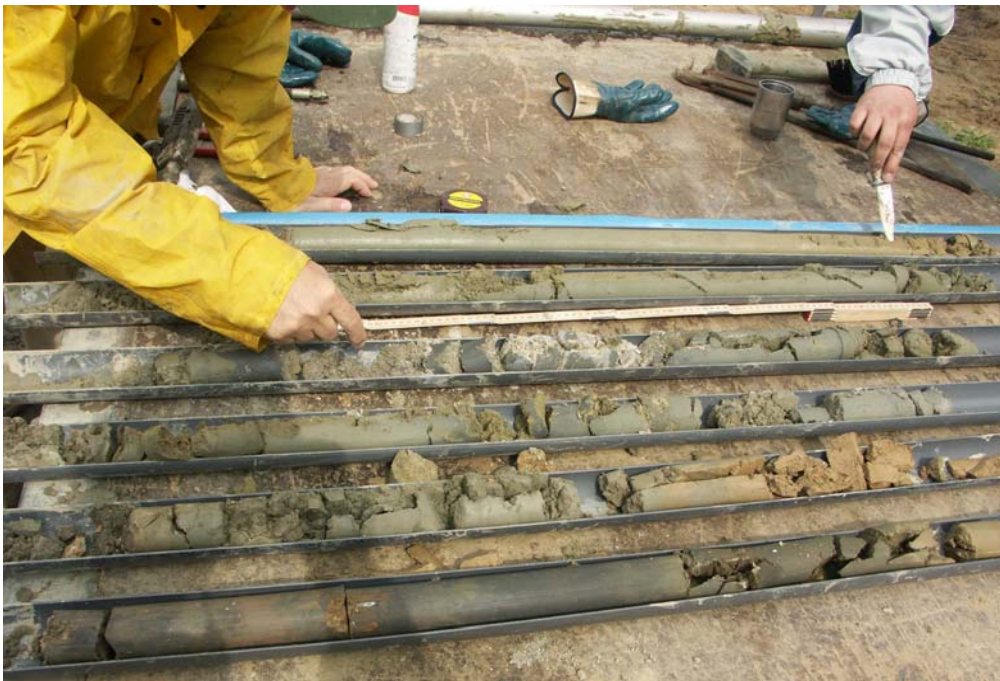
Figure 16. Coring of the hydraulic fractures in Cell 4 using Vibro Core Technique.

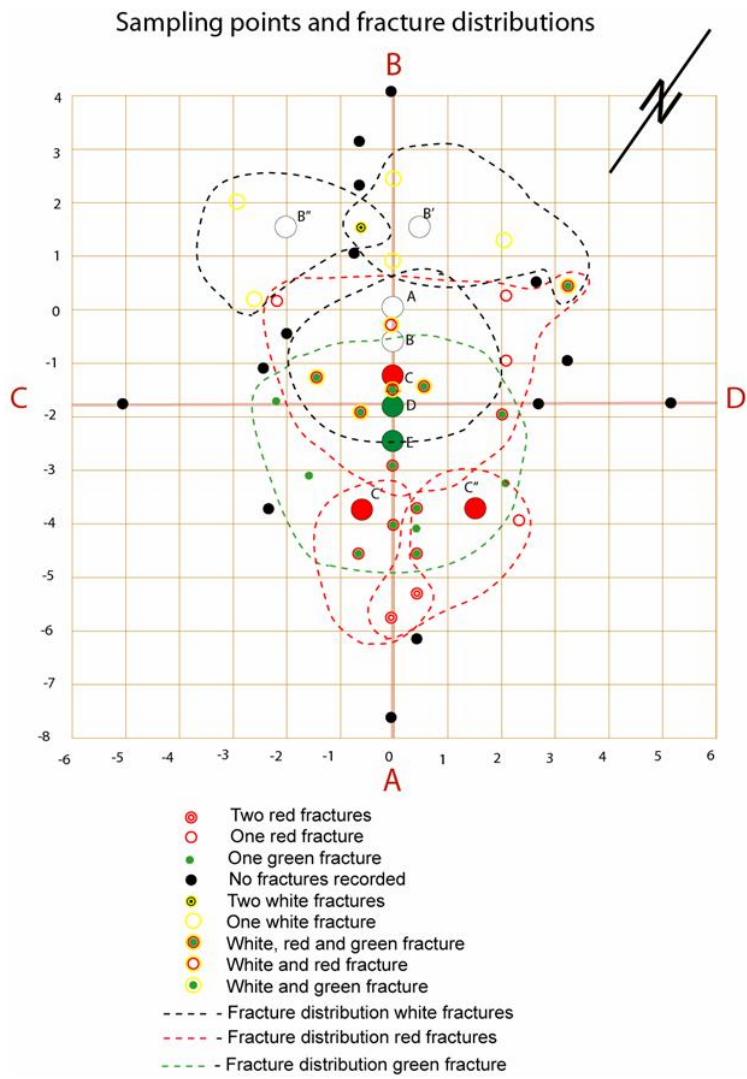
The upper complex of white fractures is all nucleated in the middle of unit 2 and shows an almost sub-horizontal fracture orientation. The fracture mapping of the individual white coloured fractures do not show appearance of one major single fracture consisting of the parent fracture grown together with the so called Mickey Mouse ears. The Mickey Mouse fractures has not propagated in exactly the same depth as the parent fractures arising in overlapping white fractures (10-20 cm apart in vertical direction). Hydraulic tests has on the other hand shown satisfying hydraulic connection between the three white fractures at 2 m depth.

Figure 17. Horizontal fracture distribution in Cell 4.

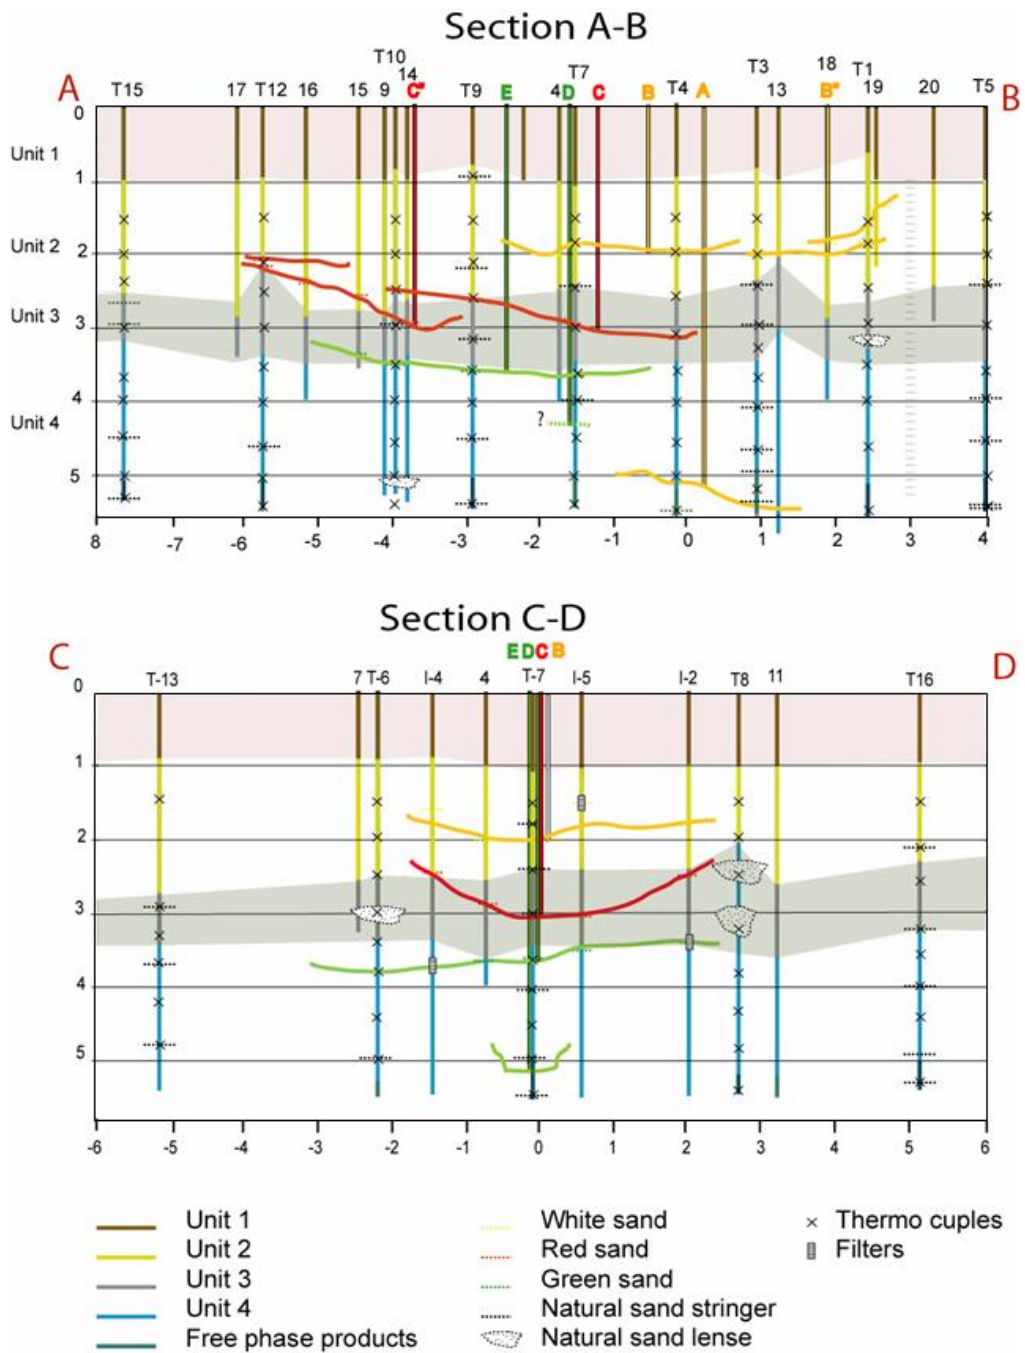
Figure 18. Cross sections of Cell 4 based on hand drilling information. Position of AB and CD are shown in Figure 12.

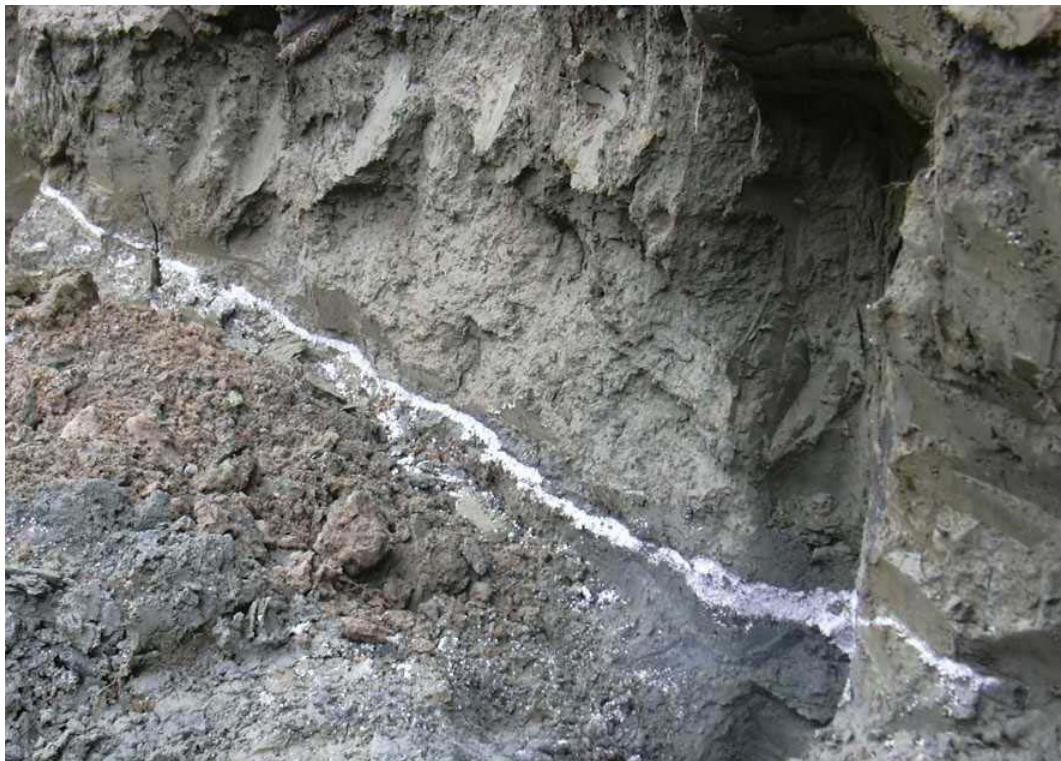
Photo of the excavation of the almost horizontal white sand-filled hydraulic fracture at 2-2.5m depth in Cell 5 is given in Figure 19. The width of the white coloured sand fracture varies between a few mm to 5 cm.

Figure 19. Excavation of Cell 5, where the Mickey Mouse ear procedure was trained (See text). The photo shows an almost horizontal white sand-filled hydraulic fracture at 2-2.5m depth. The width of the white coloured sand fracture varies between a few mm to 5 cm.

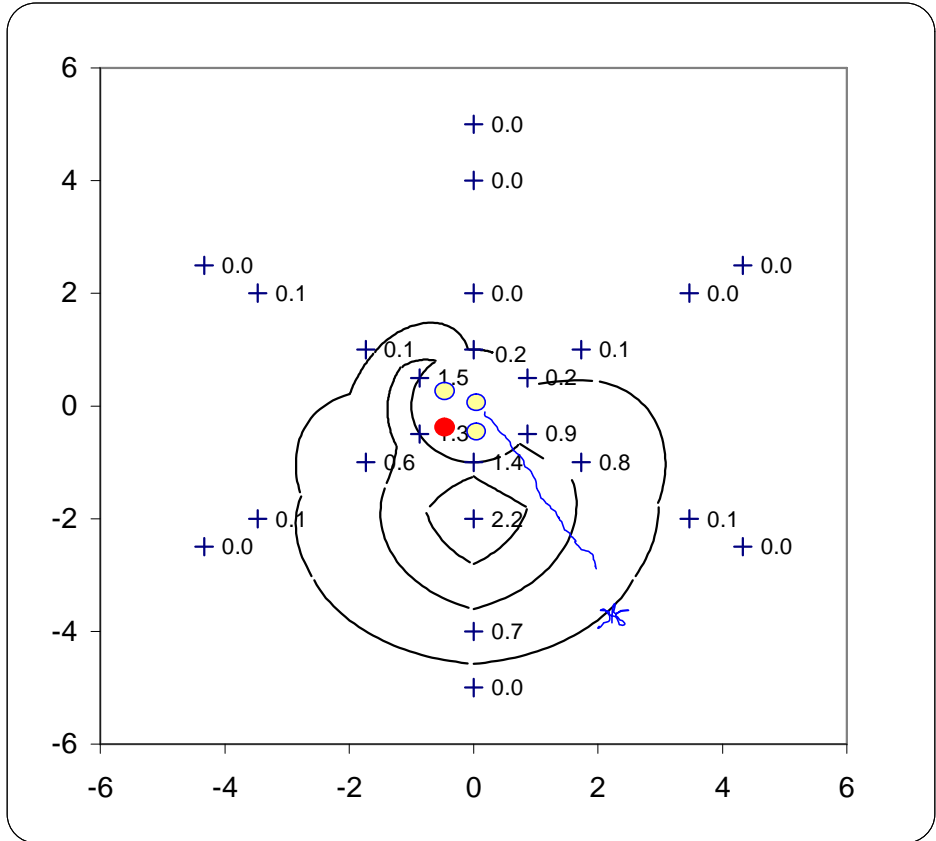
Uplift measured at locations indicated by + and recorded in cm. Axes indicate north / south and east / west distances in meters from center of uplift array. Injection occurred at the center of the array or at a location indicated by ●. Contours drawn by bi-linear interpolation in an orthogonal  $r-\theta$  reference frame among sets of selected locations. Contour intervals are specified below.

Comments: Fracture nucleated 3 m bgs from well installed at red, solid circle. Other wells to 2, 4, & 5 m shown as shaded blue circles. Doming crack noted from center of array to apparent bubble ~4m SE, shown as light blue lines.
