CO₂ SINK: WP 3.1 Rock-/Fluid Interactions. Laboratory Experiments

Deliverable D3.1-11, Preliminary caprock
analysis data from new wells

Niels Springer
Core Laboratory

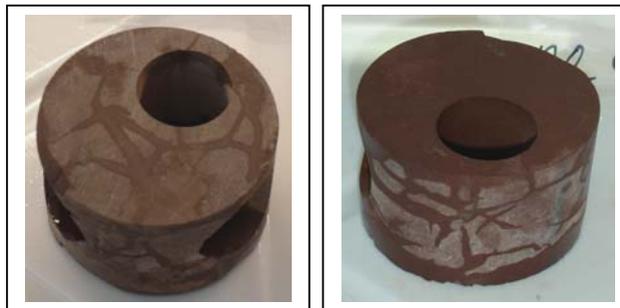
Figure 2.1. Ketzin 200/2007, core A-9-3, depth 626.70 m (cf. Appendix 2, Fig. 9). After plugging, the volatile LLP oil evaporates from the surface of the core leaving the fracture network wet, and therefore visible to the naked eye.

A visual presentation and short description of plugs are given in Appendix 2 and 3. During drilling of plugs it was observed that many core pieces were transected of an apparently stochastic network of fine open fractures – no systematic orientation of the fractures could be determined, fig. 2.1 and 2.2. We believe this chaotic fracture network to be responsible for the fragile nature of the core samples making it very difficult to drill cylindrical plugs from the Ketzin caprock core. Cementation with anhydrite is widespread and appears as white spots and irregular, flaser like textures that are clearly seen in the X-ray images; an example is shown below in fig. 2.3.

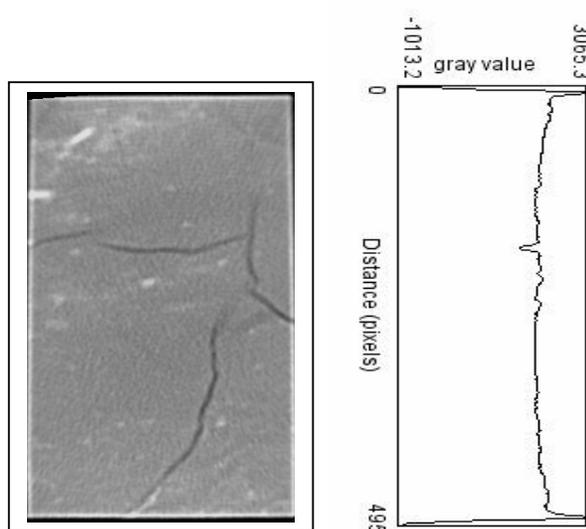
Figure 2.2. Ketzin 200/2007, core A-9-3, plug 9V (cf. Appendix 2, Fig. 9). Longitudinal X-ray CT-scan through plug 9V showing the chaotic fracture network. Fractures (high porosity) appear dark on the image and one is clearly visible from the profile plot through the middle of the image. The grey scale figure is in Hounsfield units; -1000 represents air (100% porosity) and appears dark on the images, +3000 is dense matrix (0% porosity) and appears white on the image.

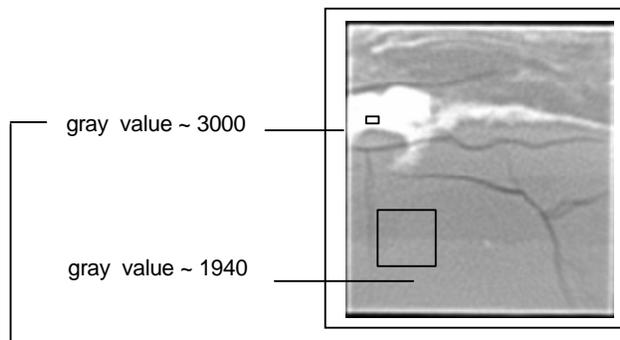
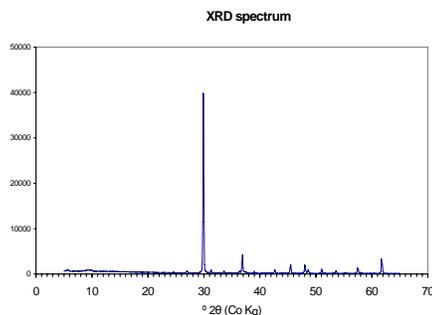
Figure 2.3. Ketzin 200/2007, core A-6-2b, plug 5V (cf. Appendix 2, Fig. 5). Longitudinal X-ray CT-scan through plug 5V showing the chaotic fracture network and flaser anhydrite. Cementation with anhydrite (CaSO_4) is seen as spots and flaser like textures in the mudstones of the Weser Fm. Anhydrite has a high X-ray attenuation and appear white on the image (gray scale figures around +3000).

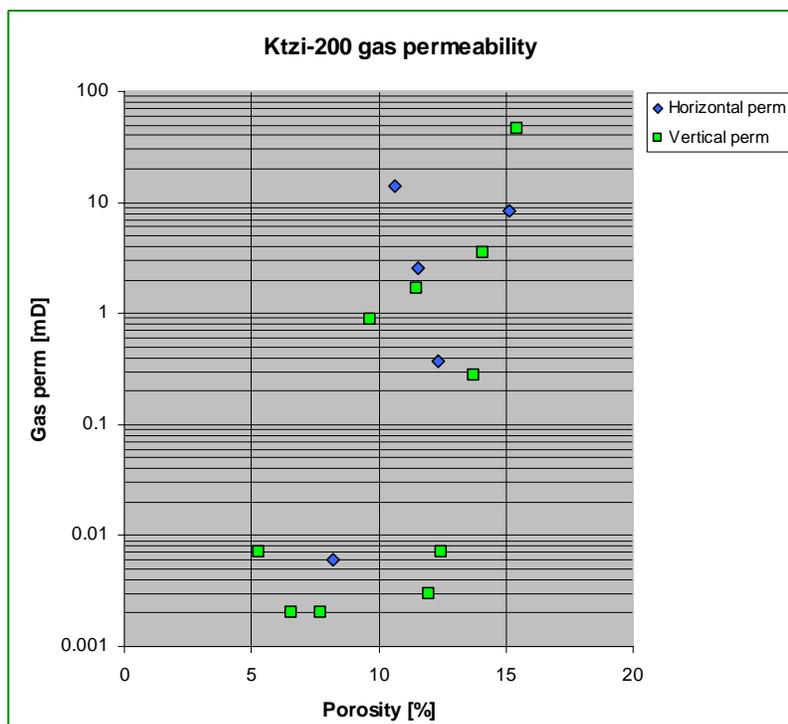
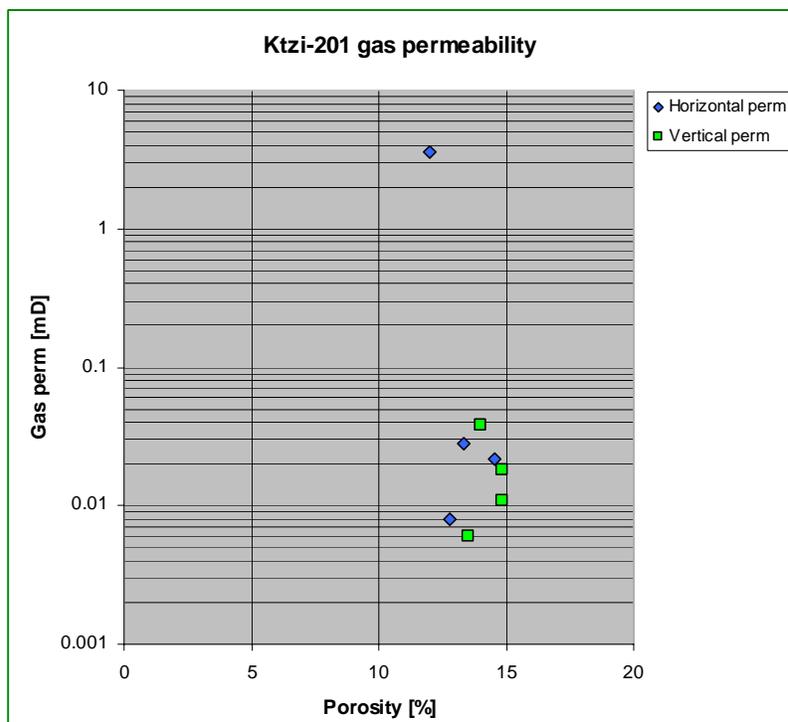
Figure A1.1. Ktzi-200/2007 and 201/2007 distribution of gas permeability vs He-porosity.

The caprock samples from Ketzin have ambient porosity values close to 12 % and slightly elevated grain densities due to the cementation with dolomite and anhydrite. There is no significant correlation between gas permeability and porosity, fig. A1.1; the distribution pattern seems to be controlled mainly by fractures and the dolomite / anhydrite cementation.

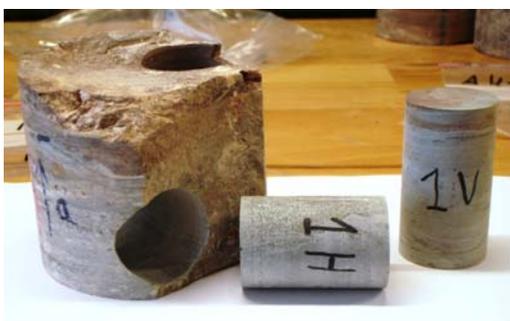
Figure 1. Plug 1H/V, core ID A-3-1, 610.70m. Variegated mudstone with flaser anhydrite.

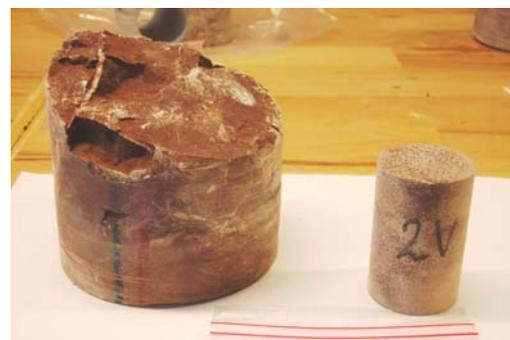
Figure 2. Plug 2V, core ID A-4-1, 612.70 m. Red-brown, spotted mudstone.

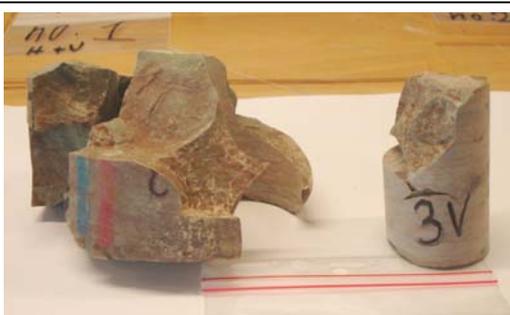
Figure 3. Plug 3V, core ID A-4-3, 614.60 m. Grey to red-brown mudstone.

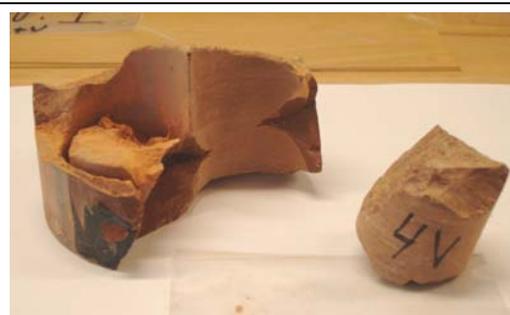
Figure 4. Plug 4V, core ID A-4-3, 616.60 m. Brown mudstone.

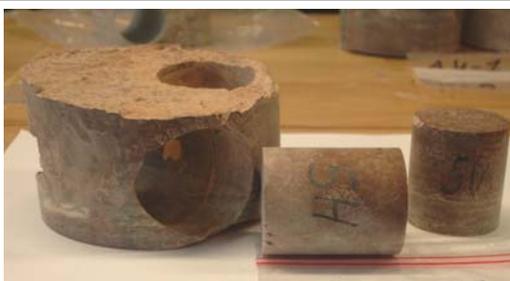
Figure 5. Plug 5H/V, core ID A-6-2b, 618.70 m. Grey to red-brown spotted mudstone with flaser anhydrite.

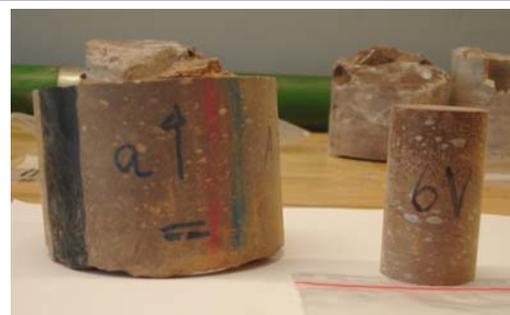
Figure 6. Plug 6V, core ID A-7-1a, 620.53 m. Red-brown mudstone with anhydrite spots.

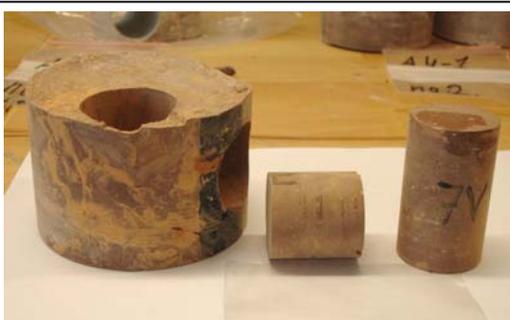
Figure 7. Plug 7H/V, core ID A-7-3, 622.64 m. Red-brown mudstone with anhydrite spots.

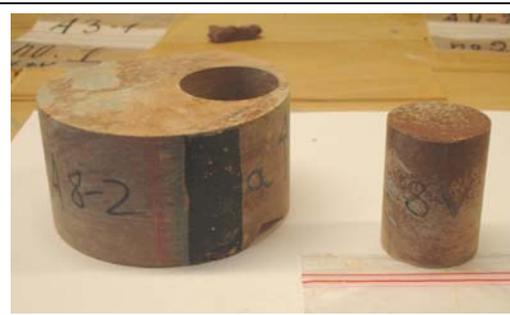
Figure 8. Plug 8V, core ID A-8-2a, 624.60 m. Red-brown mudstone.

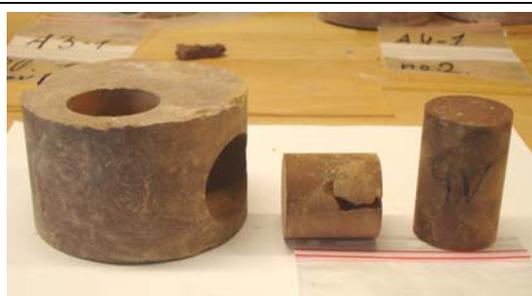
Figure 9. Plug 9H/V, core ID A-9-3, 626.70 m.
Massive, dark red-brown mudstone.

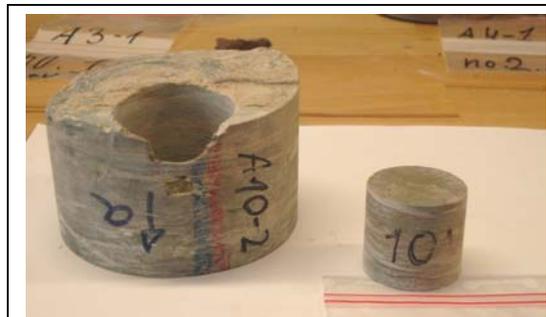
Figure 10. Plug 10V, core ID A-10-2, 628.70 m.
Light grey mudstone with flaser anhydrite.

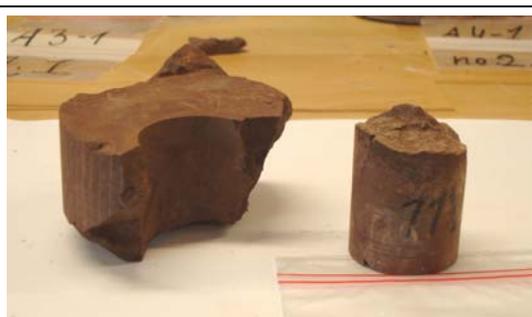
Figure 11. Plug 11V, core ID A-11-1, 630.52 m.
Massive, dark red-brown mudstone.

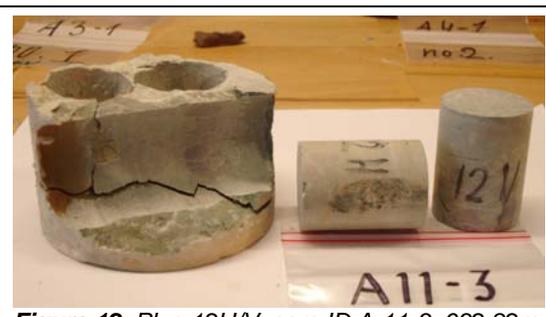
Figure 12. Plug 12H/V, core ID A-11-3, 632.82m.
Massive, variegated mudstone with anhydrite.

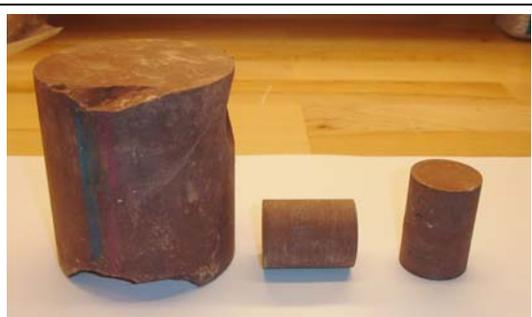
Figure 13. Plug 20H/V, core ID C-1-3, 621.9 m.
Massive, dark red-brown mudstone.

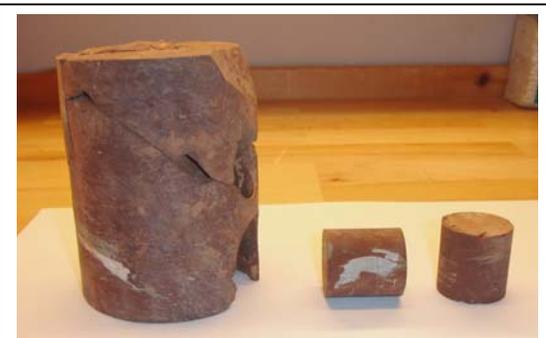
Figure 14. Plug 21H/V, core ID C-3-2, 626.15 m.
Red-brown mudstone with anhydrite.

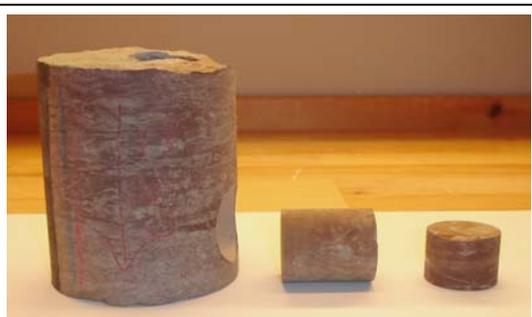
Figure 15. Plug 22H/V, core ID C-4-2, 628.1 m.
Variegated massive mudstone.

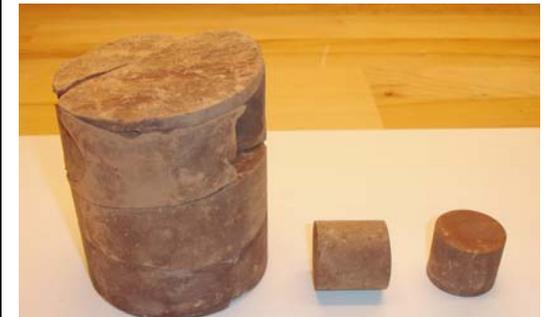
Figure 16. Plug 23H/V, core ID C-5-3, 632.32 m.
Variegated anhydrite spotted mudstone.

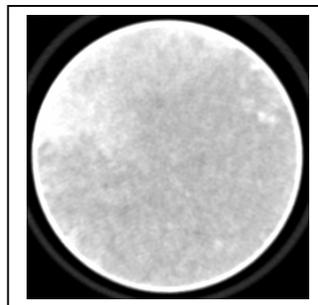
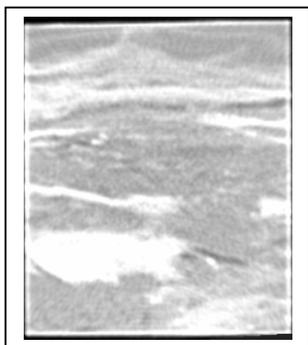
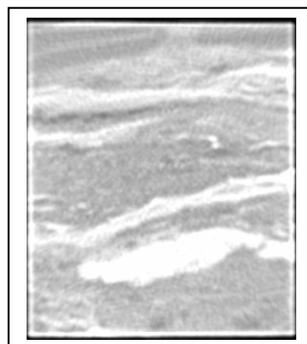
Plug 1V Depth: 610.70 [m]

Avg. gray value : 2494
Sdev : 308
Porosity : 6.6 [%]

The images below are close to real plug size and represent 2 longitudinal cuts perpendicular to each other and one transversal cut through the plug sample. The thickness of each slice is 4 mm. The average grey tone figure and standard deviation for the longitudinal cuts is given in the info box; this figure is proportional to the sample porosity. The grey scale figures is in Hounsfield units; -1000 represents air (100% porosity) and appears dark on the images, +3000 is dense matrix (0% porosity) and appears white on the images.

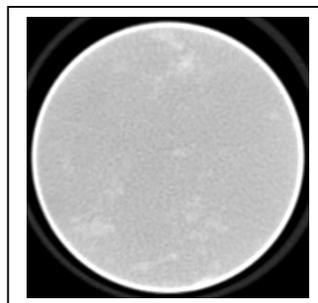
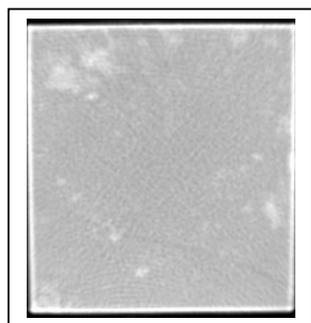
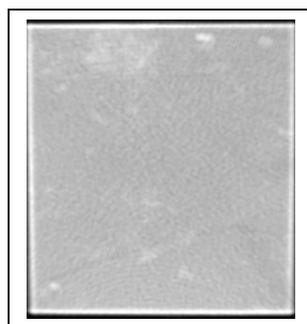
Plug 2V Depth: 612.70 [m]

Avg. gray value : 2300
Sdev : 101
Porosity : 5.6 [%]

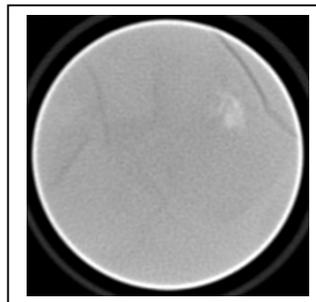
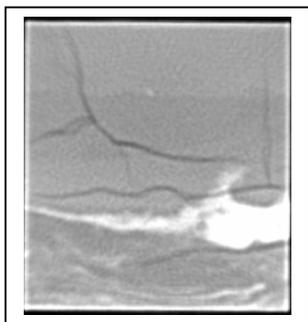
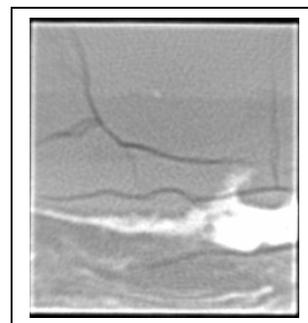
Plug 5V Depth: 618.7 [m]

Avg. gray value : 2042
Sdev : 257
Porosity : 13.7 [%]

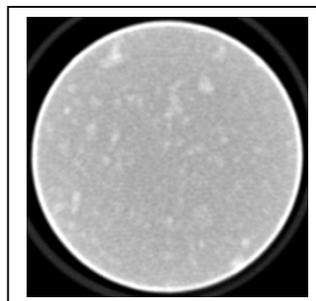
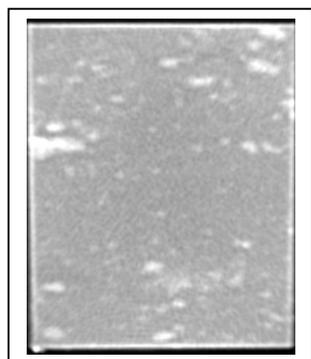
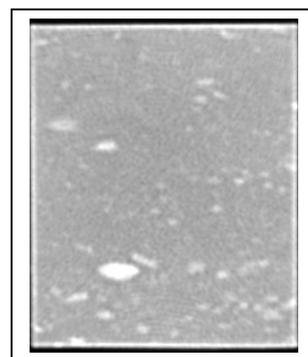
Plug 6V Depth: 620.53 [m]

Avg. gray value : 2173
Sdev : 157
Porosity : 12.0 [%]

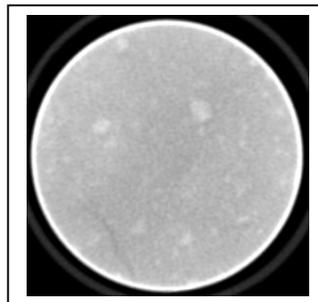
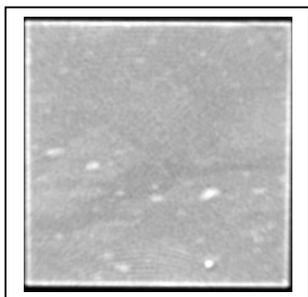
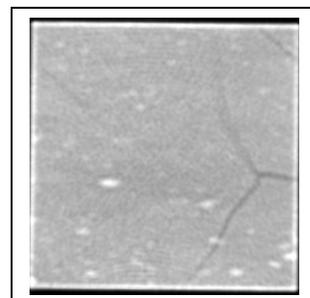
Plug 7V Depth: 622.64 [m]

Avg. gray value : 2215
Sdev : 108
Porosity : 9.7 [%]

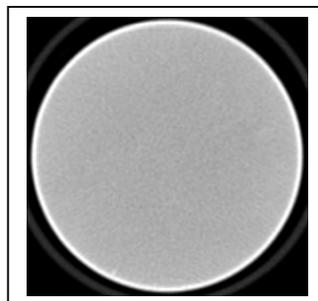
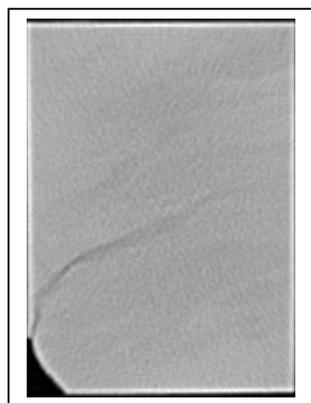
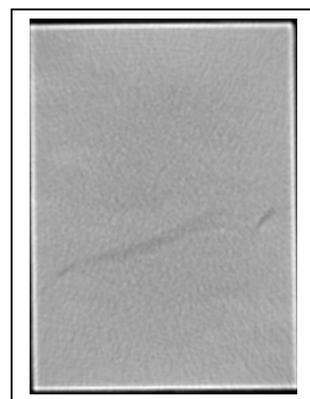
Plug 8V Depth: 624.60 [m]

Avg. gray value : 2022
Sdev : 72
Porosity : 12.5 [%]

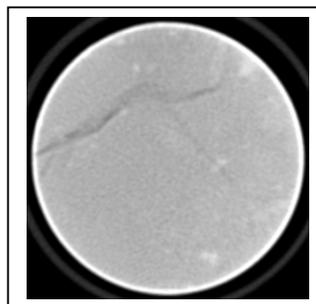
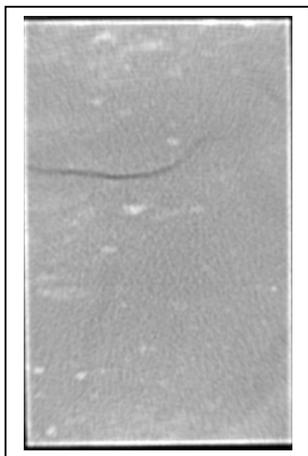
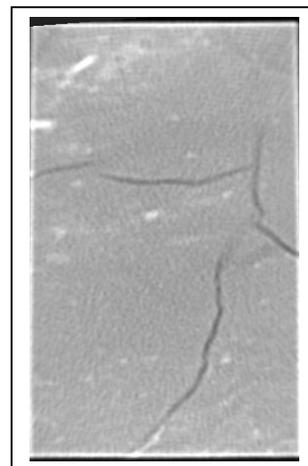
Plug 9V Depth: 626.70 [m]

Avg. gray value : 2092
Sdev : 126
Porosity : 11.5 [%]

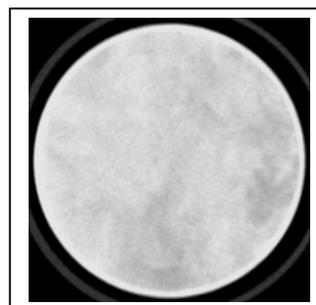
Plug 10V Depth: 628.70 [m]

Avg. gray value : 2530
Sdev : 308
Porosity : 7.7 [%]

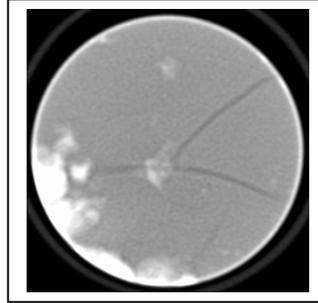
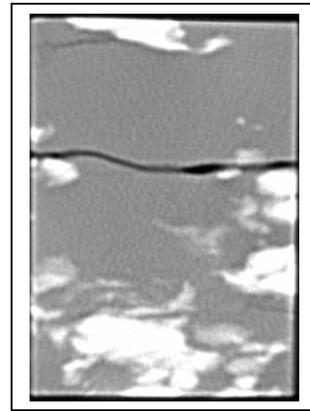
Plug 12V Depth: 632.82 [m]

Avg. gray value : 1954
Sdev : 390
Porosity : 14.1 [%]

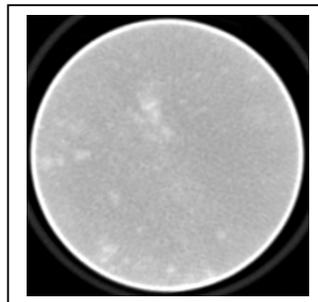
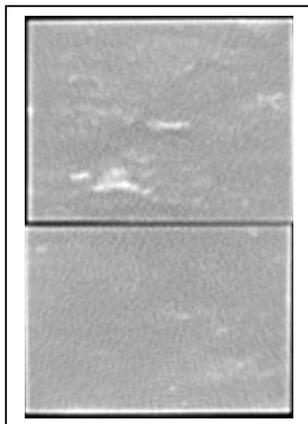
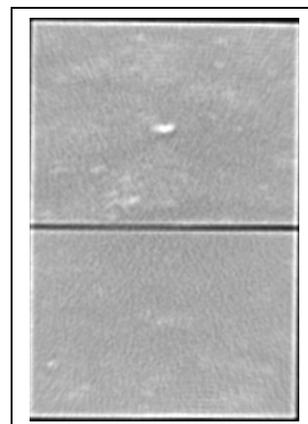
Plug 20V Depth: 621.97 [m]

Avg. gray value : 1954
Sdev : 390
Porosity : 13.5 [%]

Observe that this plug sample was split into two parts before it was CT-scanned.

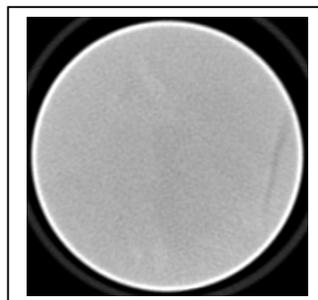
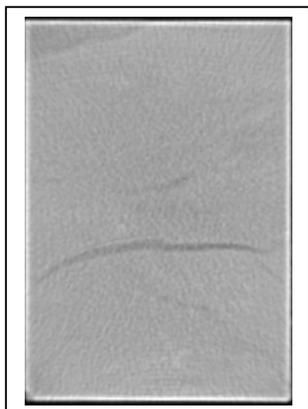
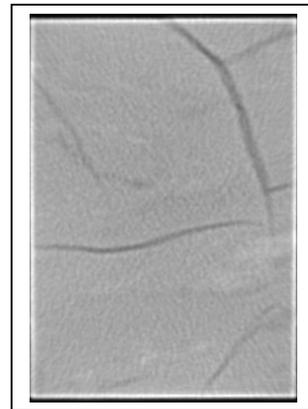
Plug 21V Depth: 626.15 [m]

Avg. gray value : 2016
Sdev : 86
Porosity : 14.0 [%]

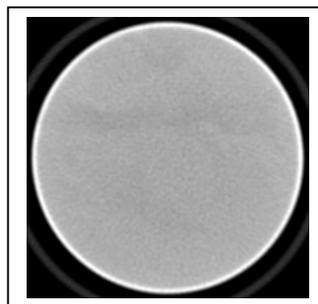
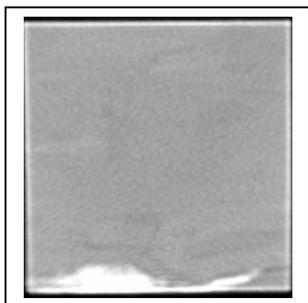
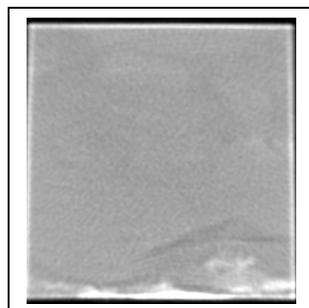
Plug 22V Depth: 628.03 [m]

Avg. gray value : 2042
Sdev : 155
Porosity : 14.9 [%]

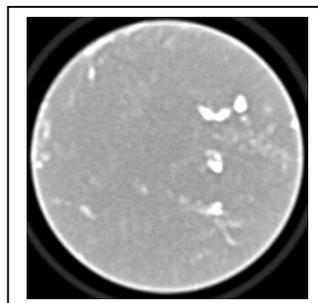
Plug 23V Depth: 632.32 [m]

Avg. gray value : 2060
Sdev : 146
Porosity : 14.8 [%]
