Ground Penetrating Radar investigations in the danish ramp area of the Femarnbelt Fixed Link

Jakobsen, P. R., Nielsen, A. M. & Møller, I.

GEOLOGICAL SURVEY OF DENMARK AND GREENLAND
MINISTRY OF CLIMATE AND ENERGY

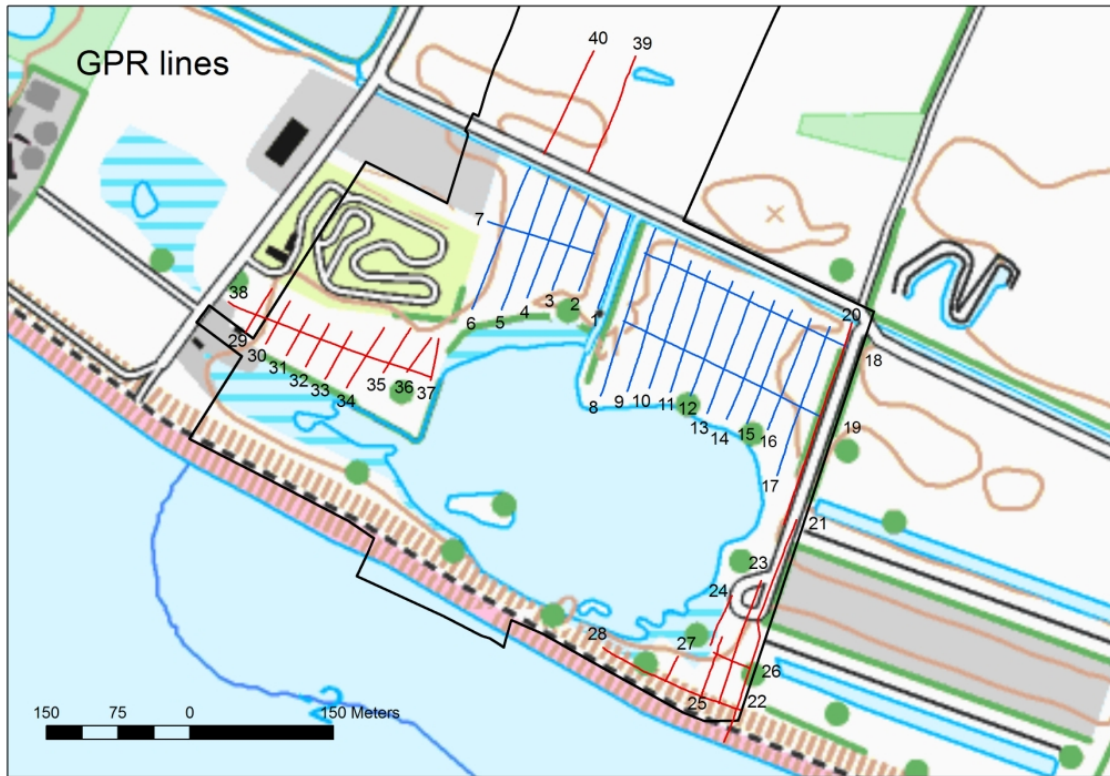
The measured Ground Penetrating Radar lines are mostly placed perpendicular or in a high angle to the expected old coastline and considering the obstacles such as e.g. ditches and vegetation. The orientation is roughly SSW to NNE except the few lines perpendicular to these and goes roughly from WNW to ESE, Figure 2.

Figure 2. The investigation area where the blue and red lines are the measured GPR lines. The black line is the tunnel ramp area.

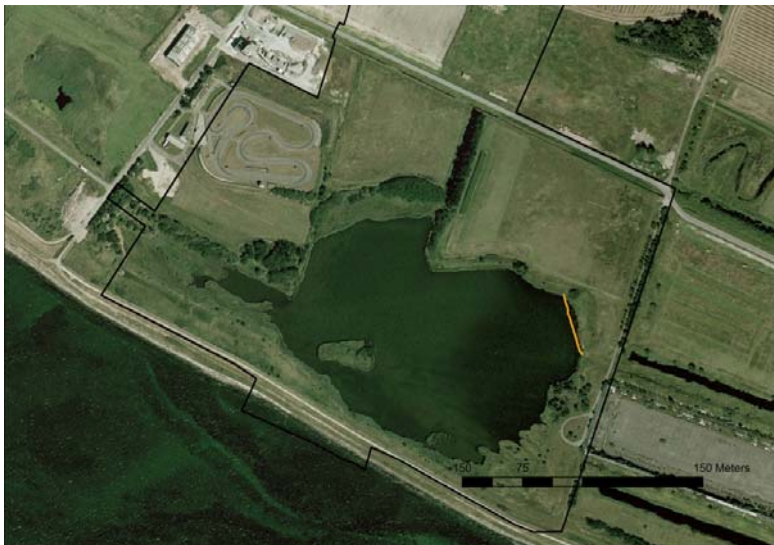
The test line at the lake within the ramp area did not bring any results.

Figure 3. The test line at the lake – orange line.

Der blev målt en linje på søen i området. Det gav dog ikke noget resultat, da saltholdigheden i søen var så stor, at signalet blev dæmpet for meget.

The salinity in the lake was to high to perform GPR measurements on the lake.

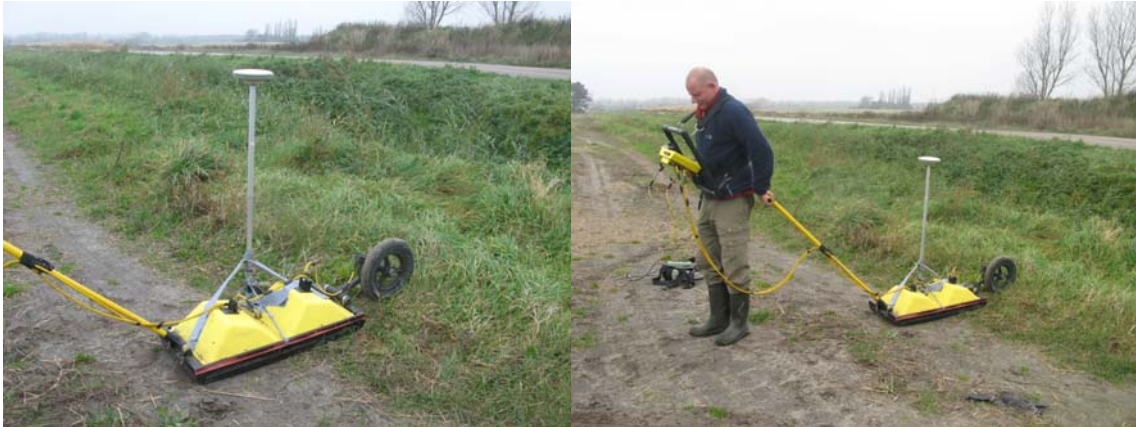
The GPR system is shown in Figure 4. The system use shielded antenna to avoid reflections from obstacles above ground surface e.g. trees and fences in the investigation area.

Figure 4: The left picture show the GPR acquisition system. The two yellow boxes are the transmitter and receiver transducers and the wheel behind is the odometer that measures the distance. The DGPS is placed between the GPR antennas. The right picture shows how it works. The GPR is pulled slowly and the operator can look at the data displayed on a screen during the data acquisition. The operator is also carrying the battery for the GPR system. The GPS measurement is managed of another person who is carrying a backpack with the antenna, cell phone and the computer all connected to the receiver.

GPR data are acquired in step mode with a Sensors & Software pulseEKKO PRO system. The system is equipped with a 165 V transmitter and a transducer with a nominal centre frequency of 250 MHz. The nominal centre frequency of 250 MHz is chosen for the survey since experience show that this frequency is a good compromise between resolution and penetration for shallow investigation of the upper 5 m of the ground. The specific data acquisition parameters are listed in Table 1.

For positioning of the GPR survey Leica System 1200 DGPS was used. The antenna was placed between the GPR transmitter and receiver (Figure 2) and the GPS data were collected along with the GPR data, but stored separately. Subsequently the GPS and GPR data were merged in the processing procedure.

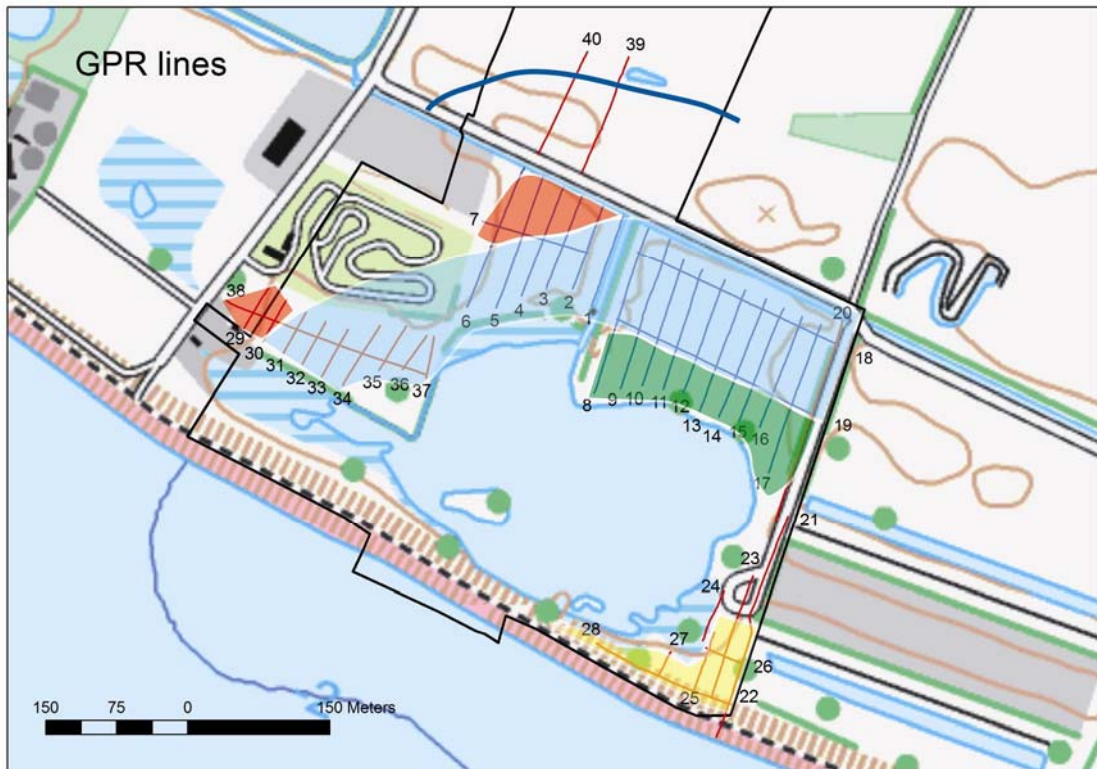
The youngest shoreline towards North is marked with the blue line on Figure 15. From this shoreline there is a 100 m broad stretch of clay till, where no marine deposits are found. In the area where lines 1 to 7 are measured, the clay till surface declines, and marine sandy sediments are deposited upon it (red shade on Figure 15). A similar, and probably the same declining till surface, is interpreted South-West of the gokart track, although at a lower level. It might be the same declining till surface which probably continues under the gokart track.

On the north side of the coastal dike dunes are deposited. Aeolian sand deposited upon marine sand is interpreted in the South-Eastern part of the investigated area (yellow shade on Figure 15). In this area there is a core of a barrier or spit, covered with dunes.

Just north of the lake within the ramp area, a series of wash over fans is interpreted (green shade on Figure 15). The top of this unit could be an old surface at about level -1. Younger marine deposits are deposited upon this unit subsequently.

The deepest part of the lagoon is marked with the blue shade on Figure 15. Here reflectors can be followed over long distances. They are concave and outline events that affected the whole lagoon, and the outline the general build up of the lagoon.

Figure 15. Conclusions from the interpretation of the GPR survey. The red shade shows the outline of the declining till surfaces. They are probably connected underneath the go-kart track. There are probably several older shorelines on this declining surface, belonging to different stages of the rising sea level since about 6500 to 7000 years ago. The green shade shows the outline of the sand unit with wash over fan structures, representing an old surface at about level -1m. The yellow shade shows the outline of dunes and cover sand on top of a barrier island or spit. The blue shade shows the outline of the lagoon basin. The blue line shows the youngest and highest shore line.

Den yngste, og højest beliggende, strandlinje følger 0 kurven. Den er markeret i terrænet som en svag stigning på marken, hvor linjerne 39 og 40 er målt. Marken ind mod strandlinjen består af moræneler, muligvis med mindre lag eller lommer af sand. Beliggenheden af strandlinjen er vist på figur 15.

I den Nordlige del af det undersøgte område, ved georadar linjerne 1 til 7 og 29 til 38, kan man kortlægge kontakten til den underliggende moræneflade. Morænefladen dykker mod SØ ud mod lagunens midte. De marine lag lægger sig ind mod den hældende moræneflade, og der er således antagelig flere ældre strandlinjer fra forskellige stadier af havspejlsstigningen. Udbredelsen af den hældende moræneflade er vist på figur 15.

Nord for søen i rampeområdet, er der strukturer, der er tolket som en udbygning af sandbarrer, med overskyldsfaner. Toppen af barrerne ligger ca. i kote -1 m. Det kunne være en landværts udbygning af en ældre barriereø, eller udbygning af et ældre krumodde kompleks, således at man i dette område muligvis har en druknet overflade og ældre strandlinjer. Udbredelsen af fladen er vist på figur 15.
