A map of the cliff overhang at Stevns Klint

A report for Stevns Kommune in support of coastal hazard assessment at the Stevns Klint UNESCO World Heritage Site

Samuel Paul Jackson, Kristian Svennevig & Erik Vest Sørensen

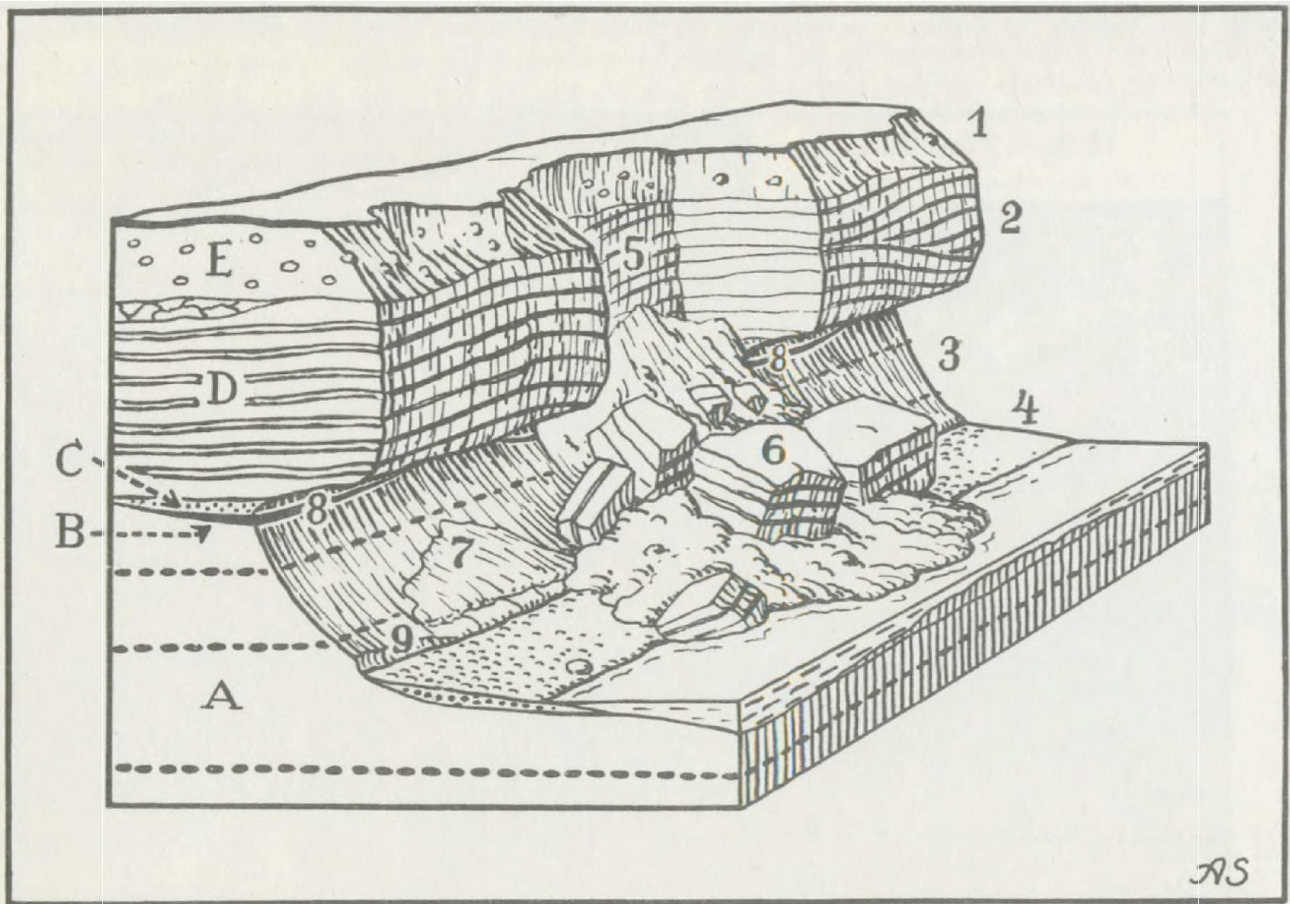
Fig. 2. Axel Schou's 1949 block drawing of the Stevns Klint profile from his 'Atlas over Danmark', concisely capturing its essential features. The view faces north and the block is 30 x 70 m. Note the overhang of the Danian limestone (D) above Maastrichtian chalk (A), and the uppermost till layer (E) with a sloped setback from the top of the limestone. The Cretaceous–Paleogene (K–Pg) boundary runs below the overhang, intermittently following the base of either the limestone or that of the two relatively thin units that occur in small basins: the Fish Clay (B) and Cerithium limestone (C). Note also that the uppermost broken horizontal line depicts the flint band digitized for this study. Schou has included a collapsed section of the cliff, showing a vertical scarp (5) and fallen blocks and scree (6).

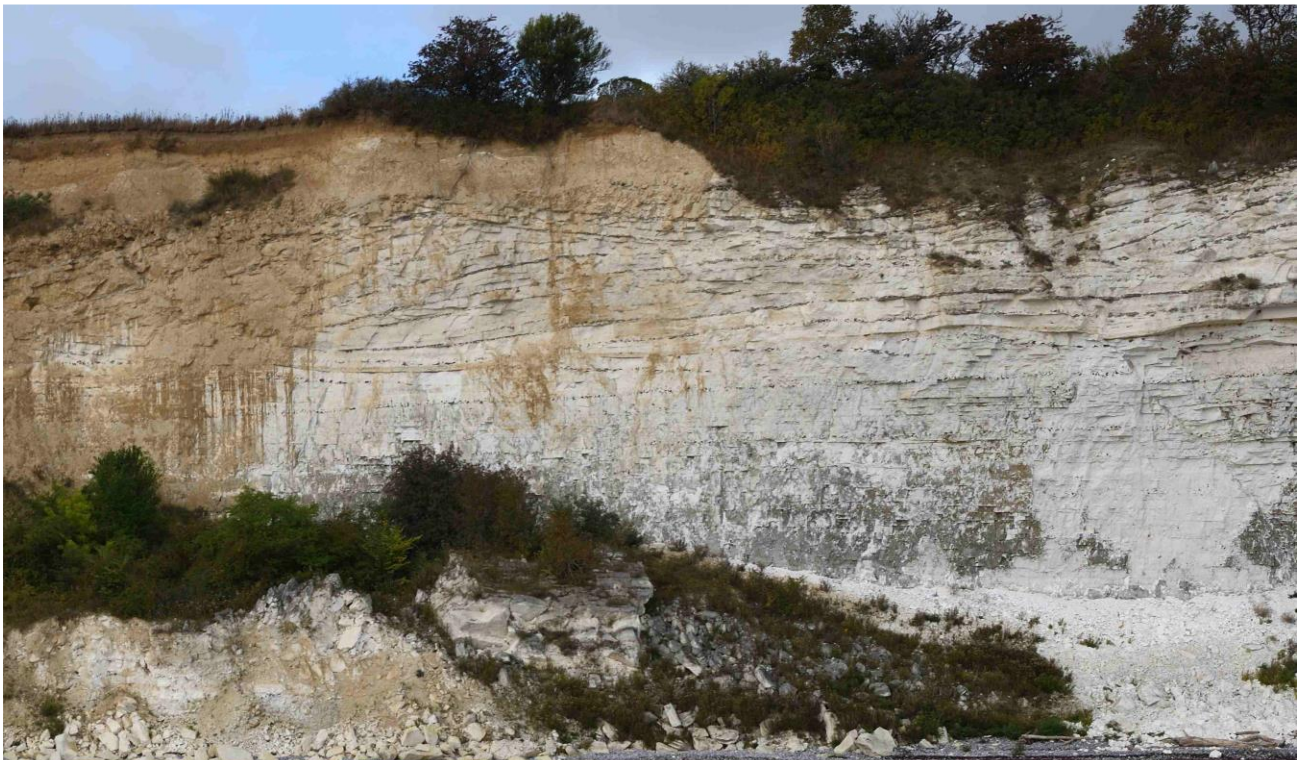
Above: Fig. 3. A section of the cliff illustrating the development of a setback in the till at the top of the cliff. On the left, a relatively fresh landslide has produced a near-vertical scarp in both the limestone and the till. At bottom left landslide debris lies on the beach. At top right, the common configuration of the clifftop – a sloped setback of the till, often colonised by vegetation. The height shown is approximately 25 m.

subsequent seasons the till layer recedes further, resulting in a sloped setback from the top of the limestone (Fig 3). We have incorporated this loss of till cover in our map as a buffer, to better reflect the full potential encroachment of landslides (Fig. 4).

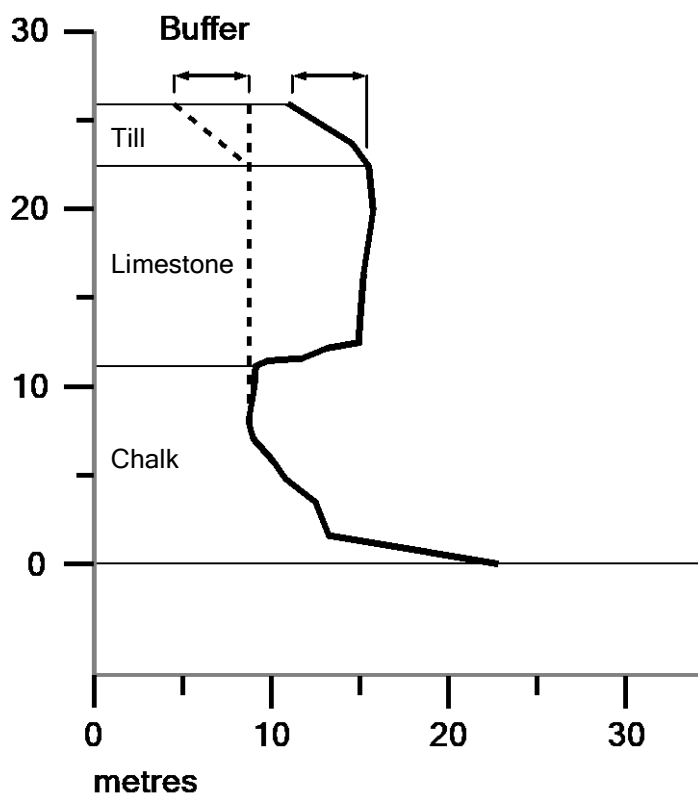
Left: Fig. 4. A profile of Stevns Klint digitised from the cliff immediately north of Højerup with a schematic depiction of geological units. The vertical dashed line traces upwards from the deepest undercut point, while the oblique line represent the additional setback in the till layer, which we have modelled as a buffer.

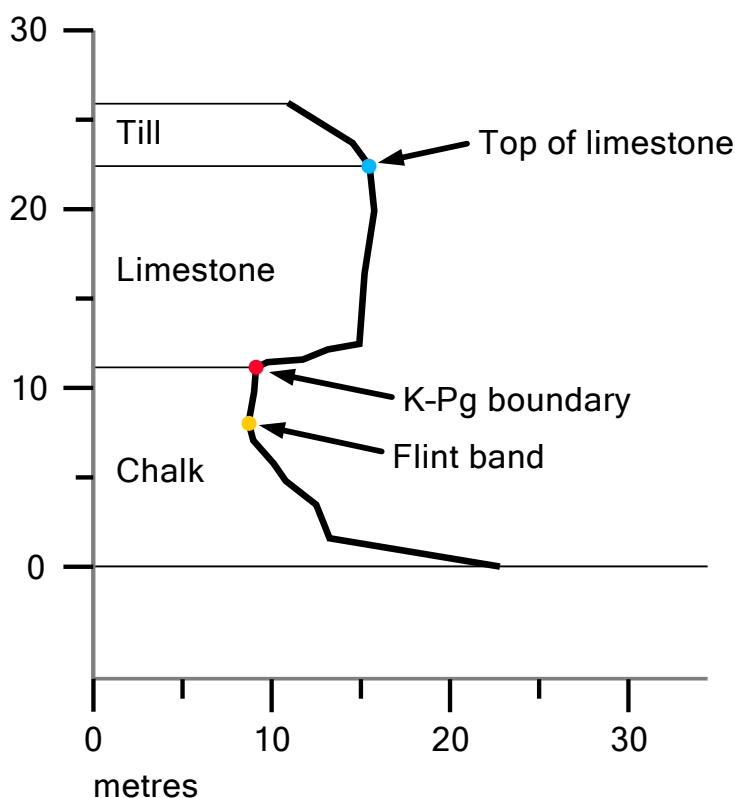
Fig. 5. Cliff profile indicating three of the features selected for digitisation. A fourth class of line was used where neither of the two undercutting features shown above could be traced.

To capture the cliff overhang, we traced the deepest undercut part of the cliff as well as the furthest protrusion. To do so efficiently, we selected proxy geological and geomorphological features that could be followed reliably over long stretches of the coastline (Figs. 5 and 6). The Cretaceous–Paleogene (K–Pg) boundary occurs at the junction of the chalk and limestone, and for much of the coast corresponds to the most deeply undercut horizon. A prominent dark flint band, some 5 m lower on the cliff, within the Maastrichtian chalk, is occasionally cut even more deeply than the K–Pg boundary. At almost any place where there are overhangs, one or other of these horizons is at, or very near, the deepest point. A separate class of polyline was digitised on the few sections where neither of these horizons is exposed, but where an undercut nonetheless

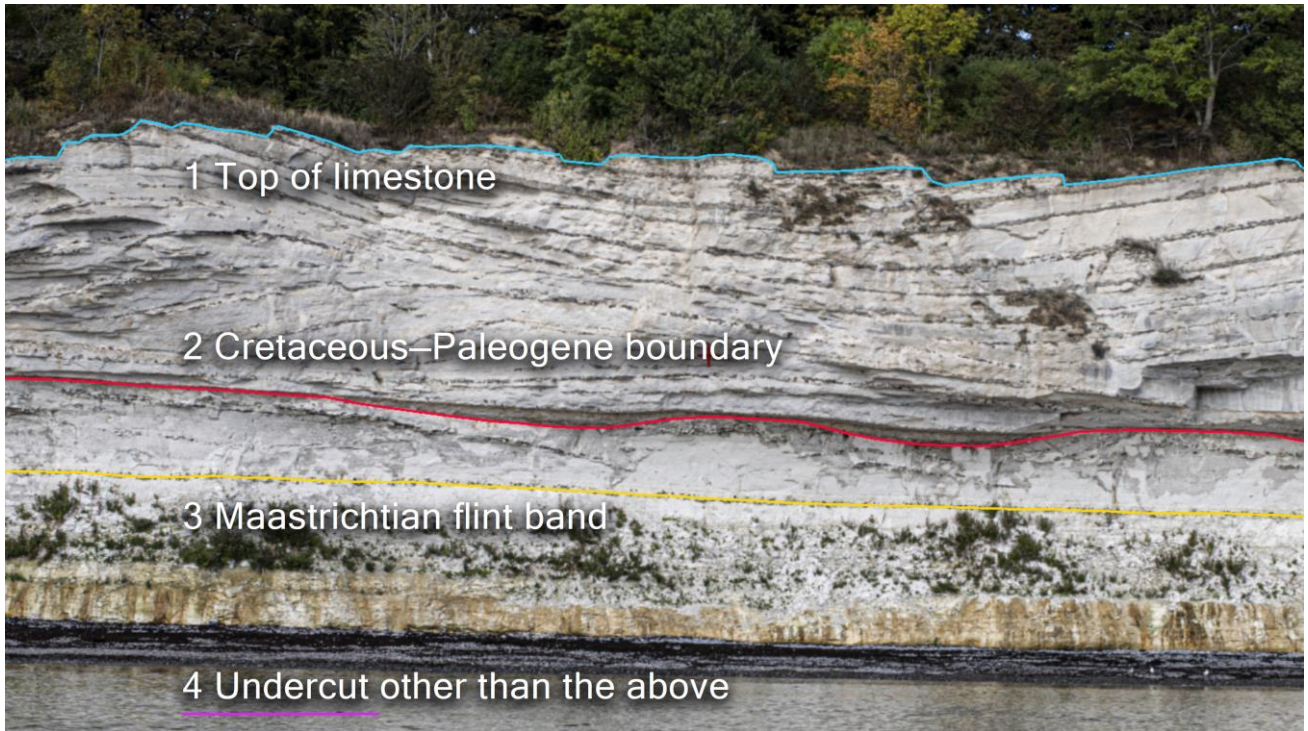
Fig. 6. The four features digitised in this analysis, of which the first three are shown in position on the cliff face. This image, minus labels, is captured directly from the stereo workstation and shows a flat version of the main working view used in the digitisation process.

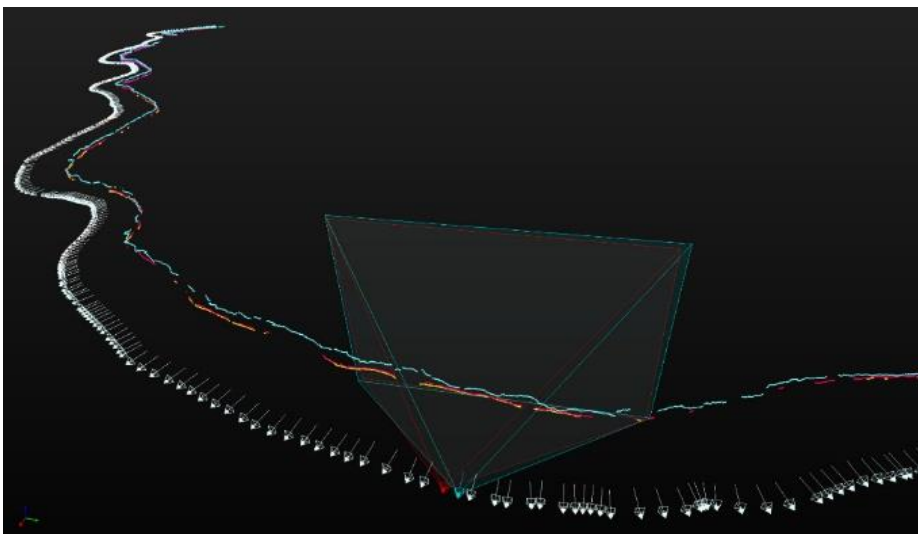
Fig. 7. A view of the 3D polyline data for Stevns Klint from the stereo workstation. The white objects mark camera positions. In this screenshot, the viewing frustum is centred in the vicinity of Stevns Lighthouse. The left of the image shows the coastline stretching southwards towards Højerup and beyond.

exists. This mostly pertains to a small section of cave-eroded coastline north of Boesdal quarry. This final class of undercut line does not trace a geological horizon but was digitised solely by stereo depth estimation. To capture the seaward reach of the overhang, we traced the visual top of the Danian limestone. This is treated as a geomorphological, rather than a geological feature, since the actual contact surface with the till is generally obscured. It should also be noted that the limestone face is in places convex, such that a lower part projects outward yet further. The top is nonetheless a good proxy that has the advantage of being consistently traceable along almost the entire coastline. The digitisation process produces a 3D dataset of categorised polylines (Fig. 7).

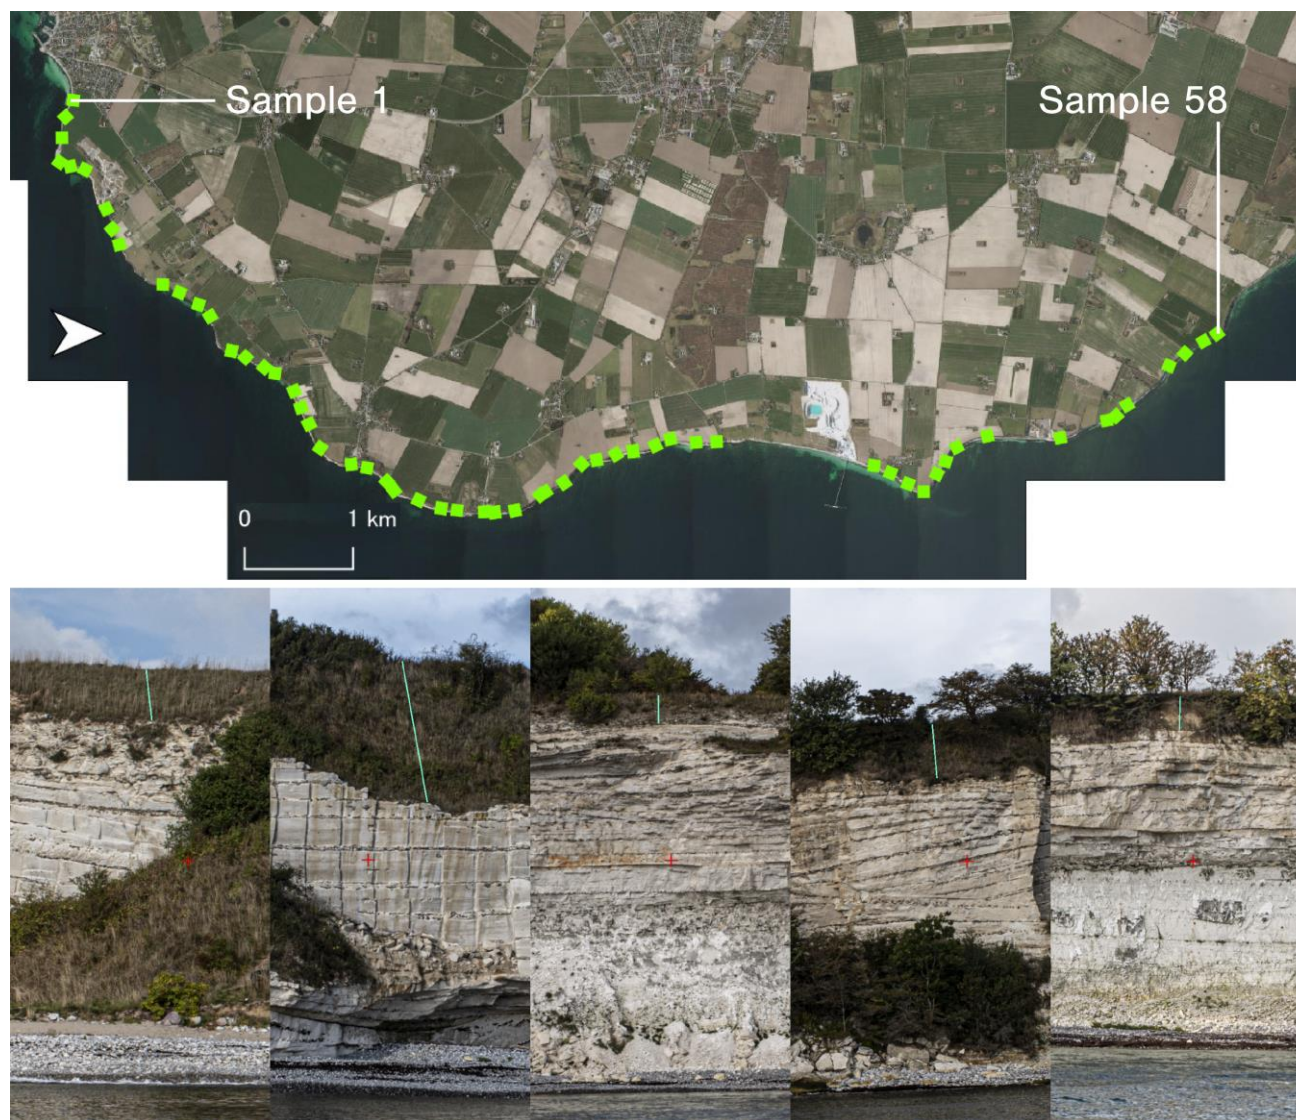
Fig. 8. Map of locations at which the till slope was measured for the purpose of calculating an appropriate buffer, with selected images from the stereo view to illustrate the sampling method. The table of measurements is supplied in Appendix A.

To calculate the buffer used to represent the post-landslide till slope, we measured the shape of the present slope at intervals of approximately 200 m, excluding sections lacking a limestone cliff or where the slope was obscured by vegetation. Specifically, we placed 58 two-point polylines extending from the top of the limestone to the top of the till slope (Fig. 8). We extracted the elevation values of the two vertices and subtracted them to give an estimate of the till thickness. We used a conservative angle of 45 degrees, shallower than the measured mean of 52 degrees, to trigonometrically calculate the landward reach of the slope.

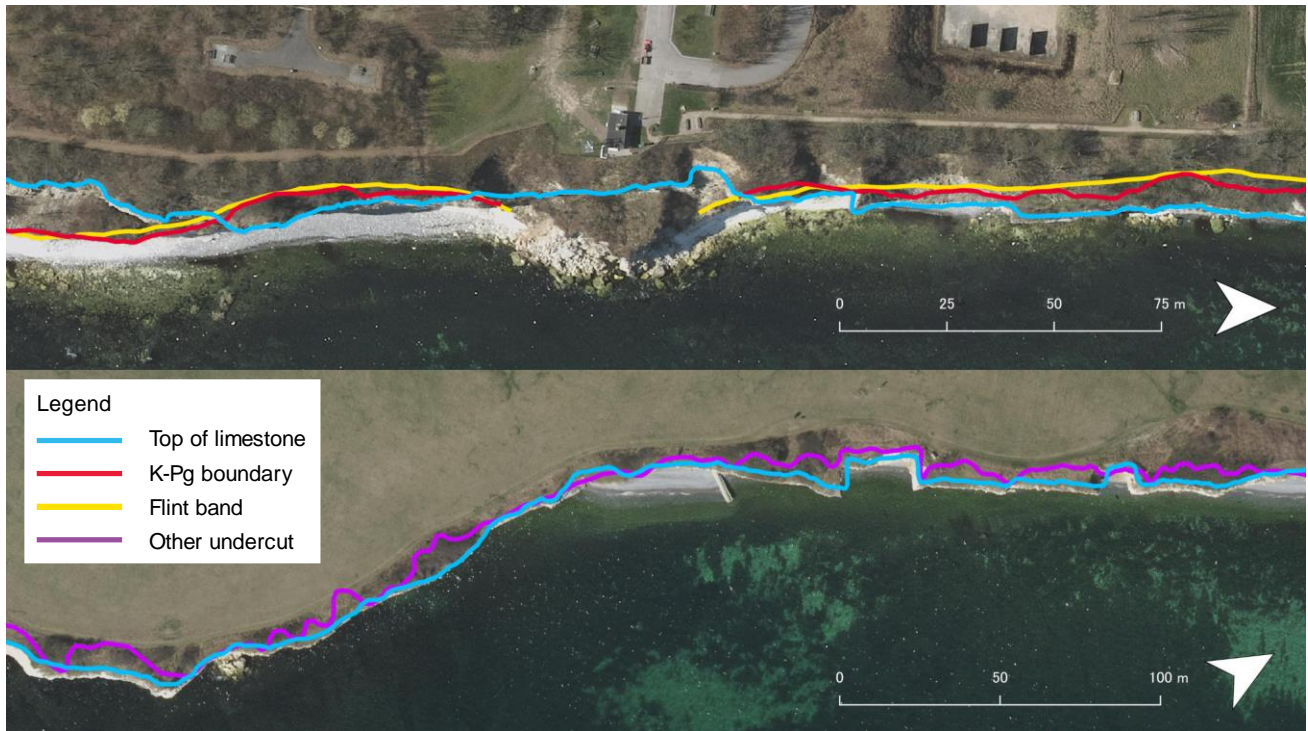
Fig. 9. Two views of the polyline data following mapping in GIS software, from Stevns Lighthouse (above) and Stevnsfort respectively. At the lighthouse, the top limestone line alternates with the two lines representing the undercut. Note the discontinuous nature of the digitised lines, in this instance due to landslide debris under the viewing point concealing the lower part of the cliff succession. At Stevnsfort, the K-Pg boundary lies too low to be traced, so this part of the coast provides an example of somewhere the undercut was judged by visual depth estimation to be the deepest point. Note the rectangular recess in the cliff, right of centre, a common tell-tale sign of former small-scale coastal quarrying.

We exported the digitized polylines from the stereophotogrammetry workflow and transferred them into GIS (QGIS) as shapefiles (.shp). We first tidied the polylines by bridging small gaps (generally smaller than 100 m) and manually removing small loops and kinks. We applied light smoothing to improve the cartographic appearance of the lines. When mapped, the four digitised line features intersect each other along the coast as dictated by the profile of the cliff (Fig. 9).

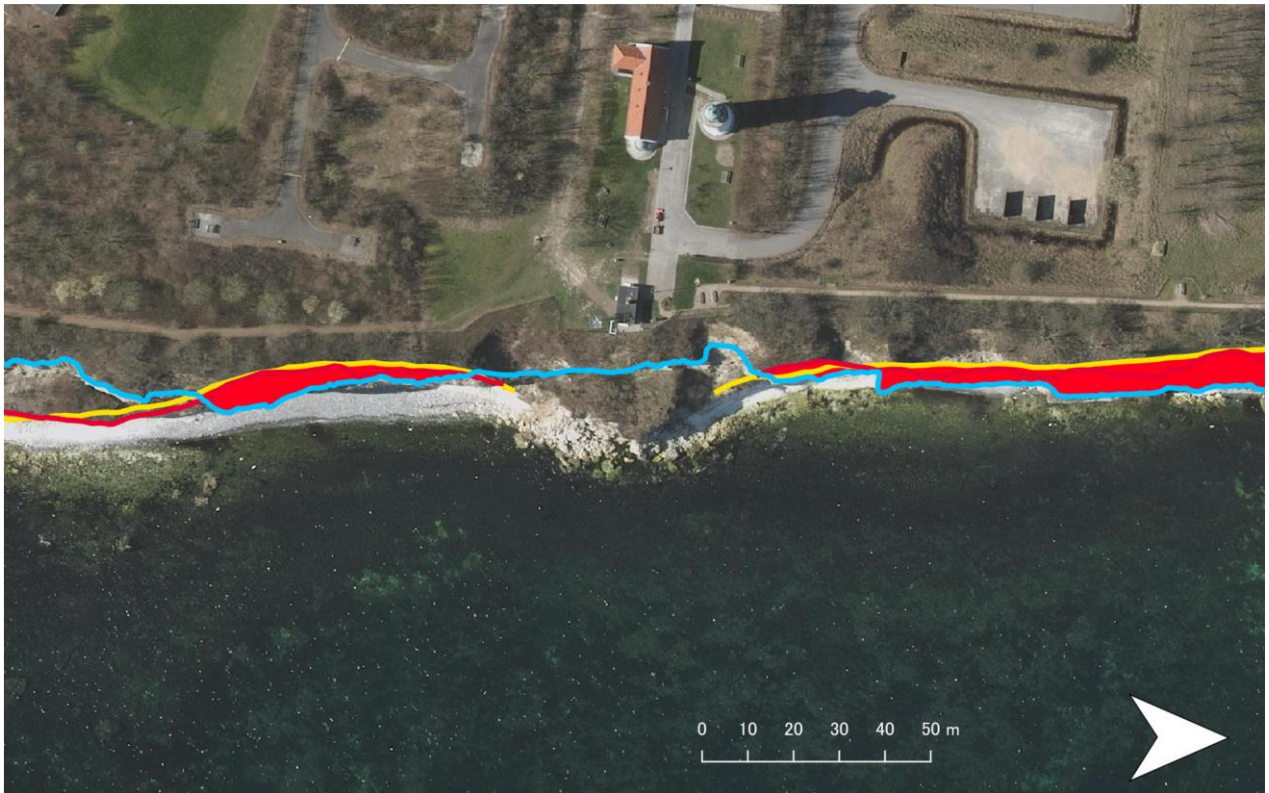
Fig. 10. Overlap polygons generated from the polylines in the vicinity of Stevns Lighthouse. This particular section illustrates a pattern observed in several places along the coastline, in which current overhangs alternate with former landslides.

The overlapping areas where the top of the limestone extends further outwards towards the sea than the undercutting lines indicate an overhanging section of cliff, while the opposite overlap indicates a cliff profile leaning landwards or containing a bench. To highlight the overhang, we generated polygons covering all of the first type of overlap (Fig. 10).

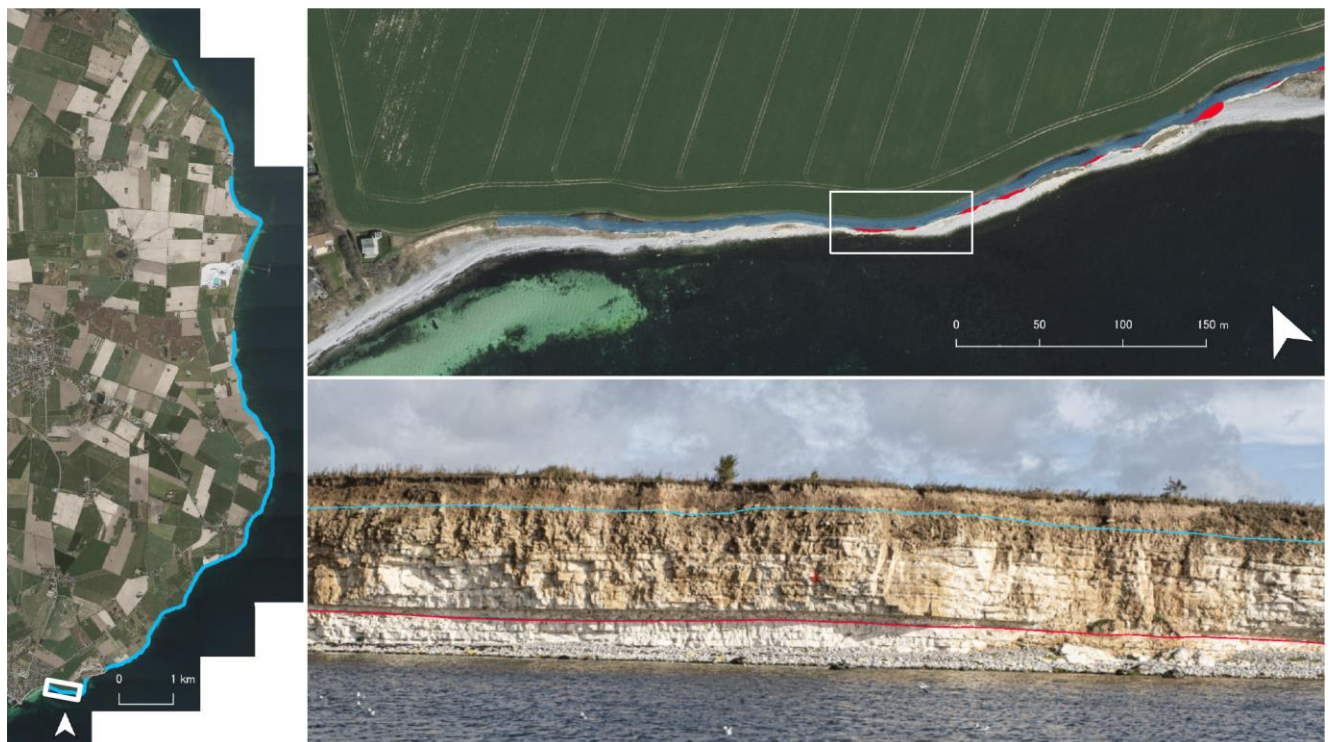
A small overhang first appears within a few hundred meters of Rødvig harbor, along the stretch of coast that runs eastward toward the point at Korsnæb. The height of the cliff is about 12 m. The till layer is relatively thin, and a correspondingly thin buffer (5 m) has been mapped.

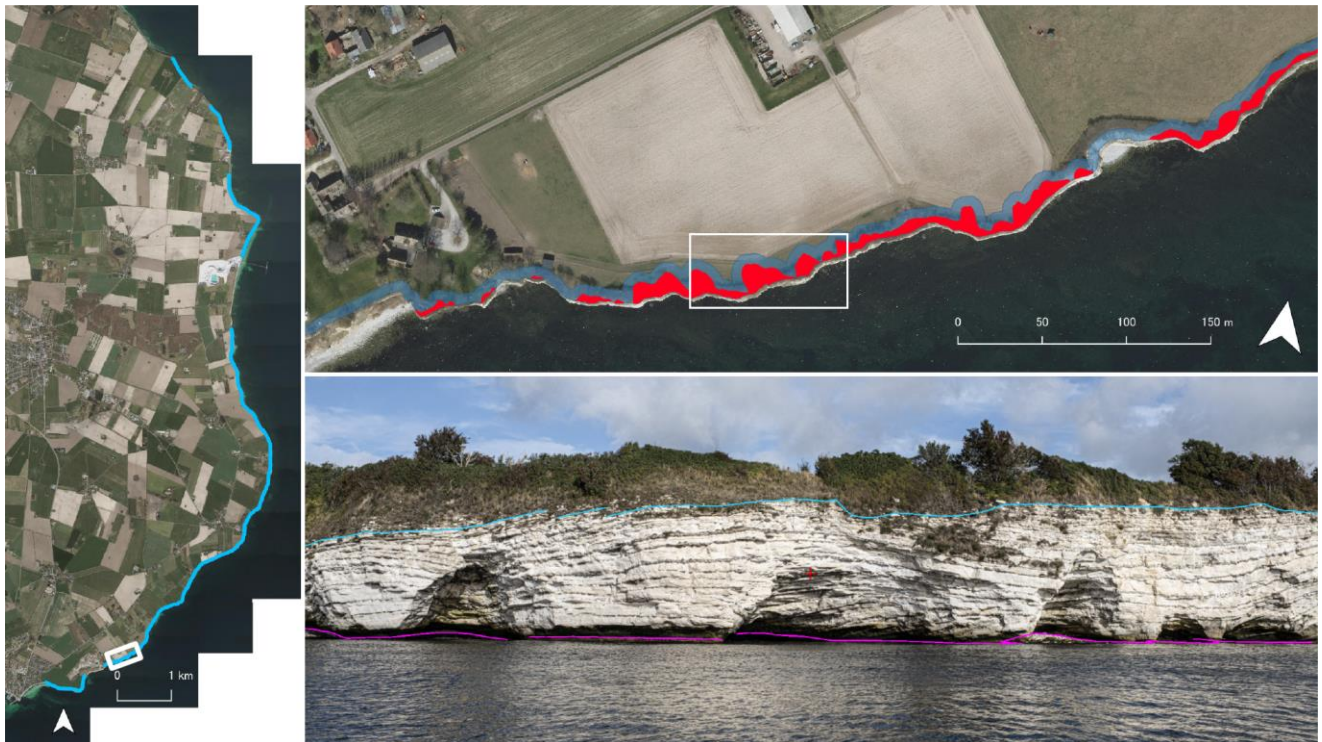
The largest overhangs along the Stevns coastline are found at the caves north of Boesdale quarry. The undercut was digitised at or close to sea level along this stretch. The height of the cliff is about 10 m.

Conversely, this type of overhang is largely absent along those parts of the coast where the K-Pg boundary is not exposed, either because it runs below sea level or above cliff level. The only portion of the coastline in which the boundary runs below sea level is a 2 km long stretch running from Boesdal quarry northwards past the location of Stevnsfort. Here it is limestone, rather than chalk that is exposed to erosion at sea level. The relatively hard limestone shows a distinct erosional pattern, essentially limited to this stretch of coast, namely the carving of deep but relatively narrow caves under the cliff. Some of these caves exceed 15 m in depth, thus greatly exceeding the depth of overhang seen elsewhere on the coastline. We hypothesise that a key factor may be that the cave overhangs have roughly $\frac{3}{4}$ lateral contact with the adjoining limestone beds, compared to between $\frac{1}{2}$ and $\frac{1}{4}$ in the case of cliff overhangs, and the limestone may therefore be subject to a more uniform stress distribution. We also conjecture that the mounded bedforms of the limestone might confer some additional resistance to collapse by forming natural arches. Either the first or both of these conditions could explain why overhangs can form to a greater depth here than elsewhere.

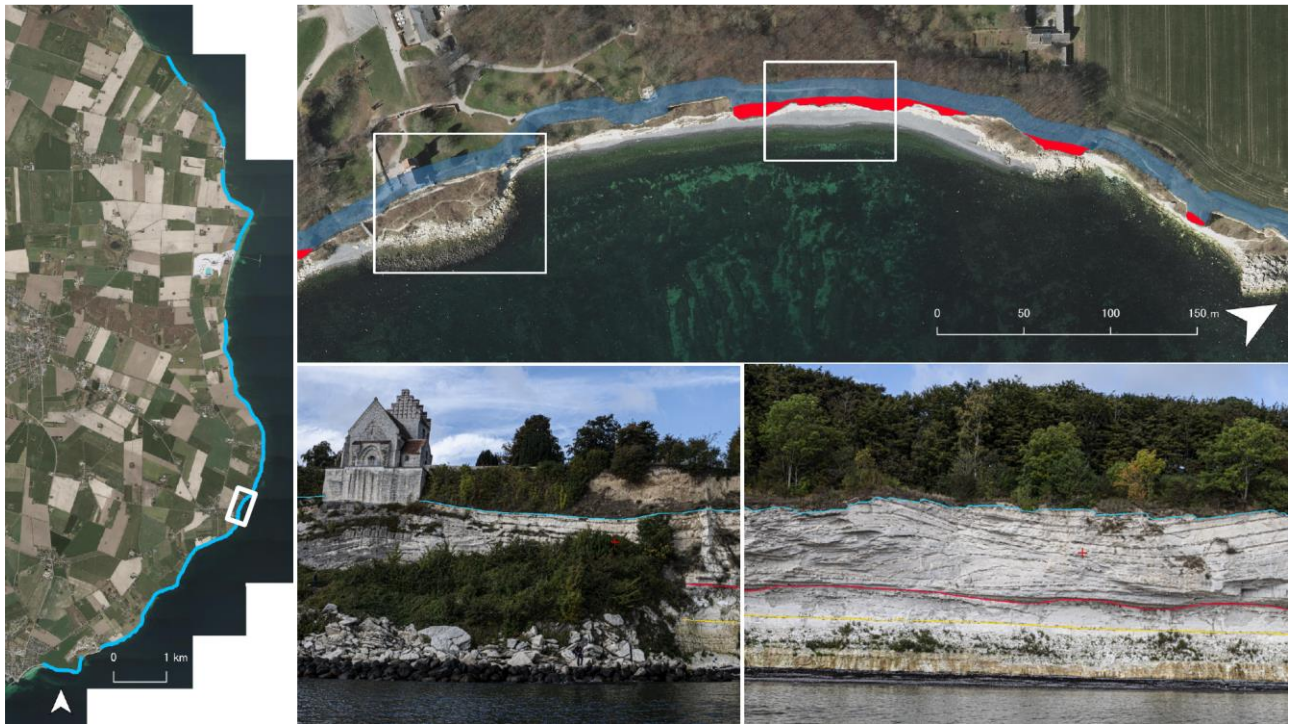
The best documented landslide on the coast is that which claimed the choir of Højerup Old Church in 1928. The Church is now well shielded by the former landslide and defensive boulders. However, immediately to the north the beach passes under a large and well-visited overhang, the southern edge of which coincides with a former quarry wall. The height of the cliff is about 25 m.

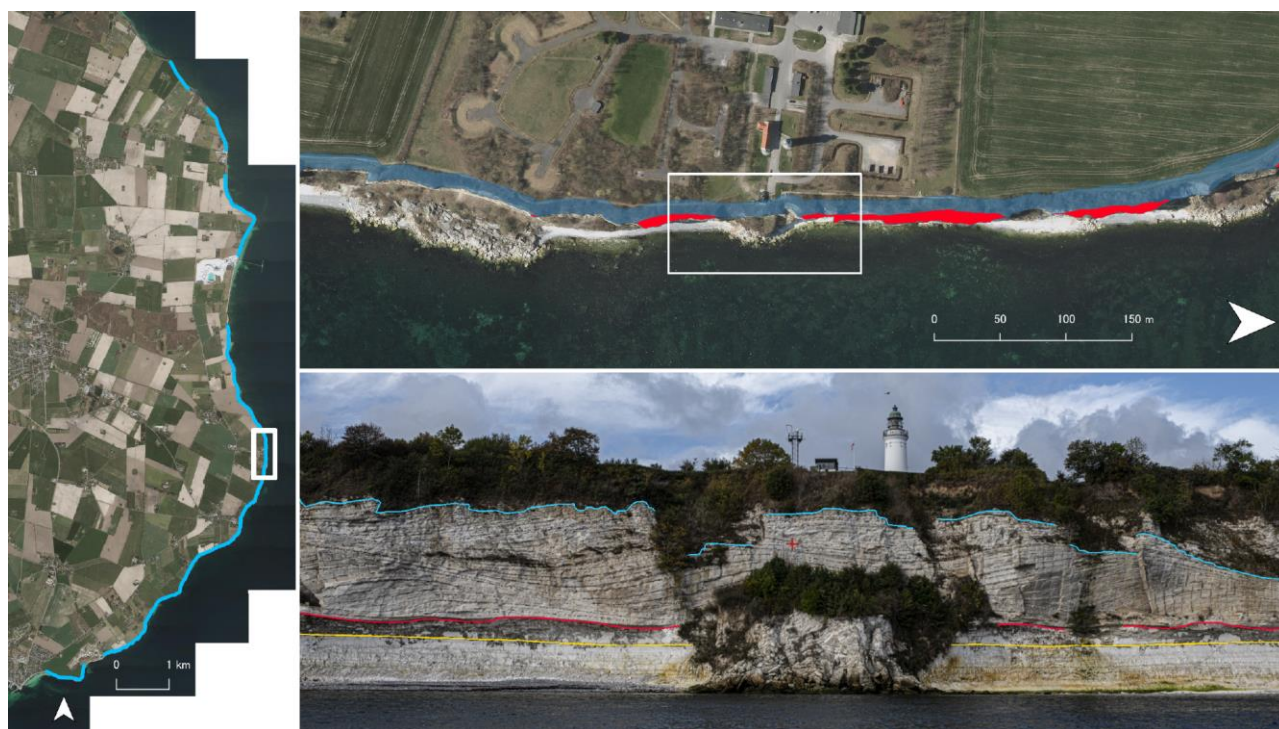
Stevns Lighthouse (Stevns Fyr)

Stevns Lighthouse sits above a 50 m collapsed section of cliff. To the south, a much larger landslide, over 150 m wide, lies on the beach, and is partly responsible for a relative lack of overhang on the coast running southwards from the lighthouse. To the north, still-intact overhangs are among the largest along the coast. A thick buffer is applied here to reflect the relatively thick till along this stretch. The height of the cliff is about 40 m.

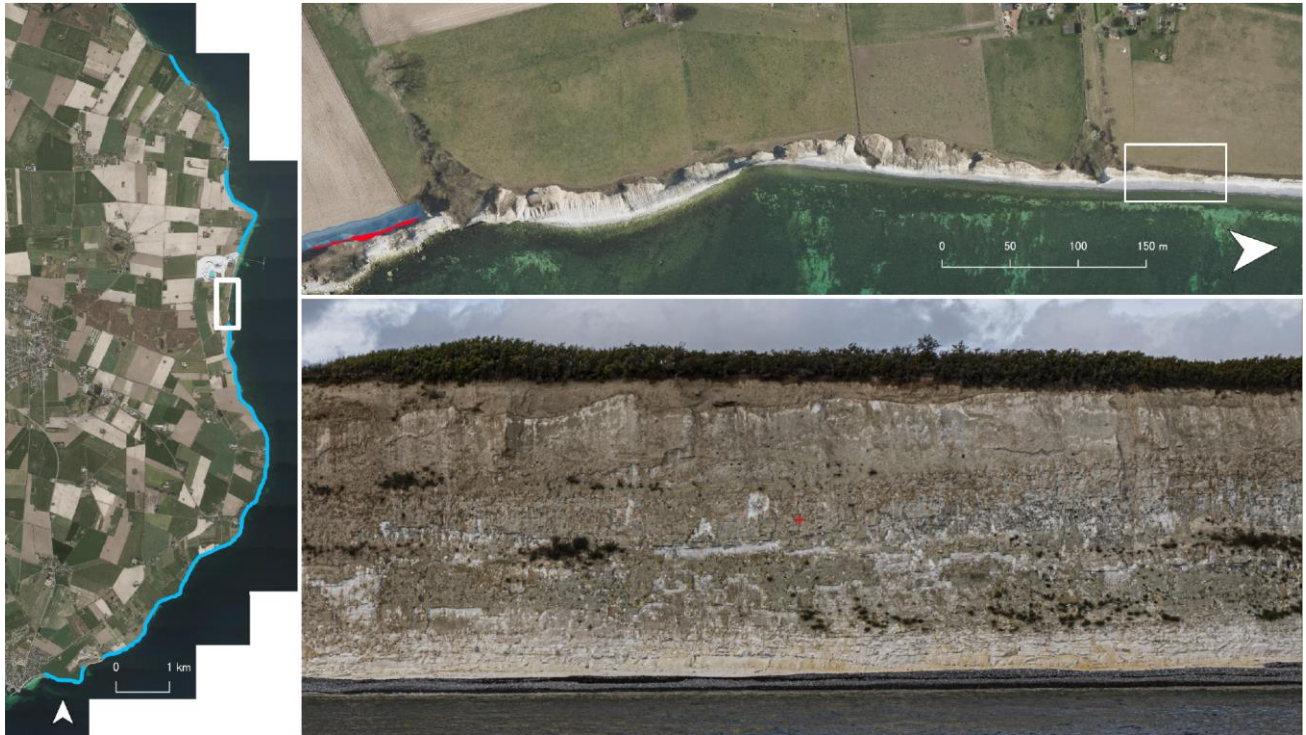
Lilledal

Between Storedal and Sigerslev quarry the K-Pg boundary rises above the present topography, with the result that the cliff is made up of chalk with a cover of till. This composition does not permit the formation of large overhangs, and the absence of past landslides on the beach points to smaller-scale continual erosion predominating. The height of the cliff is about 25 m.

Where the K-Pg boundary exceeds the height of the cliff the entire face is composed of Maastrichtian chalk and overlying Quaternary till. This is the case between Storedal and Sigerslev quarry, and in a stretch either side of Kulstirende, for a combined extent of about 2 km. This cliff configuration probably suppresses the formation of a significant overhang due to the lack of contrast in strength between layers. In such instances cliff erosion is more heavily dominated by smaller-continual erosion, which nonetheless can occur at significant overall rates (Pederen & Gravesen, 2016). These sections are neither amenable to the present methodology nor do they present an overhang hazard of the type seen elsewhere along the coast, and are thus omitted from the scope of this analysis.

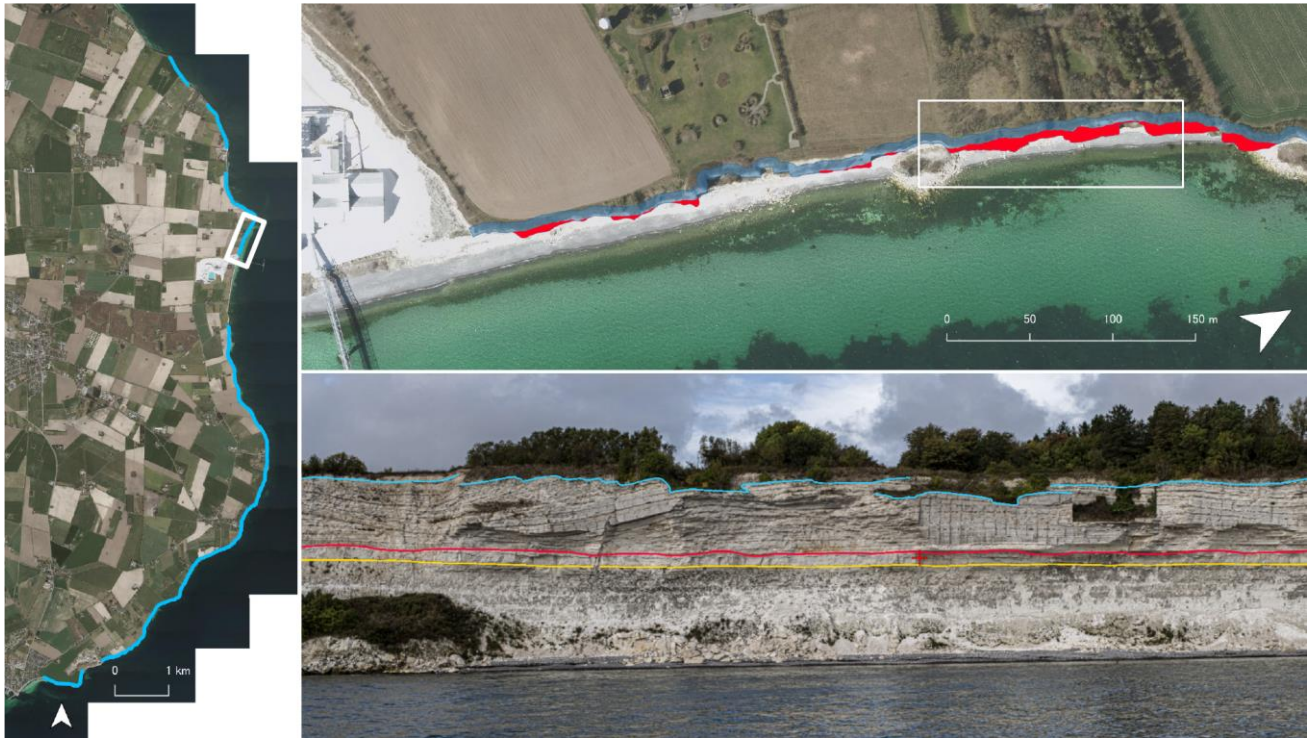
North of Sigerslev quarry

The reappearance of the K-Pg boundary north of Sigerslev quarry instigates the resumption of cliff overhangs. Although the overhangs are large, the till cover is relatively thin, so a correspondingly narrow buffer has been applied. Note the small abandoned quarry (upper right in the lower photograph) causing angular blocks of limestone to protrude over the beach. The height of the cliff is about 35 m.
