# **Inventory of pollutants in urban stormwater – documentation report**

D4RUNOFF deliverable 1.3

DOI: 10.22008/gpub/34769

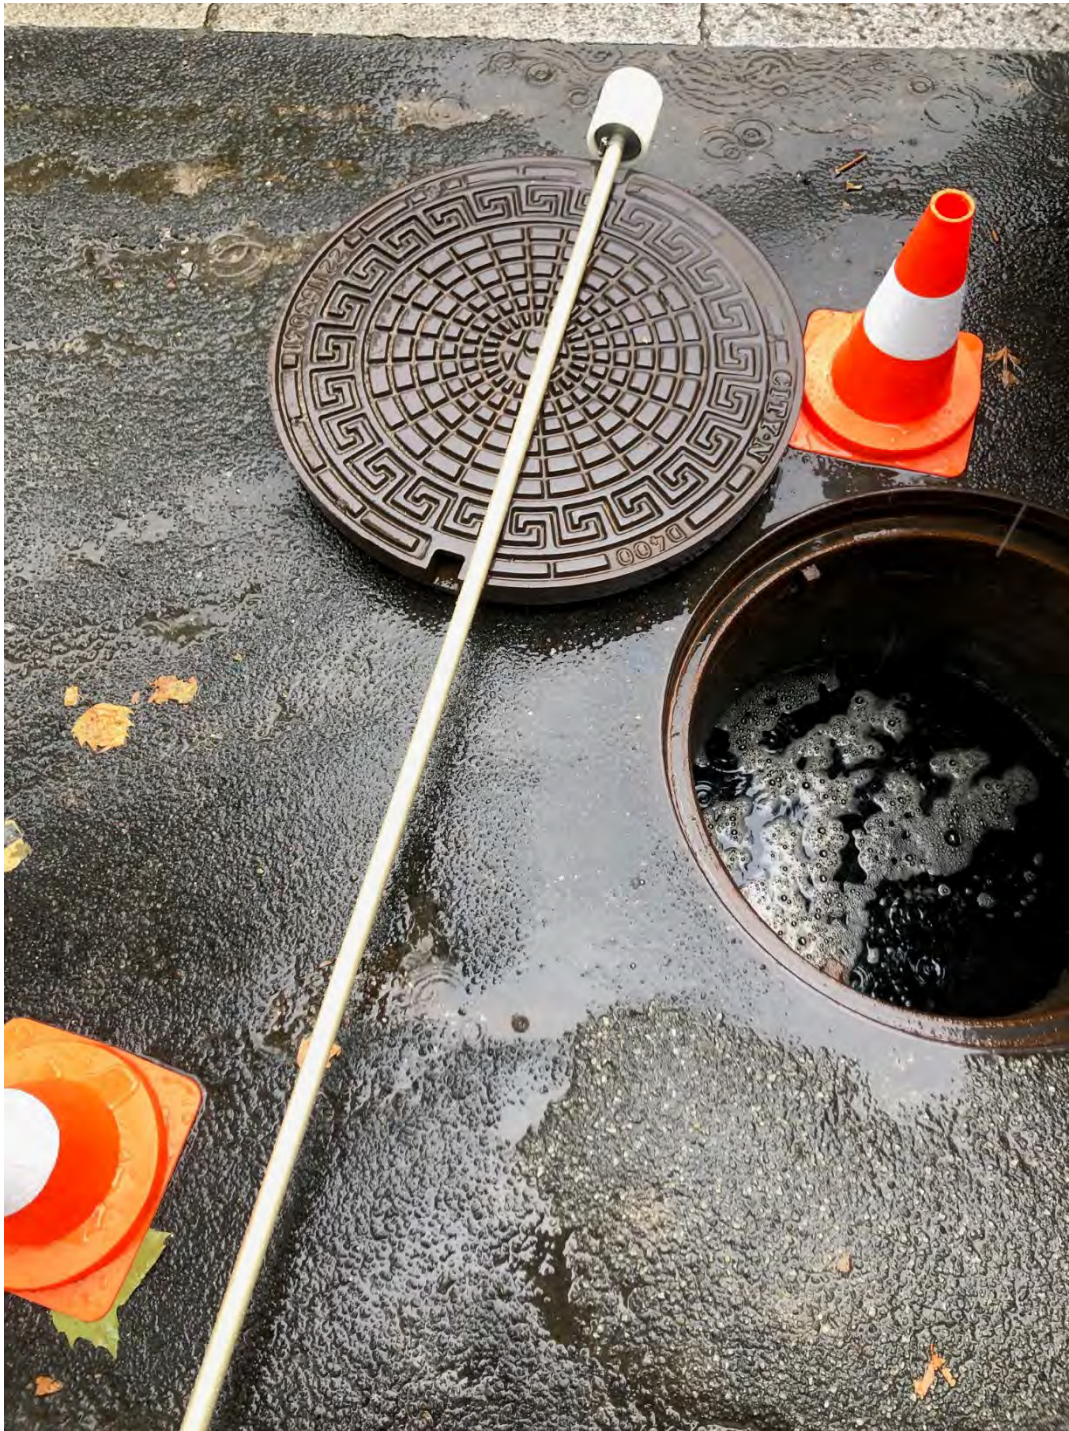
*Sampling setup with sub-surface grab sampler.*

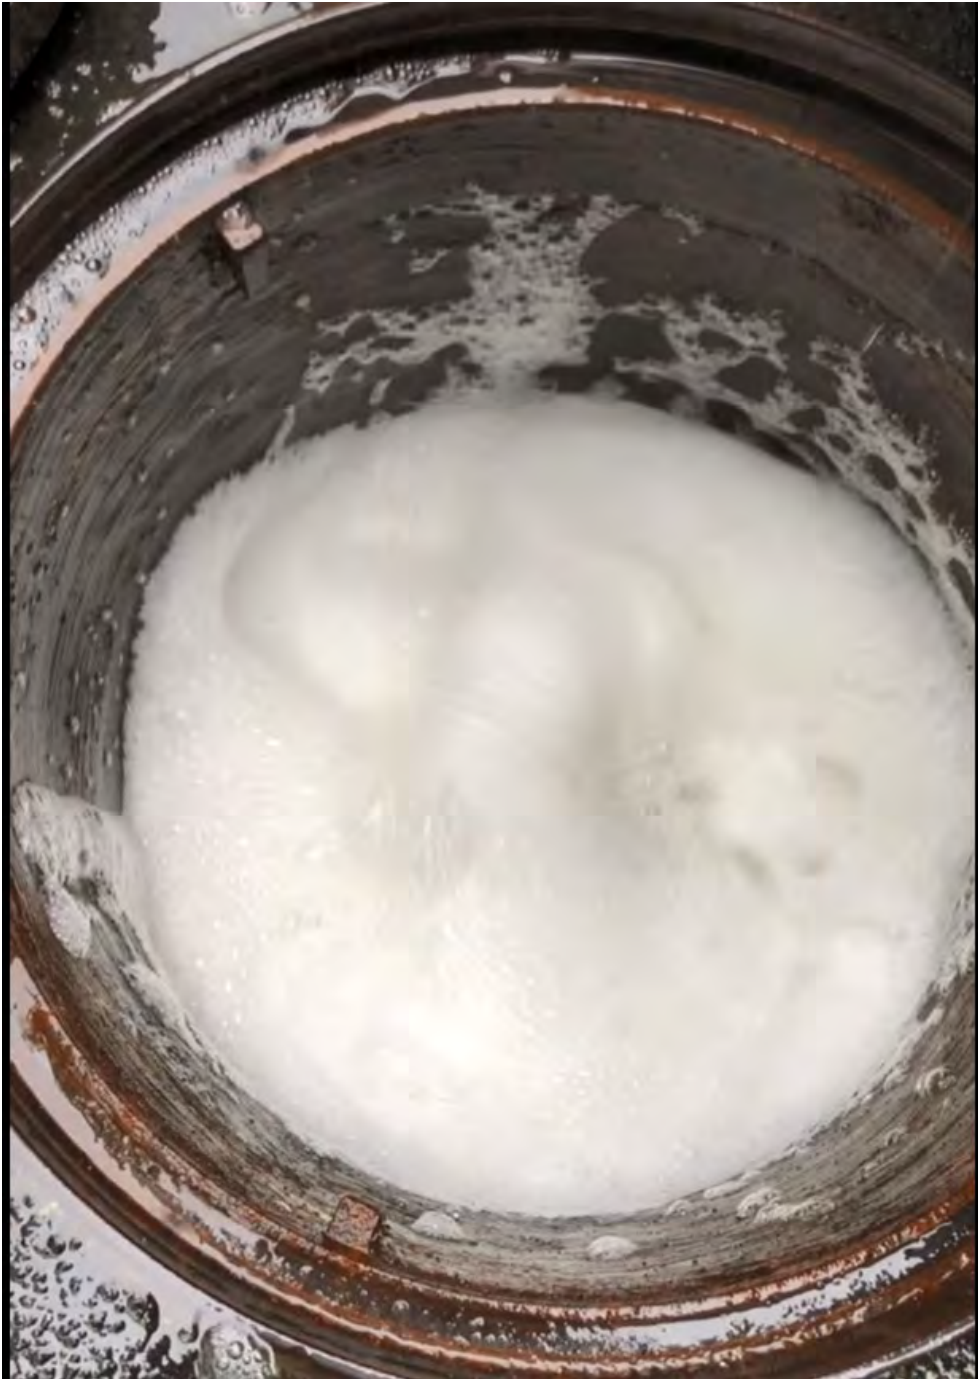
*Manhole where samples were collected, at peak flow (approximately 10 minutes after rain started).*

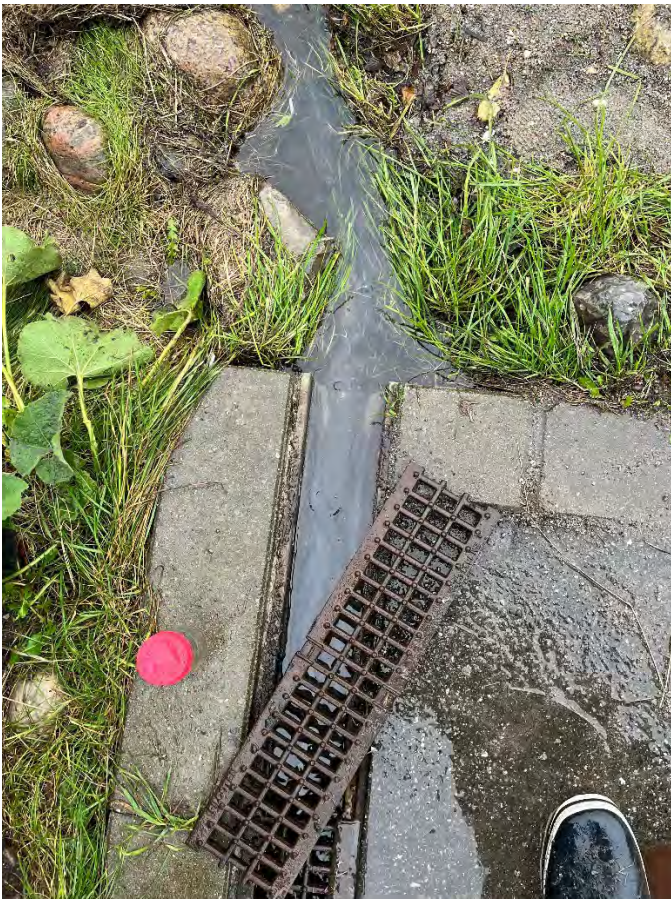
Infiltration trench with overrun pipe from upstream ponds and trenches
