Rockfalls at Stevns Klint

Landslide hazard assessment based on photogrammetrical
supported geological analysis of the limestone cliff
Stevns Klint in eastern Denmark

Stig A. Schack Pedersen

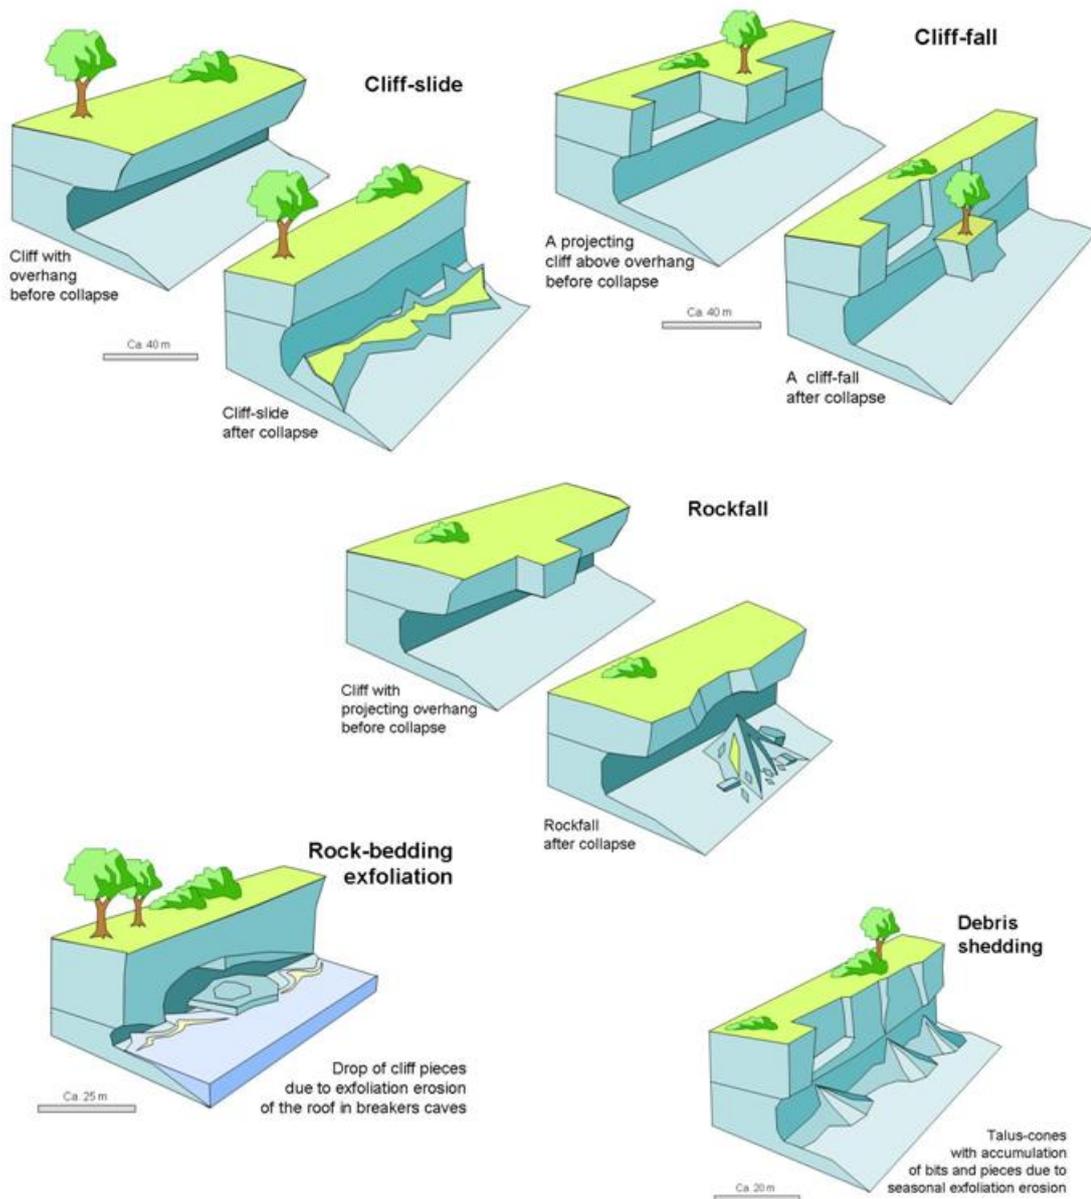
Figure 4. Characterisation of the rockfall types occurring at the chalk and limestone cliff along Stevns Klint. The most hazardous type is the cliff-slide involving volumes in the order of 5000 m^3 . The cliff-fall only includes volume in 500 m^3 size, but it gives an impressive prospect with the bedding completely preserved in a displaced cliff. The rockfall is the general type of landslide with a pieces of the cliff translated into a debris cone. The rock-bedding exfoliation generates platy limestone blocks the size of $1\text{--}10 \text{ m}^3$, which drop off from the roof below the overhangs. The main erosion along the cliff is due for debris shedding, which is responsible for the talus at the toe of the cliff.

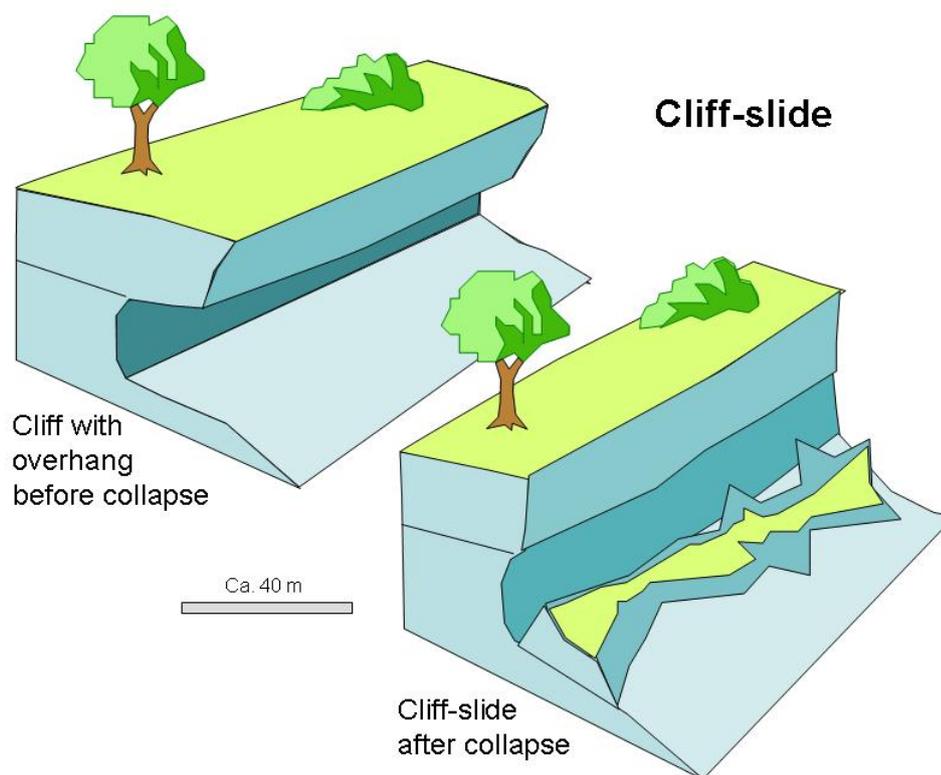
Figure 5. *The cliff-slide is characterised by the drop and slide of an overhang, which extend for about 100 m along the coastal cliff. The cliff-slide takes places where a long section of the chalk cliff is exposed to erosion from the sea for a long period (50-100 years).*

The rockfall type at Stevns Klint which involves the largest volumes is classified as cliff-slide (Fig. 5). Prior to a cliff-slide a whole section of the chalk was eroded away to create an undercutting below the limestone resulting in a considerable overhang. The size of the overhang is about 10–12 m and the thickness of the limestone and till in the overhang is about 15–18 m. The landslide at Højerup old church is regarded as representing such a slide (Figs 6, 7). The map in Fig. 7 shows the extent of this landslide, which prograded several tens of meters out into the sea. Today a coast protection with erratic blocks secures the survival of the remaining part of church for more than hundred years (Fig. 6).

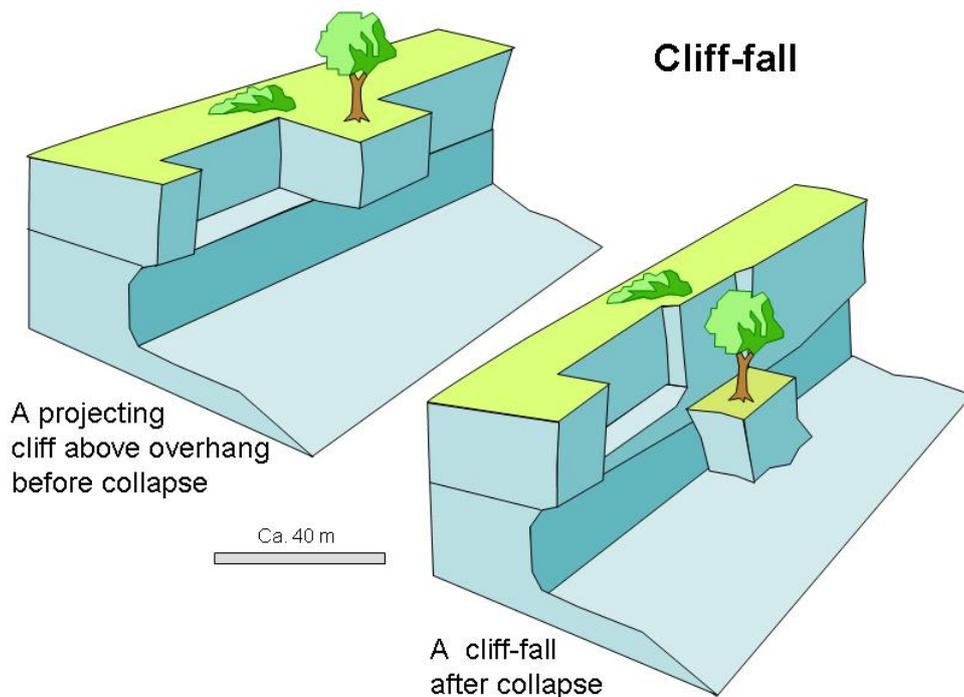
The cliff-fall is a term here used for indicating a specific part of the cliff that has dropped to the toe of the cliff (Fig. 10). In the displaced cliff the bedding is still preserved and it has not been subjected to noticeably rotation. The size of the blocks have been measured to be about 1200–1500 m³, and the surface area measures 100 m² indicating an overhang of about 10 m for a limestone cliff thickness of about 12–15 m.

Figure 10. Principal sketch of a cliff-fall. Note that this type of rockfall typically affects a protruding point of the cliff due to former limestone quarrying along the coastal cliff.

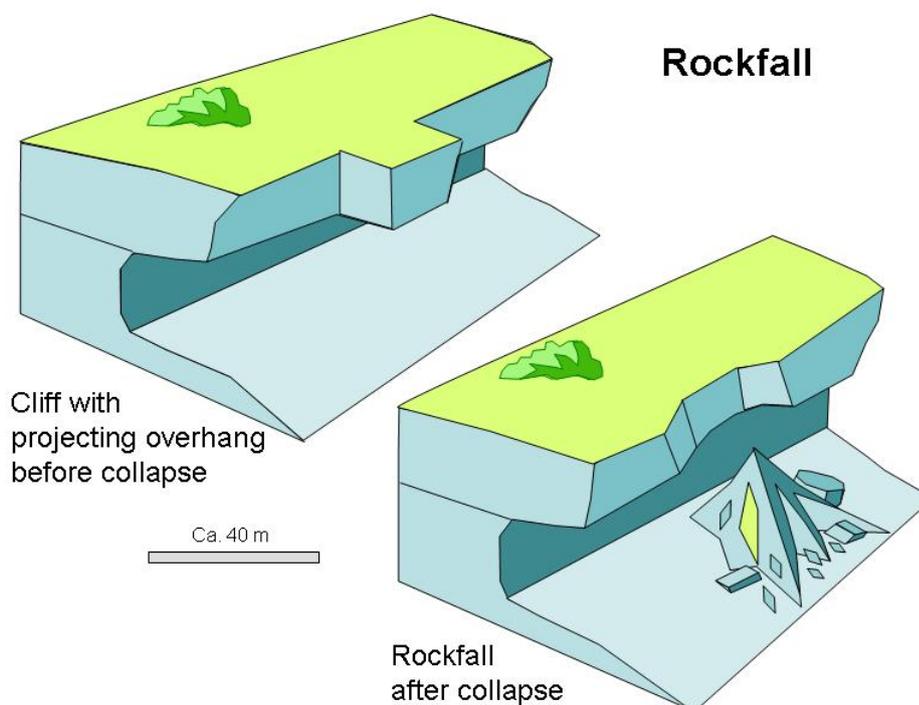
A number of ordinary rockfalls are present along Stevns Klint (Fig. 14). Their sizes vary between 100 m^3 and 1 m^3 , but may occasionally be up to 1000 m^3 . The largest blocks involved in the rockfalls are up to 50 m^3 . Frequently the rockfalls includes thicker beds of till displaced from the top of the cliff into mixed cataclastic breccias. The exact mechanism of these slides is not fully understood, but it seems as if sequential steps of sliding may facilitate block-sliding.

Figure 14. The block diagrams illustrate the ordinary type of rockfalls occurring at Stevns Klint. The rockfall accumulates a cone shaped pile of debris at the foreshore, and a concave escarpment is created in the cliff.

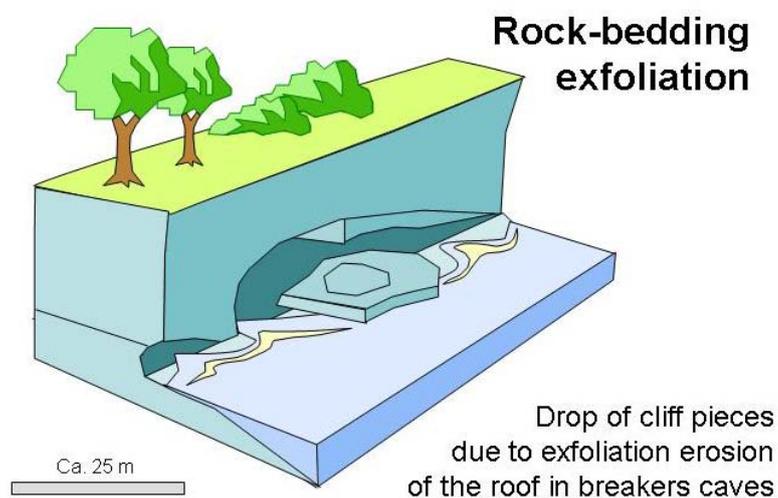
The rock-bedding exfoliation is a significant erosion mechanism at Stevns Klint. It is typically related to cave eroded by breaking waves, which wash directly against the toe of the cliff (Fig. 16). This type of erosion is enhanced by the structure of the bryozoan limestone, because the roof of the caves coincides with the bedding of the bryozoan mounds as seen in the overhang shown at Stevns Fyr (Fig. 12). From the roofs of the caves layers are loosened due to exfoliation and slaps with thicknesses of c. 0.3 m and diameters of up to 3 m have fallen from the roofs to the floor.

Figure 16. The block diagram illustrates the erosion of breakers, which creates arc-formed caves at the base of the cliff. The layers in the antiformal shaped mounds are peeled off and platy bedding-blocks are successively dropped to the shore.

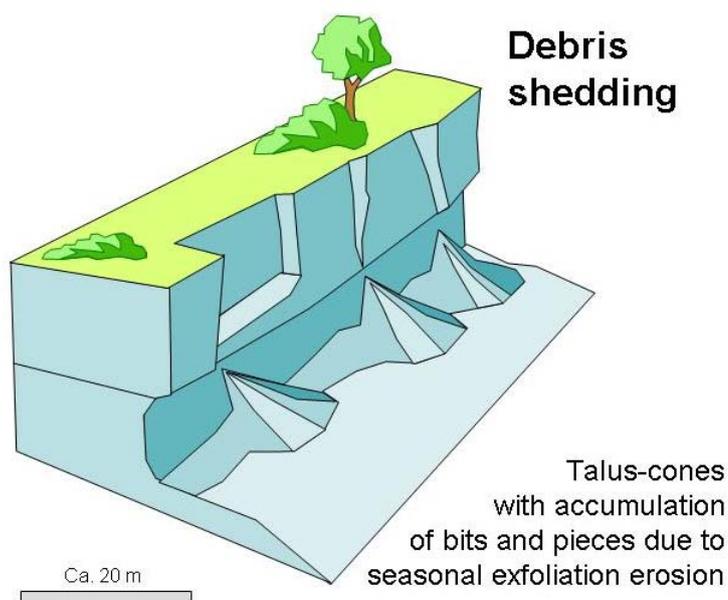
The debris shedding from the cliff (Fig. 19) is just on the border of being regarded in the context of rockfall. However, the registration of the debris shedding has contributed with an important part of outlining the coastal cliff profile and it is an important part of understanding the dynamics of the background erosion. The average grain sizes of debris shedding are pebbles and cobbles and only occasionally clasts of stone-size are loosened from the cliff surface. The debris shedding is accumulated as an apron of talus along the toe of the cliff, which often is arranged as irregular cones (Fig. 20). The main cause of the debris shedding is the seasonal variation in frost and thaw during the winter time and desiccation in the dry part of the summer time, which results in the contraction and expansion that loosens pieces from the cliff. The order of erosion by debris shedding is regarded to be equal to the rate of average erosion, namely 15 cm/year.

Figure 19. The general debris shedding is regarded to represent the main coarse of erosion along the coastal cliff of Stevns Klint. Compared to the rate of erosion this shedding is in the order of 15 cm/year.

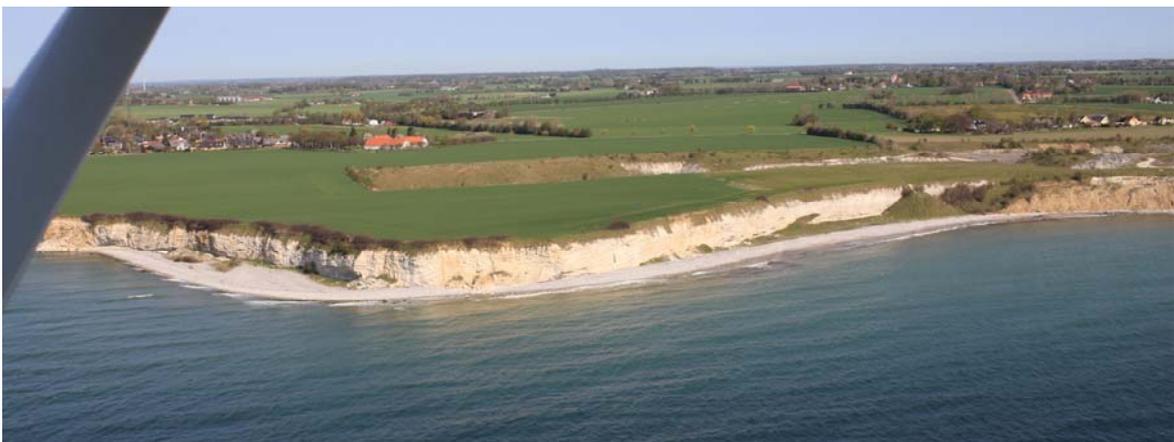
Figure 21. *The promontory Korsnæb is the location of the largest progradation of the coast line due to the accumulation of beach ridges along the foreshore.*

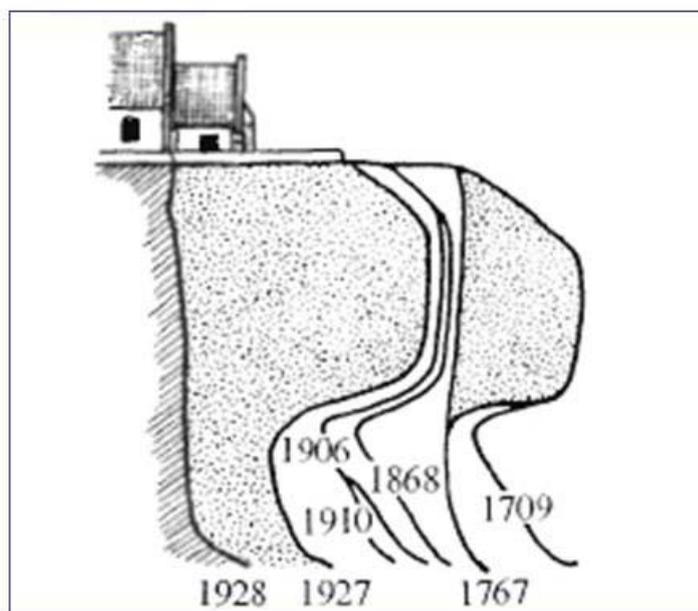
Figure 22. The recession of the cliff below Højerup old church from Rasmussen (1967). Note that the two large rockfalls occurred in 1767 and 1928. Since then the cliff below the church has been saved by coastal protection.
