# **TRACe-Fracture Toward an Improved Risk Assessment of the Contaminant Spreading In Fractured Underground Reservoirs**

Deliveries from GEUS Task 1.1, 1.2 and 1.3  
Annual Progress report

**Annual Progress Report No. 34. March 2001**

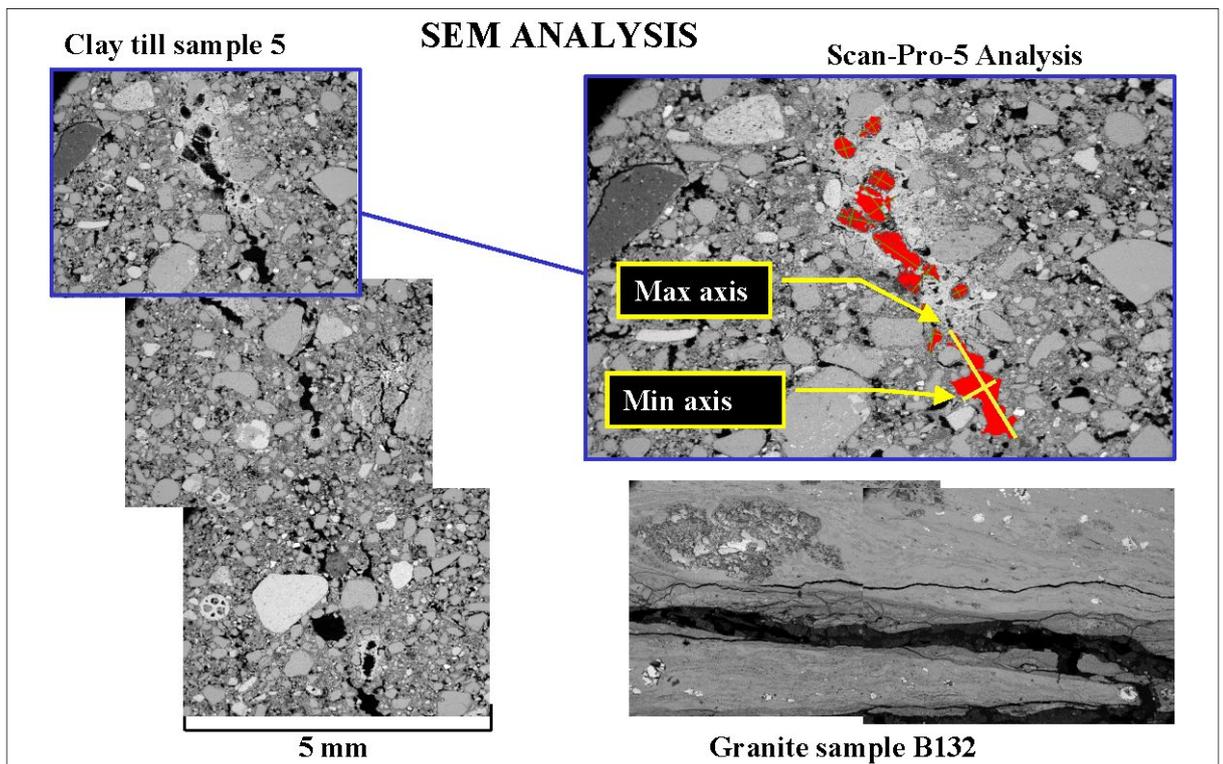
Figure 1. Example of fractures in Granite and in Clay till. With Scan-Pro 5 analysis of the pore size on one image. The scale is the same on both samples. Note how the till fracture consists of a number of channels while the granite fracture is relatively smooth with a continuous opening.

The fractures have in general very large apertures, and since the maximum size of an image is 5.000  $\mu\text{m}$ , fractures with an aperture larger than 5.000  $\mu\text{m}$  were analysed on normal images captured in incident light and UV-light. The granite fractures are generally very different from the clay-till fractures. The variation of apertures (up to 15.000  $\mu\text{m}$ ) in granite are much larger than the maximum fracture apertures in clay till (up to  $\sim 1.000 \mu\text{m}$ ).

The fractures in the crystalline rocks at the “Spanish site” vary in many respects from the fractures in the clay till. While the clay till allows formation of biogene channels within the fracture, the fractures in the crystalline rocks are entirely depending on the type of deformations. Some fractures have a very irregular or undulating shape face with a rough surface, while other have a planar shape with a smooth surface (Figure 1). Slickensides are abundant on many fracture surfaces as well as growth of quartz crystals on some fractures. Aperture varies at a much larger scale than in the clay fractures. The size of the fractures and the shape of the fracture network are very different from the clay fractures. So a new approach must be considered in this model.
