Geological Setting and Fracture Distribution on a Clay Till site in Ringe, Denmark

TRACe-Fracture
Toward an Improved Risk Assessment of the
Contaminant Spreading in Fractured
Underground Reservoirs
Progress report

K.E.S. Klint, A. Rosenbom and P. Gravesen

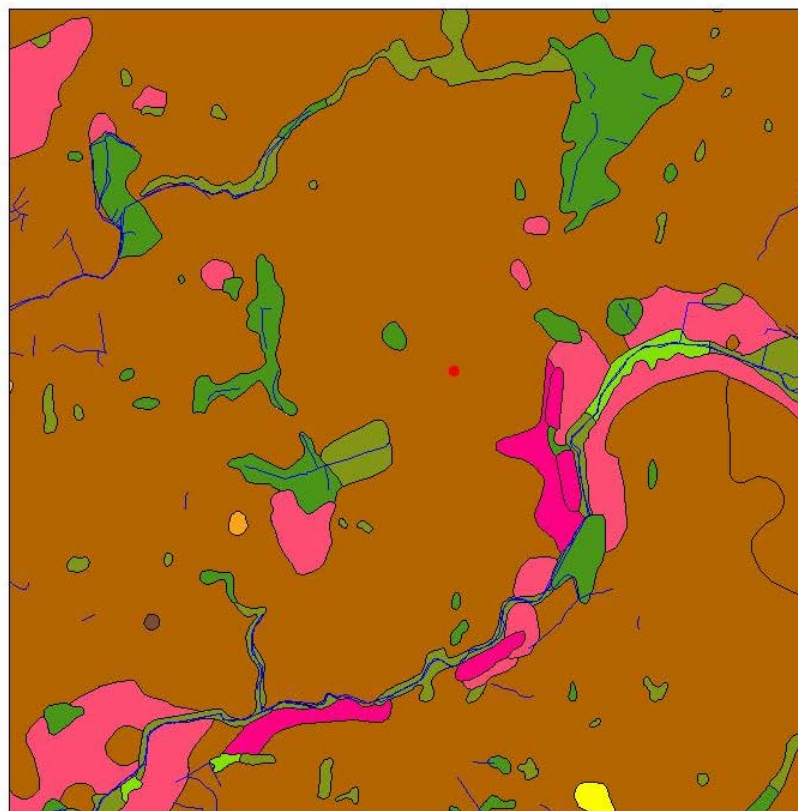
Figure. 4.1 Soil map that shows the distribution of sediment types in one meter depth.

The Ringe area is strongly dominated by clay till in the uppermost 5 meter of the surface (see figure 4.1). The contaminated site is situated on an elongated hill approximately 80 meters above sea level.

Soil type map

composed of meltwater gravel and sand (figure 4.1), and such overridden and buried meltwater valleys constitutes important groundwater reservoirs throughout Denmark.

The primary sandy aquifer in the area consist of a more than 16 meter thick and more than 60 meter wide elongated body consisting of glacio-fluvial sand and gravel. This body is crossing the whole area from north-east towards south-west and is probably outlining a buried glacial river valley, which may be related to the Main Glacial North East Advance (Houmark-Nielsen, 1987) - transgressed the area approximately 20.000-16.000 BP. This river valley cut down into an older clayey till or maybe two clayey till units separated by a 4-5 meter thick sandy layer 26-30 meter below the surface. This buried river valley may be an equivalent to the present river valley situated approximately 1 km south of the area (figure 4.1)

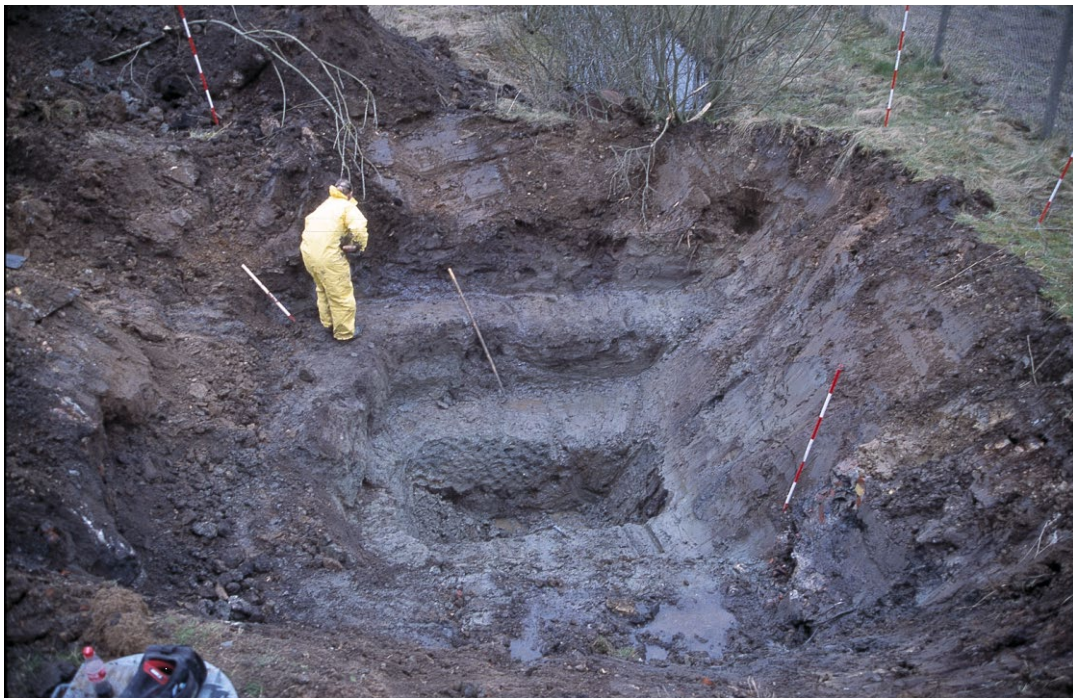
Figure 5.1 Pit no. 4. All matrix was saturated with dissolved phase contamination.

A pit 7 x 7 meter large and 3.5 meter deep were excavated by a backhoe (Figure 5.1). The surface of the freshly excavated pit-face was cleaned from smeared material. The cleaned face were then "chipped" off with knives trowels and wherever a fracture made the till "break" along a natural fracture plane, the fractures was carefully cleaned and described along vertical and horizontal profiles according to the terminology and methods described by Klint and Fredericia (1998). Fractures with contamination on the surface was photographed (Figure 5.2) and the contaminated areas registered.

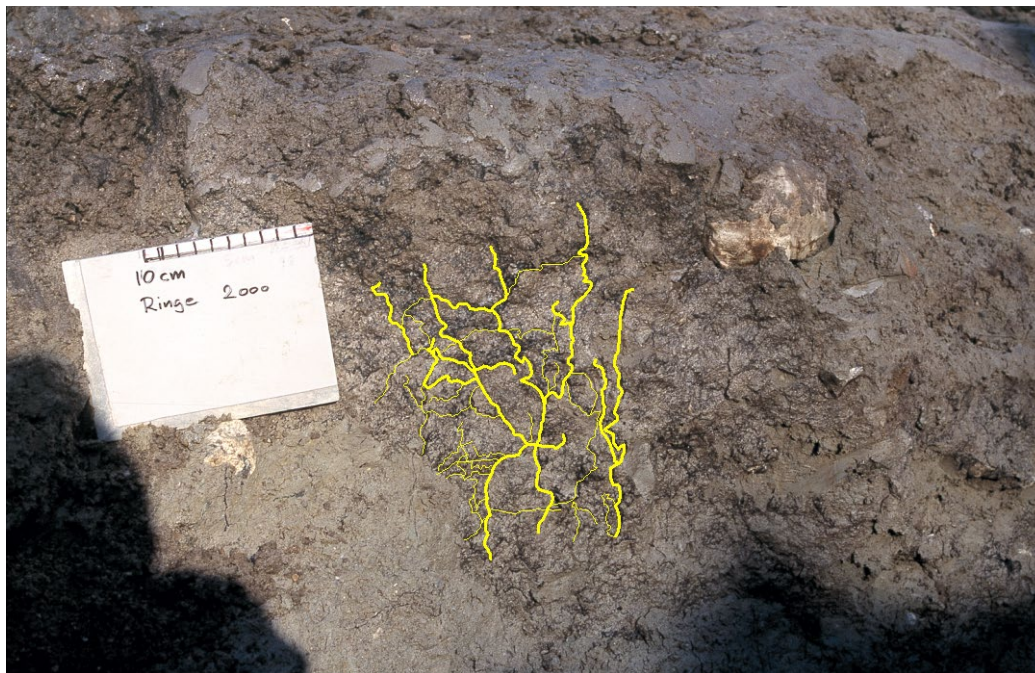
Figure 5.2 fracture surface with contamination distributed in channels.

Fractures forms a clear network of polygonal vertical desiccation-fractures. A clear network on the fracture surfaces shows that the contaminant flows in a channel like network on the fracture surface (Figure 5), but root-holes and burrows are also filled with the NAPL's.

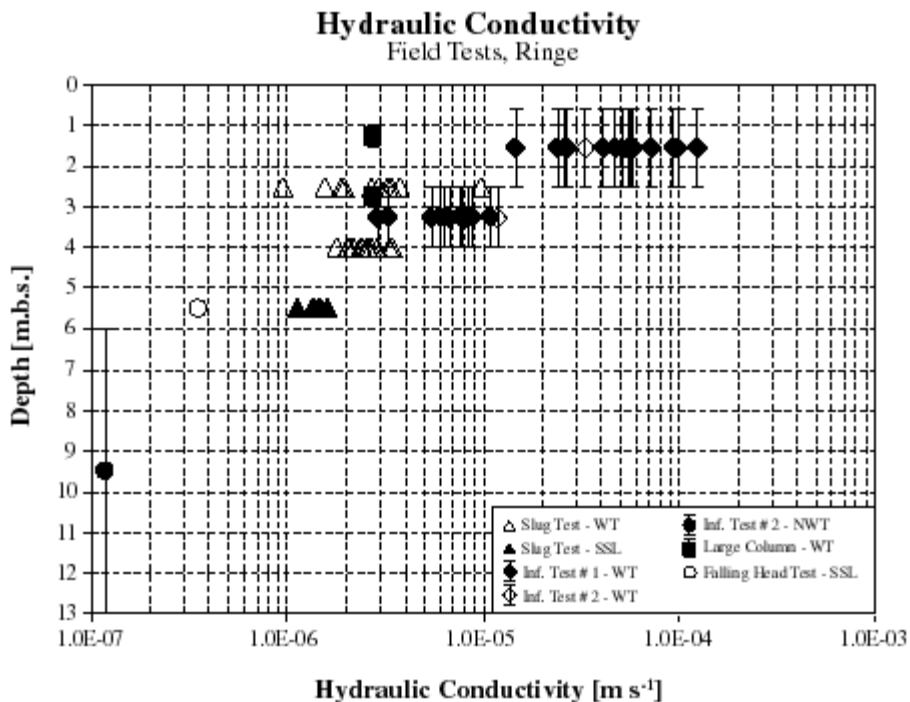
Figure 6.1 Hydraulic properties of the fractured till at the Ringe site.

A large number of hydraulic tests has been conducted at the Ringe site over the years. Figure 6.2 shows the results from Peter Jørgensen's (1998) hydraulic tests on the two LUC samples (Large Undisturbed Columns).

Four types of full field-scale tests were employed in order to determine the hydrologic properties of the complex, coupled till – sand lens - sandy aquifer system (Nilsson et al 2001). Hydraulic conductivity was also calculated from break through curves of tracers. Based on the fracture spacing measured in Pit 1 and 2 the hydraulic apertures of the fractures were calculated at three different depth intervals. (2.5-4 and 5.5 m b.g.s.) (Sidle et al., 1998).
