Image and SEM-analysis of Fractures in Granite

TRACe-Fracture
Toward an Improved Risk Assessment of the
Contaminant Spreading in Fractured
Underground Reservoirs
Progress report

A. Rosenbom, M. Hansen, K.E.S. Klint,
H.J. Lorentzen and N. Springer

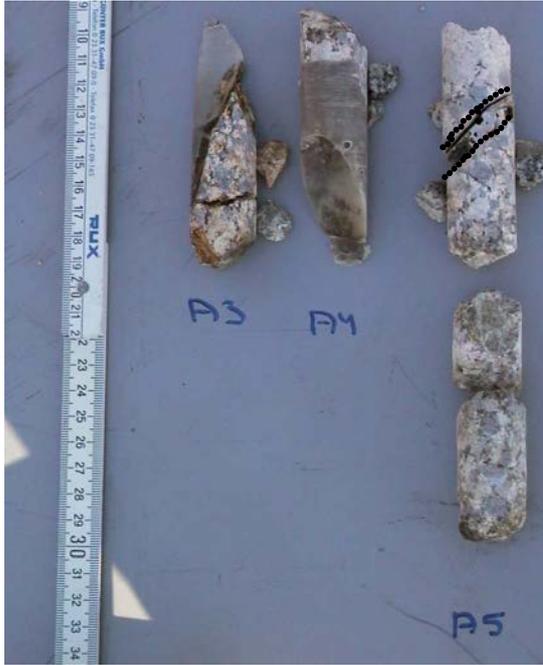
Figure 4. Sample A3, A4 and A5. In sample A5 the partly impregnated fracture plan 1 (marked with black lines) is represented. The aperture is measured to be app. 0.5-1 cm.

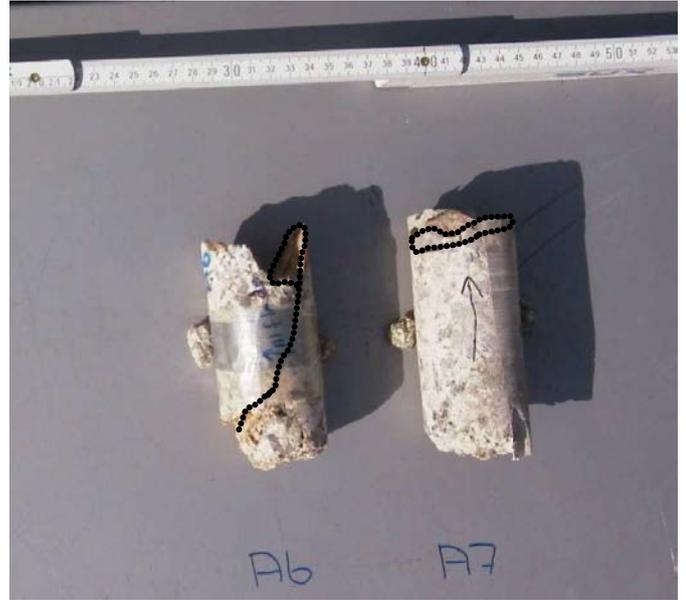
Figure 5. Sample A6 and A7. Impregnated fracture marked with a black line.

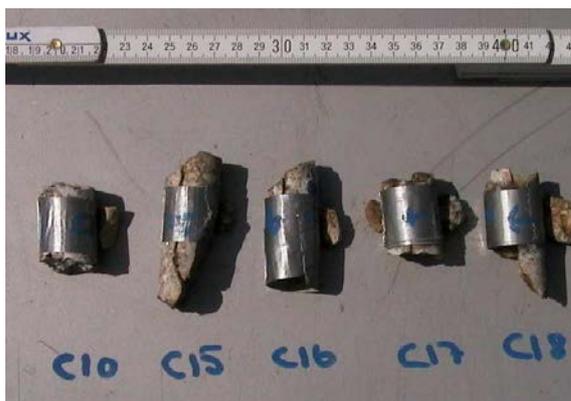
Figure 9. Samples of type I from Site C.

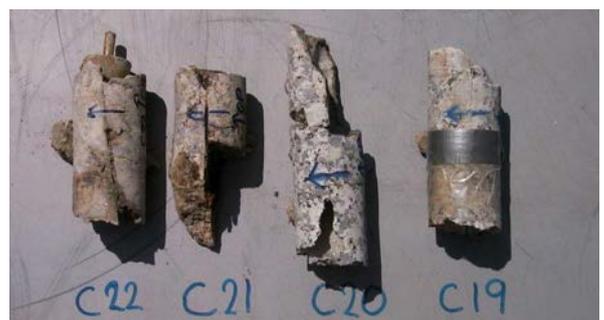
Figure 10. Impregnated samples of type III from Site C.

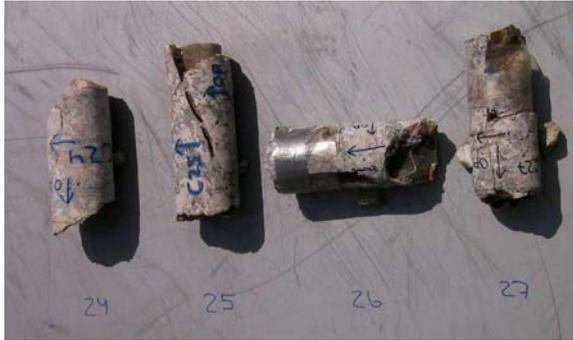
Figure 11. Impregnated samples of type III from Site C.

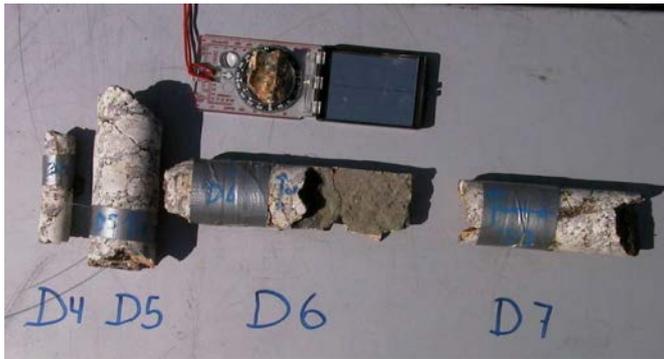
Figure 13. Samples of type I collected at site D.

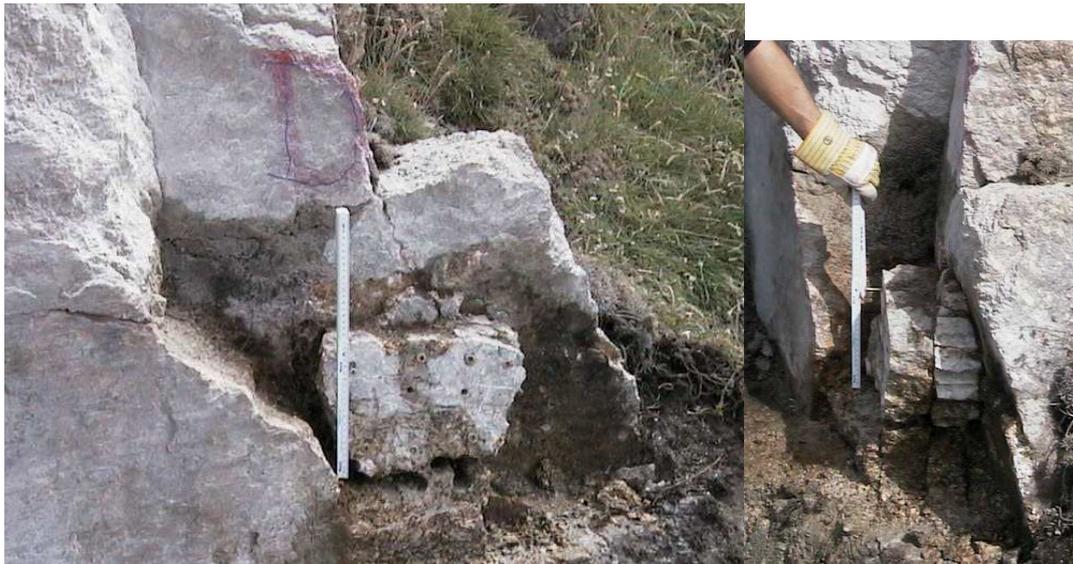
Figure 14. A block of granite containing fracture 1 is collected at site D.

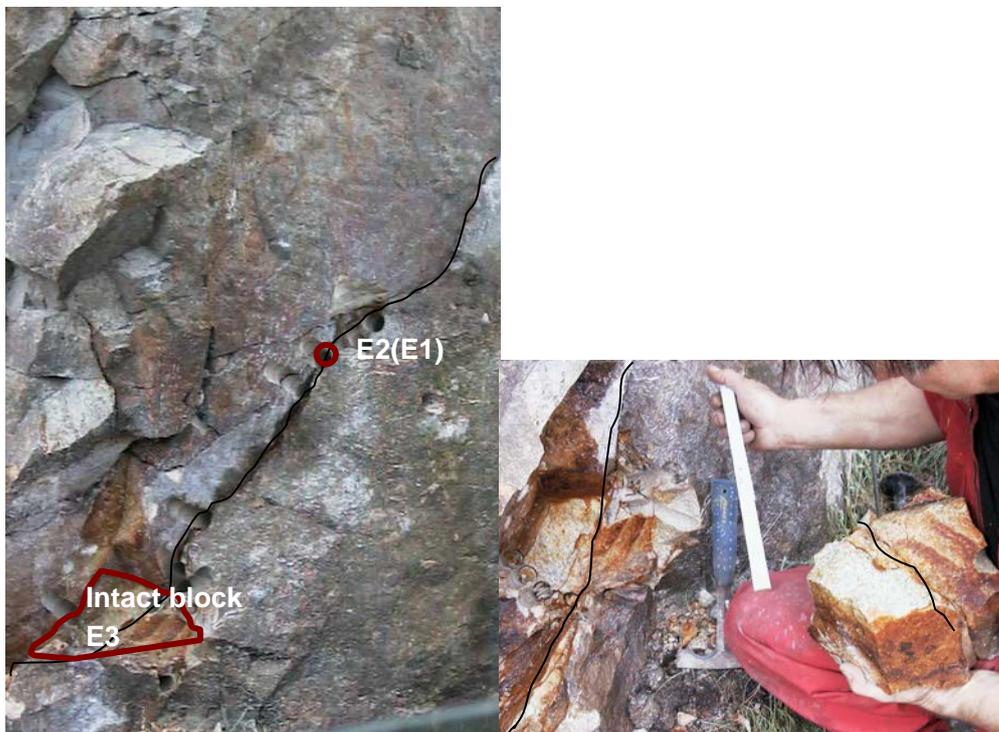
Figure 15. The fracture is marked with a black line. One intact partly impregnated core samples (E2) and one block sample (E3) type IV were collected at site E.

The fracture is photographed, Figure 15. Only two samples were collected at this site: One intact partly impregnated core samples (E2) and one block sample (E3) type IV. The fracture in plug E1 was not intact.

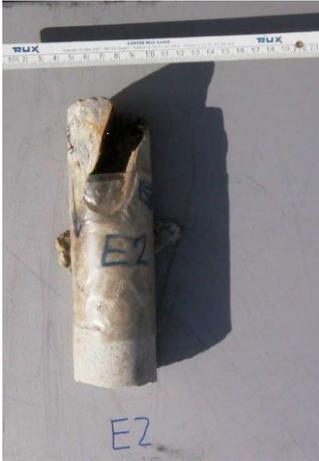
Figure 16. Only intact partly impregnated core sample (type III) from sites E.
