Faults and fracture systems in the Nuuk area

Structural analysis and photo-interpretation of
faults and fracture systems along the coast
of Nuuk prepared for TELE-Greenland

Pierpaolo Guarnieri & Peter Roll Jakobsen

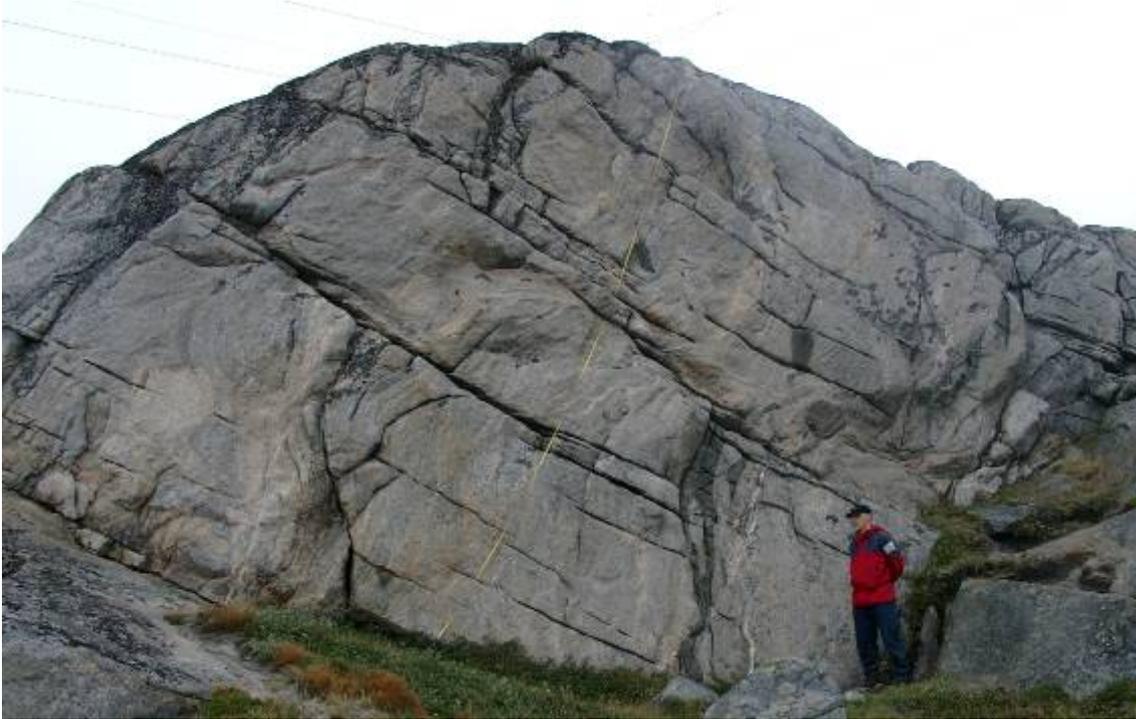
Figure 2. Grey gneiss with lenses of amphibolite.

The light grey gneiss is grey or light reddish grey. It is sometime migmatitic and has generally a weak foliation defined by biotite. It always appears as a massive rock (Figure 2).

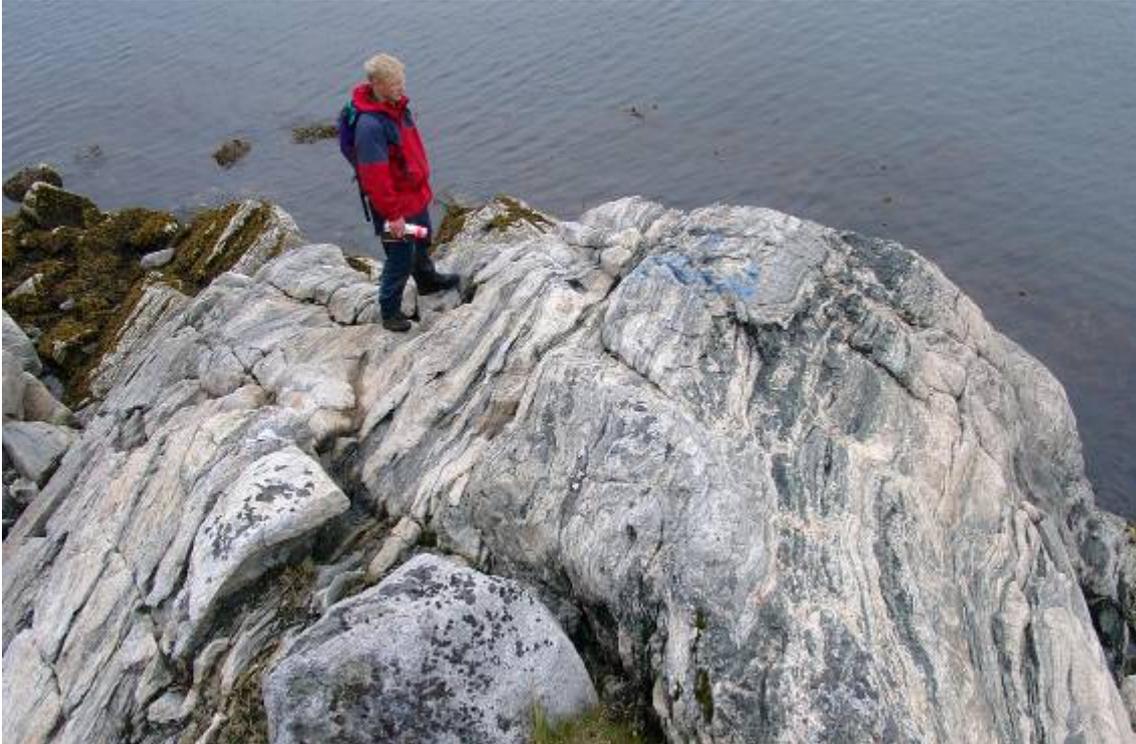
Figure 3. Banded gneiss at the road cut on Borgmester Annitap Aqquserna.

The Banded gneiss is composed of alternating bands of grey gneiss, amphibolite and metagabbro (Figure 3). It occurs as smaller units in the grey gneiss.

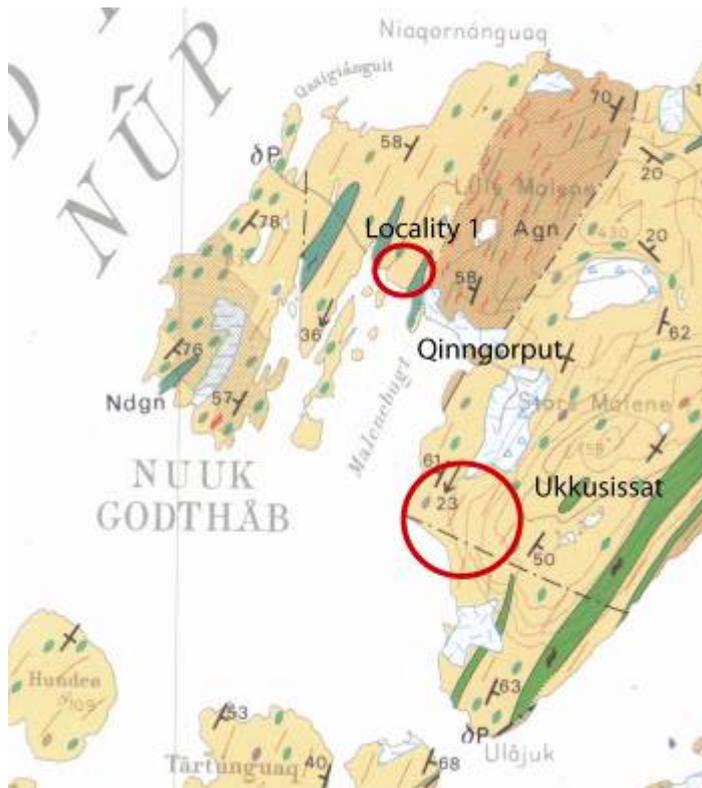
Figure 4 Geological map of the Nuuk area. The areas where earlier investigations have been carried out are indicated on the map with red circles.

In connection with planned tunnels and road cuttings in the Nuuk area toward Qinngorput and at Ukkusissat (Figure 4e 4), investigations of the rock quality was made in order to estimate the stability of the rocks (Jakobsen & Karlsen, 2001, Jakobsen & Larsen 2004a, 2004b). In these investigations fractures and faults played a major role and they were systematically studied. The main results of these investigations are presented in the next paragraphs.

On the Geological map (Figure 4) a fault crosscut the southern part of Ukkusissat, striking N130°. This fault corresponds to the fracture system A on Figure 9 and Figure 10.

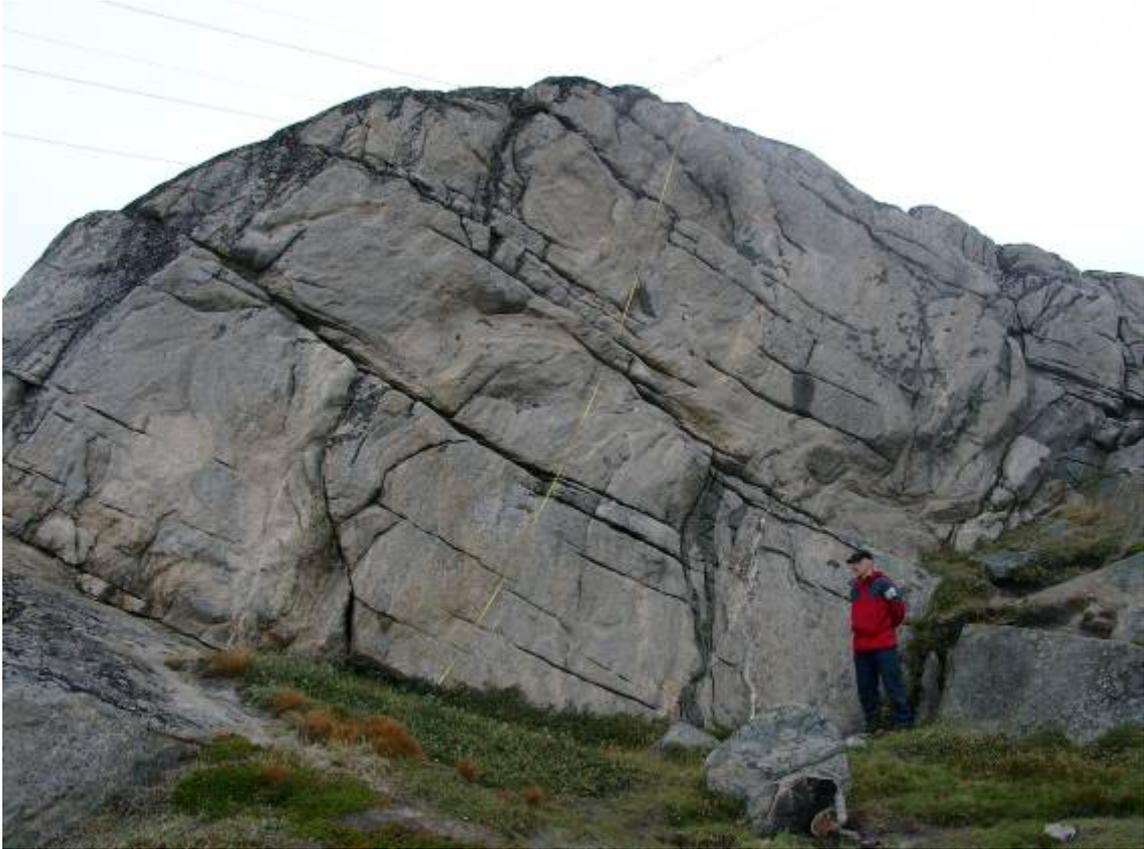
Figure 7. System 4 fractures in grey gneiss.

The System 4 fractures strike in about 30° with an inclination of about 22° (Figure 7), which is nearly perpendicular to the foliation-parallel system 3 fractures.

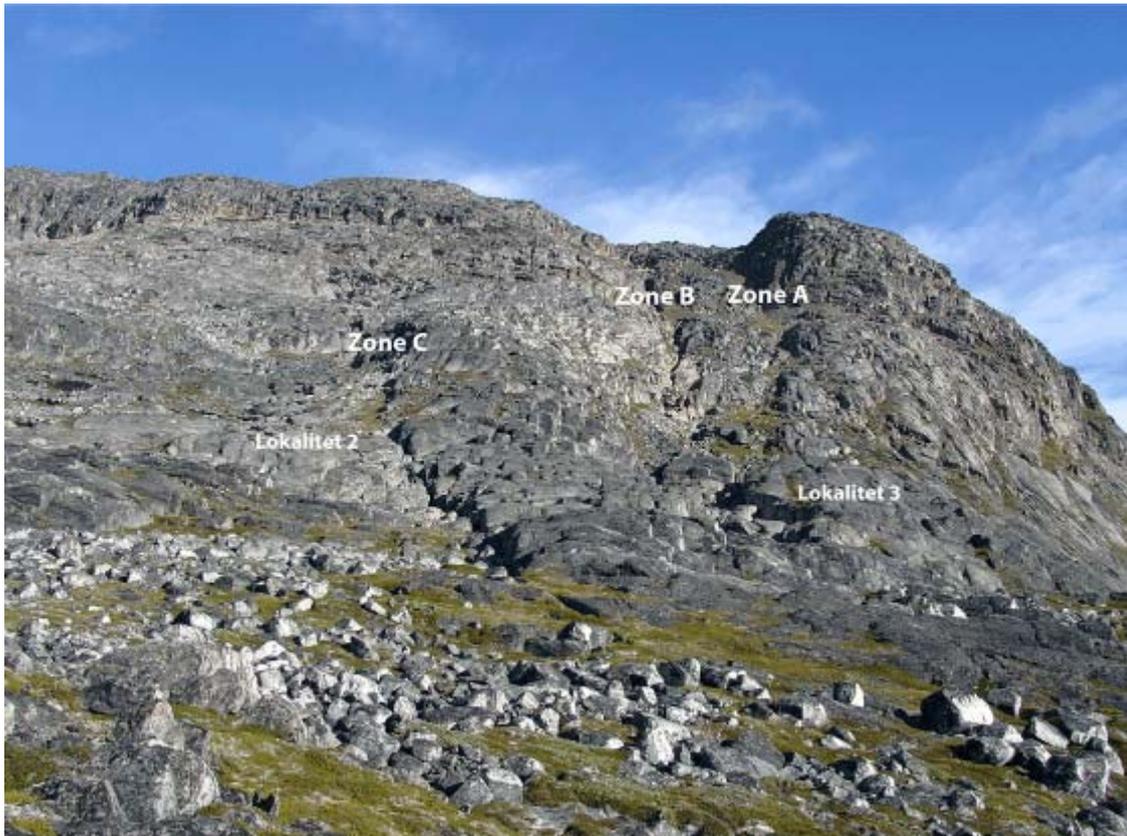
Figure 11. Oblique view towards the deeply eroded zones A, B and C.

Apart from zone A two other zones cut the ridge from coast to coast and up to about level 700 m, and they show a distinct morphological erosional features (Figure 11 and Figure 12). Zone A can be followed for 2.3 km on land, and continues below sea level. Within the fracture systems the gneiss is heavily fractured and crushed

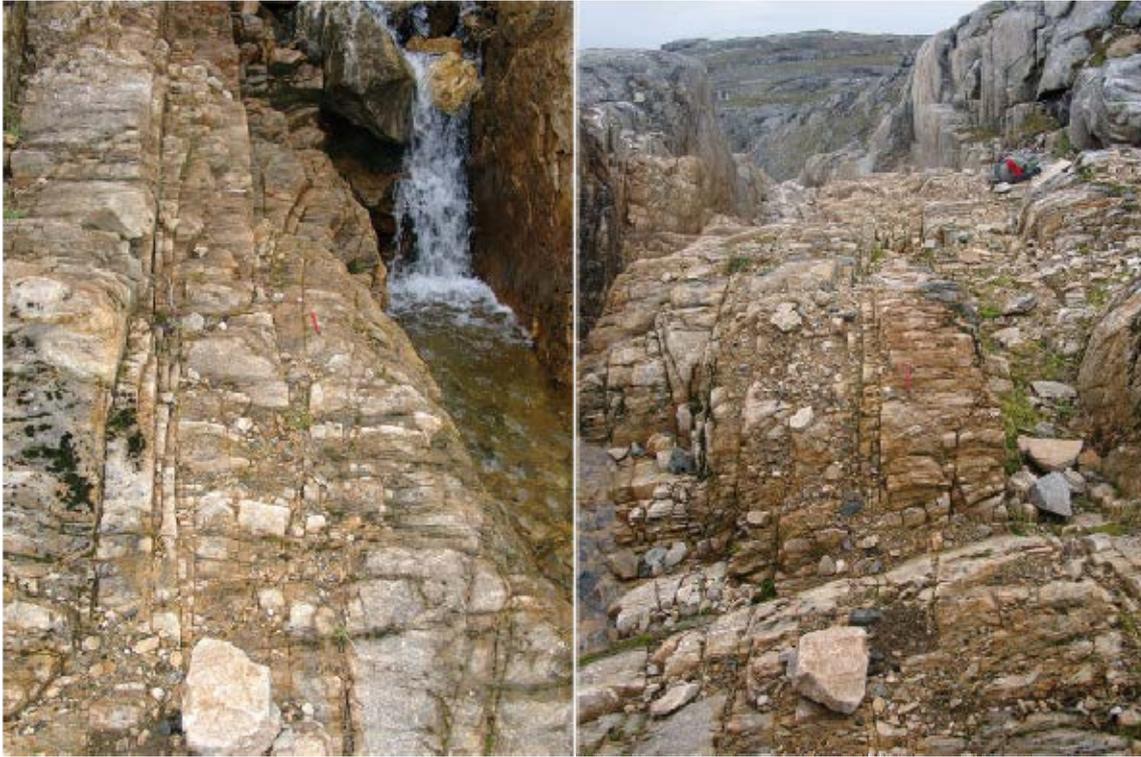
Figure 13. Heavily fractured and crushed gneiss within zone A at about 200 m of elevation.

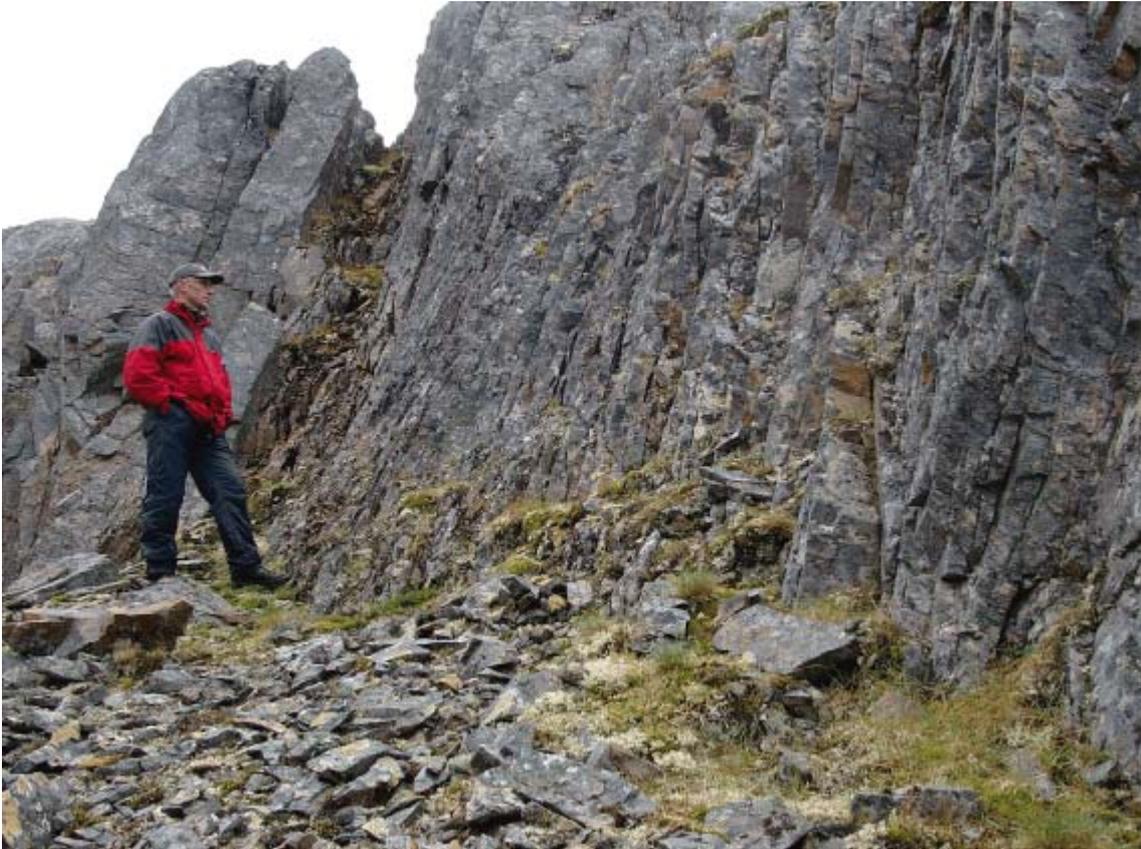
Figure 14. Heavily fractured and crushed gneiss within zone E

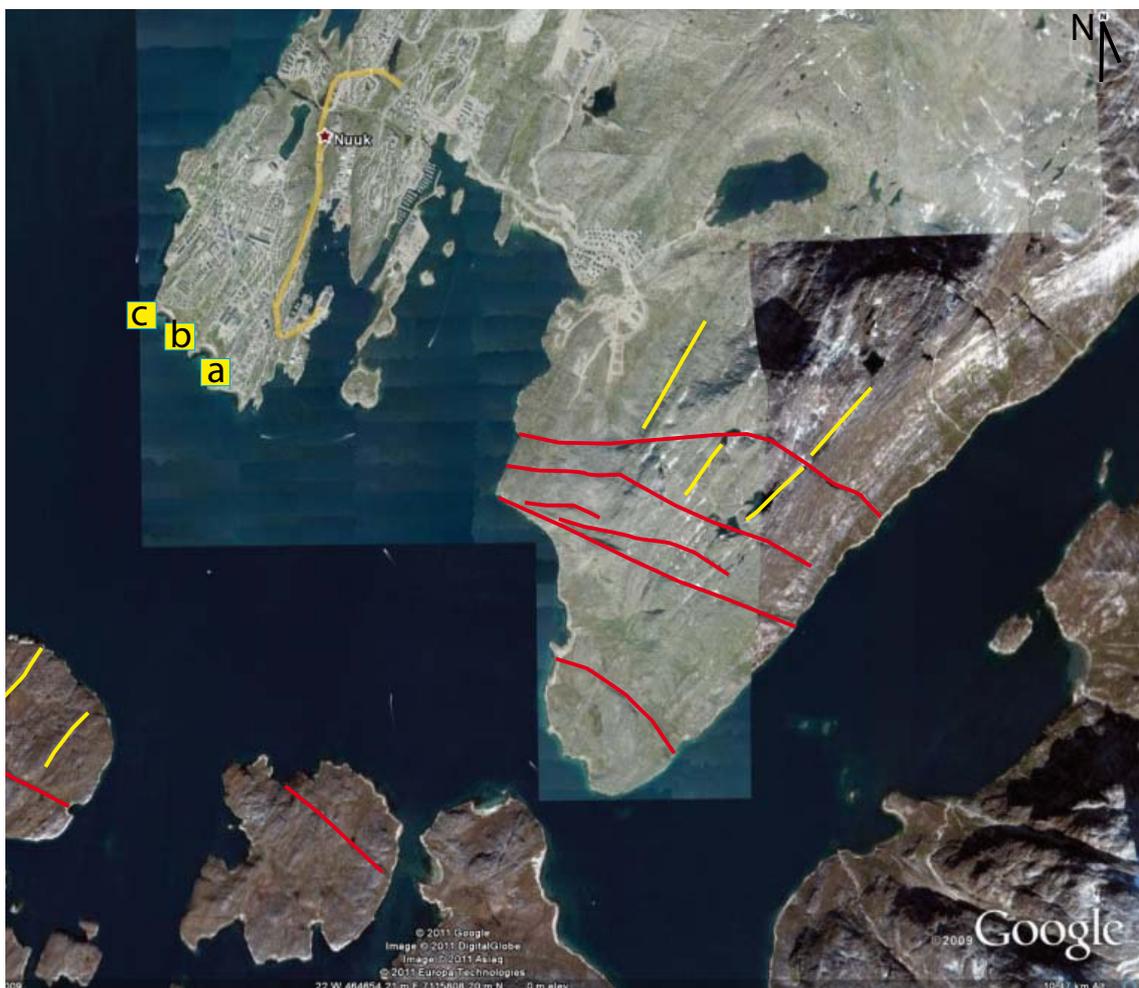
Figure 14. Orthophoto from Google Earth of the Nuuk area and detailed enlargements (yellow squares).

A preliminary analysis of structural trends along the coast is possible with the help of the published Orthophotos in Google Earth (Figure 14). The images show the presence of two orthogonal trends corresponding to the main structural trends. The first is coast-parallel (red) and the second one is fjord-parallel (yellow). At site b (Figures 14 and 16) there is an evident shear zone with brittle, not weathered deformation zone. This character could represent an indication of relative recent activity (compared to the basement rocks) of the fault zone. Fieldwork along those faults/fractures could reveal the kinematics and cross-cutting relationships useful in understanding recent movements together with an evaluation of the fractured rock mass along recently active fault zones.

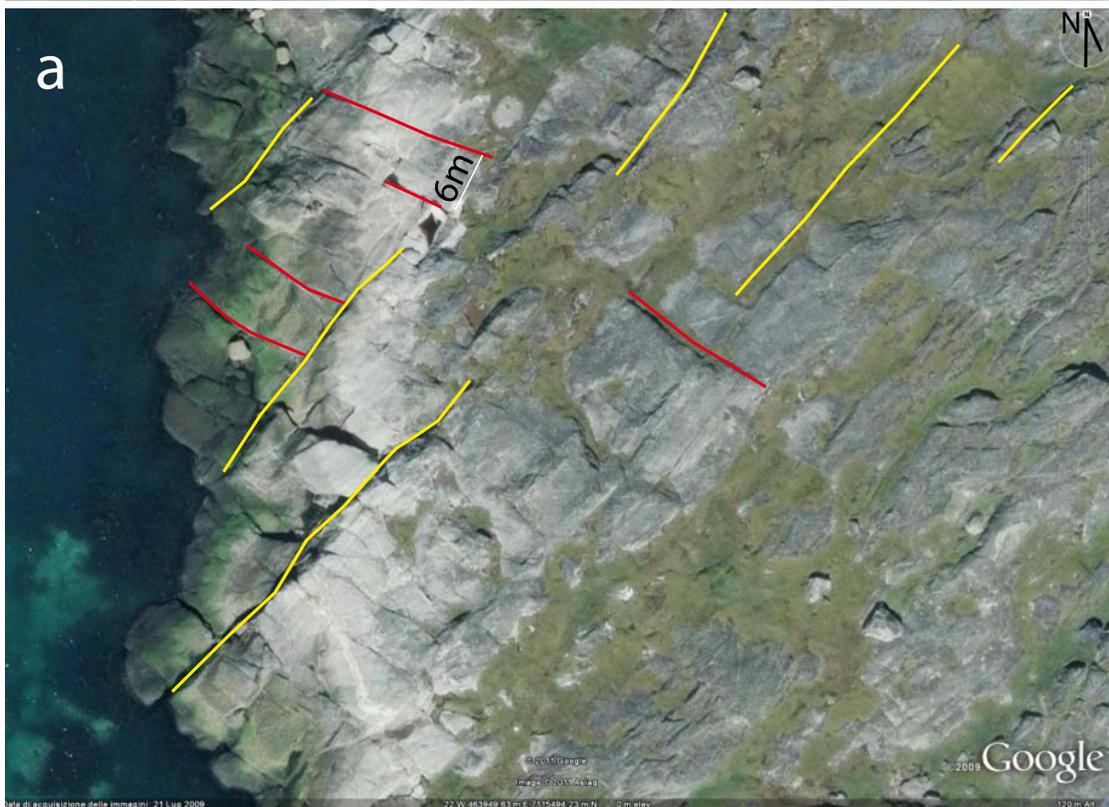
Figure 15. Enlargement-a from Figure 14. Fracture systems with orthogonal trends well developed along the coastline.

- System 1 (Figs 8 and 9) corresponds to the coast parallel lineament depicted in Figure 16 (black lines);
- System 2 (Figs 8 and 9) corresponds to the coast parallel lineament depicted in FigureS 15-17-18 (red lines);
- System 3 (Figs 8 and 9) corresponds to the fjord parallel lineament depicted in Figures 15-17-18 (yellow lines);

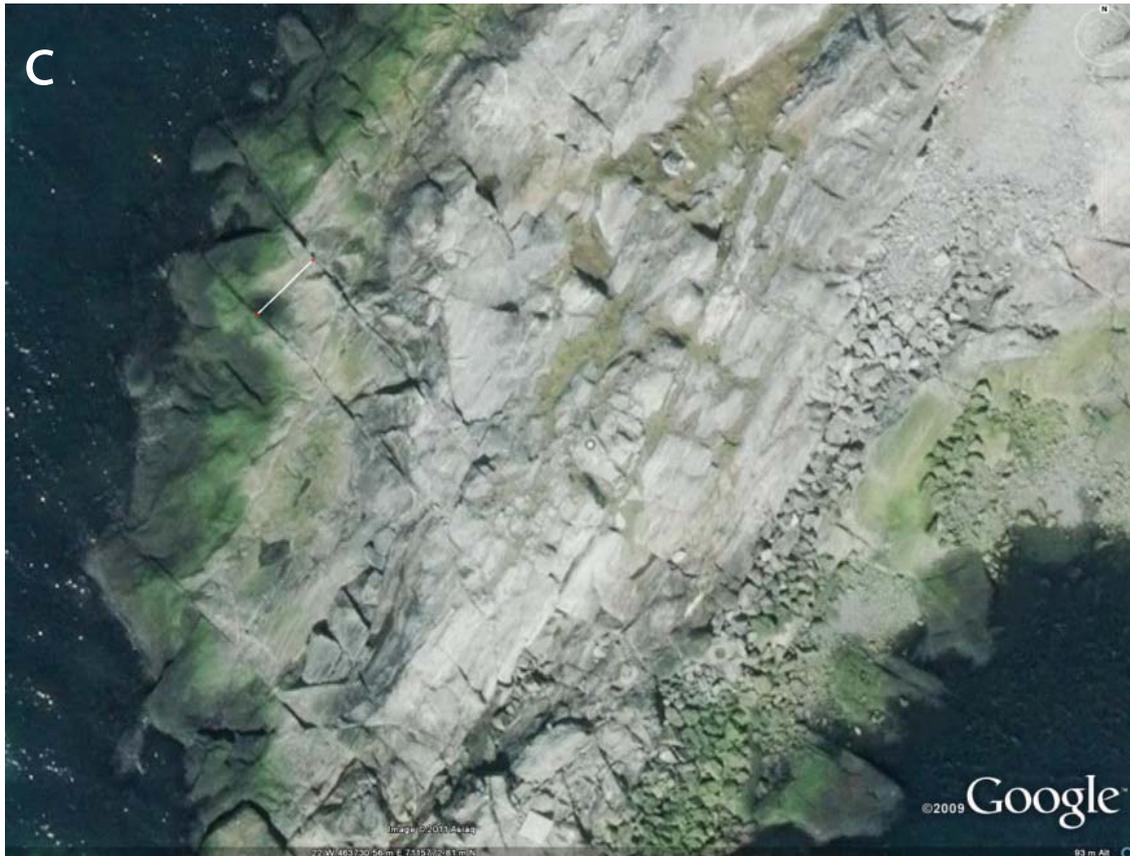
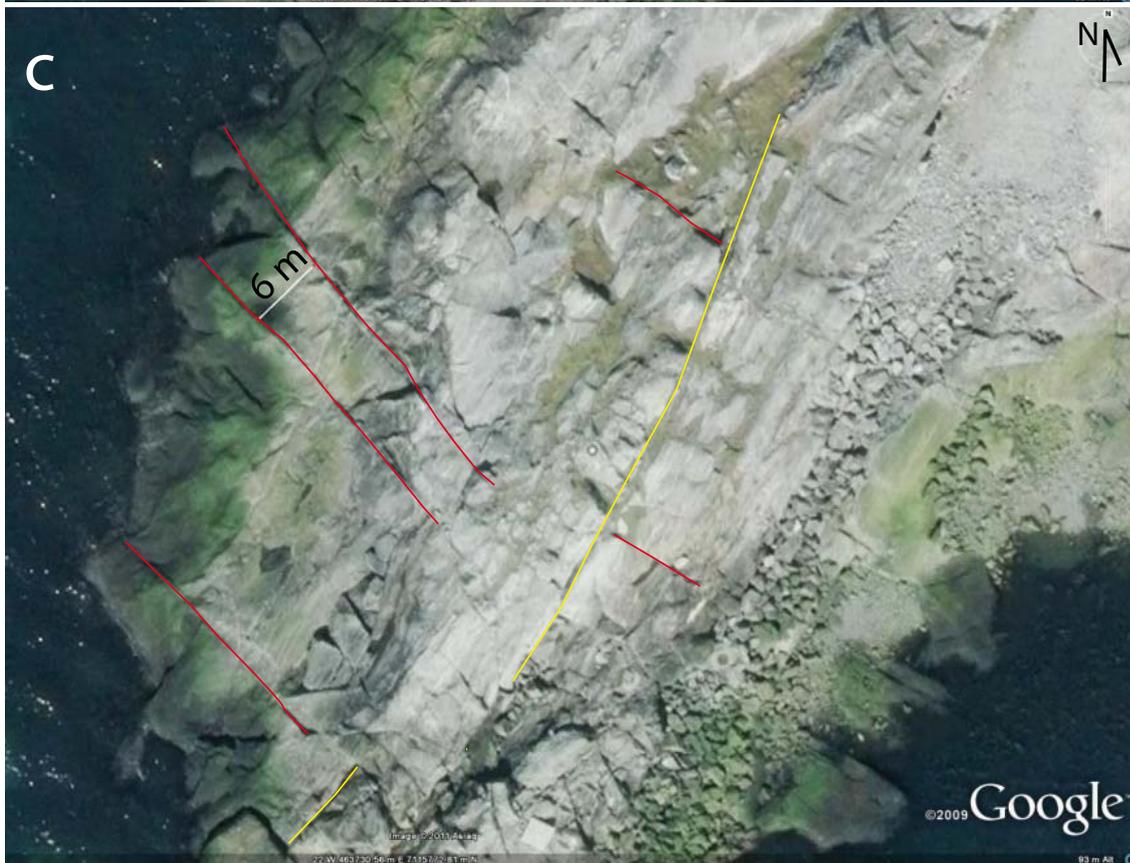
Figure 17. Enlargement-c from Figure 14. Fracture systems with orthogonal trends well developed along the coastline.
