# Low- and intermediate level radioactive waste from Risø, Denmark. Location studies for potential disposal areas. Report no. 7

Characterization and description of areas Langeland, Tåsinge and Fyn

> Peter Gravesen, Bertel Nilsson, Stig A. Schack Pedersen & Merete Binderup

GEOLOGICAL SURVEY OF DENMARK AND GREENLAND MINISTRY OF CLIMATE AND ENERGY

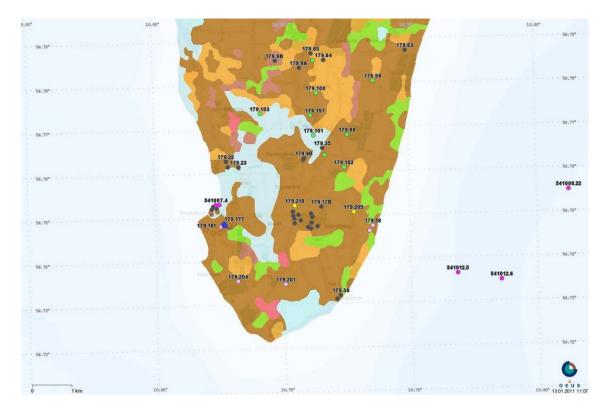
Figure 3. Map of the Quaternary surface deposits (From GEUS's Homepage. After Pedersen, 1989). Legend: Brown: Clayey till, Red brow: Sandy till, Red and orange: Meltwater sand and gravel, Green: Holocene freshwater deposits, Light blue: Holocene marine deposits. Legend for boreholes: See fig.4.

The surface geology mainly consists of clayey till but an area of meltwater sand and gravel is found in the northern part of the area and just outside the area. To the west along the coast, the tills are bordered by marine Holocene deposits. Just outside the area, a cliff section occurs at Ristinge Klint cliff that shows that the area is build up by glaciotectonic disturbed glacial and interglacial deposits. Along the south coast at Gustav, low cliffs consisting of clayey tills and meltwater sand and gravel are lsituated (Dovnsklint, Gulstav Klint) (Fig. 3).

The area is dominated by relatively thick sequences of Quaternary sediments, mainly clayey tills but locally also thick meltwater sand and gravel layers (Figs. 3 and 12). All the information is from borehole sample descriptions but in Ristinge Klint cliff, some of the sediments can be recognized besides interglacial clays and silts from the Eemian.

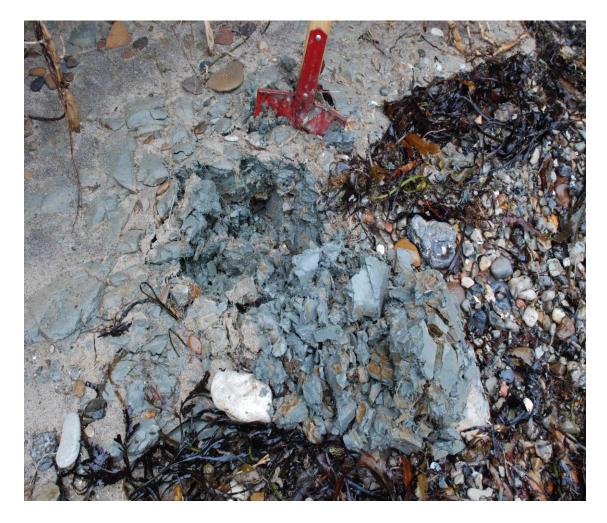
Figure 8. Green plastic clay, probably the Eocene Lillebælt Clay Formation from Albæk Hoved Cliff, Jylland.

According to the map of the pre-Quaternary deposits (Fig. 7), the sediments below the Quaternary should belong to Eocene. The relatively few borehole samples are mainly lithological described as plastic, very fine-grained strongly calcareous to calcareous brown and red brown clay or green calcareous plastic clay. One green sample is dated by foraminifera to the Eocene. The clays could tentatively belong to the following formations: The green clays to the Lillebælt Clay Formation and the brown to the Røsnæs Clay Formation. Examples of the two clay types can be seen in figs. 8 and 9.

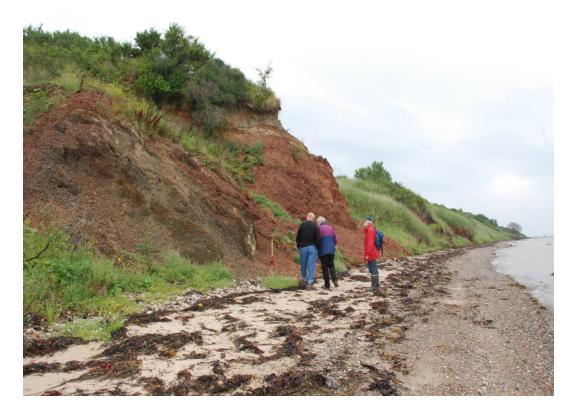
Figure 9. Section from the Albæk Hoved clift, Juelsminde, Jylland. Red and green plastic clays which are comparable clays with the Lillebælt Clay and Røsnæs Clay Formations.

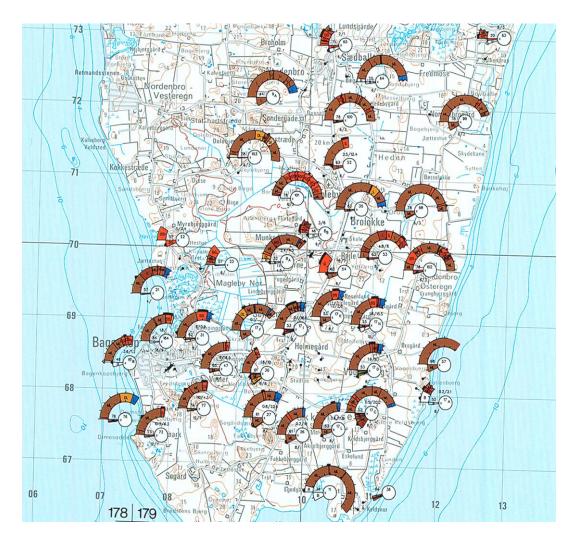
Figure 10. Geological Basic Data Map. a. Legend to the map (From Andersen & Gravesen, 1989. b. Part of Geological Basic Data map 1311 I Rudkøbing showing borehole data from southern Langeland. Original scale 1:50.000 (From Gravesen, 1993).

Towards the north, outside the area, the Eocene clays are reached in 25-30 m depth and at Hjortholm and Skovsgård 25-40 m clayey till rest on Eocene clays. The borehole data can be seen on the Geological Basic Data Map (Fig. 10).

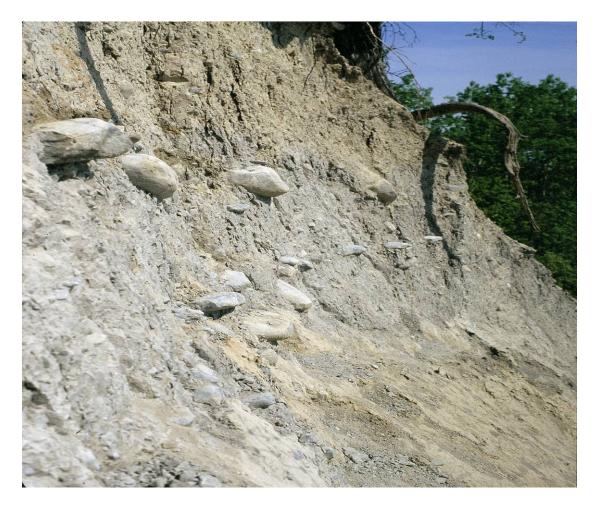
Figure 11. Example of clayey, sandy and stony till deposits.

The upper 5.5 m of clayey till is sandy and silty, gravelly, non-calcareous and slightly calcareous. The color is brown to yellow brown indicating the oxidized character of the sediment. The lower clayey till is sandy, silty and calcareous. The color is grey or olive grey and the till often contain chalk particles. This till is reduced (Fig. 11). Tills just above the pre-Quaternary sediments are called local tills because they contain material of the Eocene clays from below. Floes of Eocene clays also occur in the clayey tills. The meltwater sediments consist of stony sand and gravel, fine to medium-grained sand and silt. These sediments are often intercalated in the tills but they are also found resting directly on the pre-Quaternary surface.

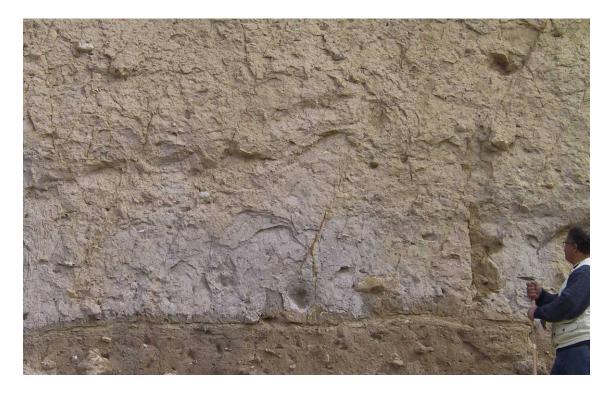
Figure 14. Example of fractures in clayey till (Photo: K.E.S. Klint).

There is no information from the boreholes. From the cliff sections, fractures in the clayey till have been recognized to 5 m below ground surface (Fig. 14 and 15). Fractures in the fine-grained Tertiary clays have to be expected.

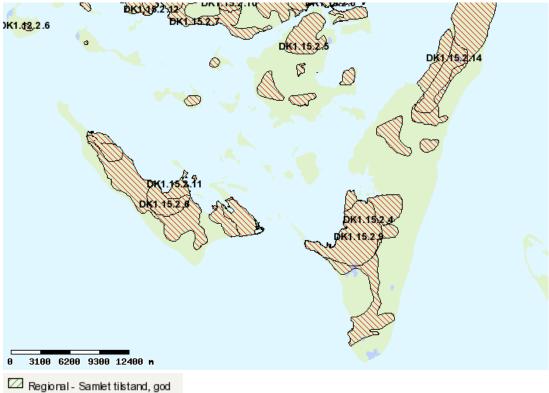
Figure 18. Regional groundwater bodies in the Langeland-Tåsinge region. Near Langeland South area (Area7): DK1.15.2.4; Near Langeland Mid Area 8): DK1.15.2.9; At Vemmenæs (Area 9): DK1.15.2.5. The overall assessment of chemical and quantitative status for all three areas: poor status (Red shaded area) (After Ministry of Environment, 2010).

Langeland South (Area 7) is positioned in an area that is characterized by the presence of two shallow groundwater bodies (DK1.14.1.3 and DK1.15.1.4) and one regional groundwater body (DK1.15.2.4) (Figs. 17 and 18). All three groundwater bodies consist of meltwater sand deposits. Deep groundwater bodies have not been identified in or near Area 7 in the catchment management plan. The subdivision into groundwater bodies is described as part of the basis analysis carried out by the former Fyn Amt (www.ode.mim.dk). The overall assessment of the chemical and quantitative status of the shallow and regional groundwater bodies is poor, due to a poor qualitative status (see Section 5.9).

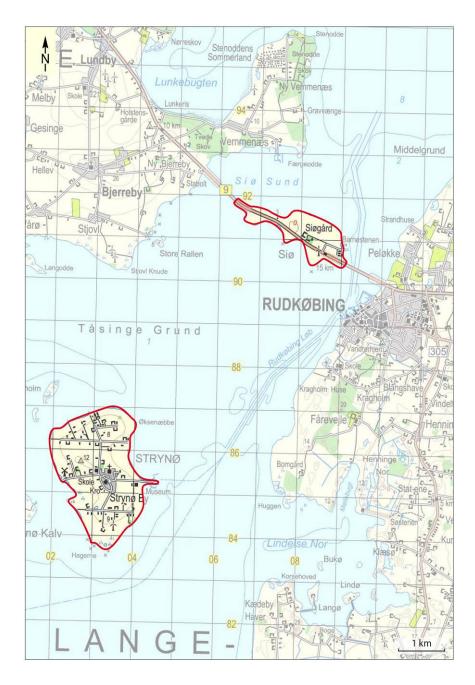
Figure 24. A detailed map of Area 8. Area 8 is located on: a. the central part of Langeland and b. on Siø and Strynø.

The area is situated from east of the city of Rudkøbing to Spodsbjerg in the west and from Tullebølle in the east and Fuglsbølle in the south. The two islands east of Langeland Siø and Strynø are included in this area (Fig. 24).

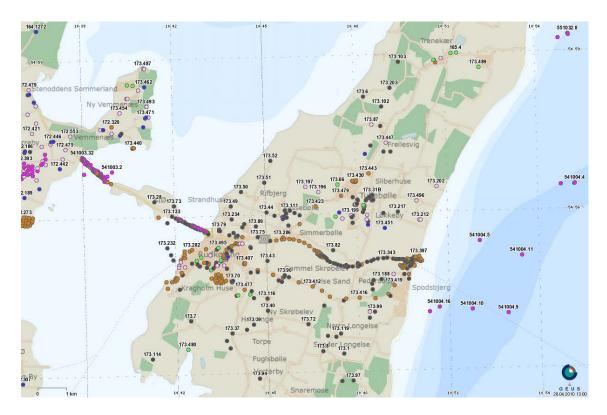
Figure 26. Map of the locations of boreholes from the Jupiter Database at GEUS. Legend: 173.4: DGU No., Blue dot: Water supply well, Red dot: Geotechnical borehole, Pink dot: Raw material borehole, Green dot: Other borehole, Light red dot: Abandoned borehole, Black dot: Unknown purpose.

The target is Eocene/Paleocene clays and several boreholes within the area reach these clays. Many ditch samples have been collected and described lithological. No sample has been dated by microfossils (Figs. 26, 27, 28 and 29). An example of borehole data can be seen in fig. 30.

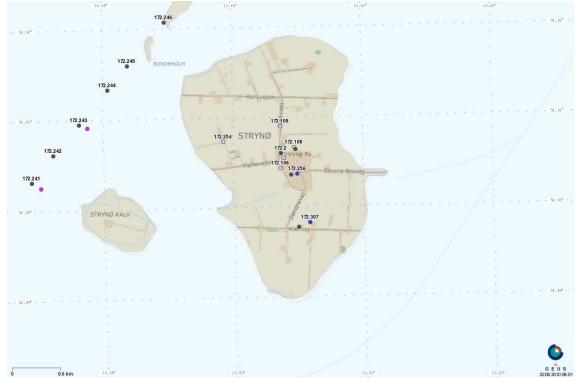
Figure 28. Details about the borehole locations on Strynø. Legend: See fig.26.

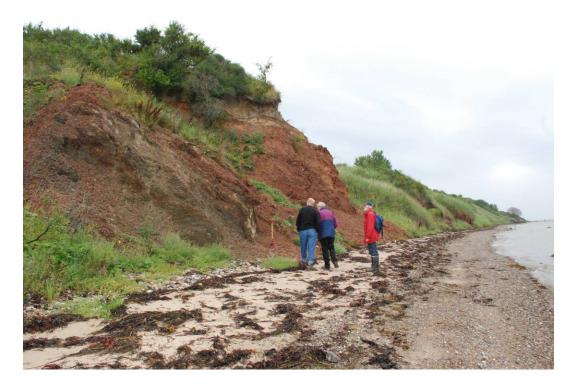
Figure 32. Section from the Albæk Hoved cliff, Juelsminde, Jylland. The plastic clay is lithological comparable to the plastic clays from the Røsnæs and Lillebælt Formations.

The Eocene plastic clays have red, brown, grey and green colors often with volcanic ash layers in the red and brown parts. The clays are very fine-grained and calcareous or non-calcareous. Some samples contain glauconite. It is difficult to distinguish between the Røsnæs Clay Formation and the Lillebælt Clay Formation in the area but the Røsnæs clay is nearly always calcareous. The Eocene deposits are approximately 20-40 m thick in the central part of the area and probably 25 m at Tullebølle (if present)(Fig. 32).

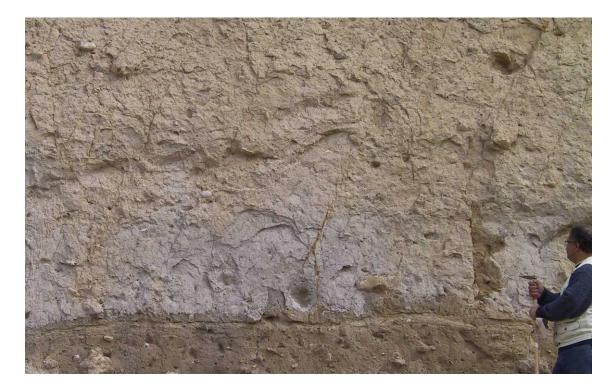
Figure 36. Fractures in clayey tills.

The plastic clays often contain fractures and some small faults or fractures. The clayey tills are always cut by fractures but the conditions on southern Lolland are not investigated because of lack of field localities (Fig. 36).

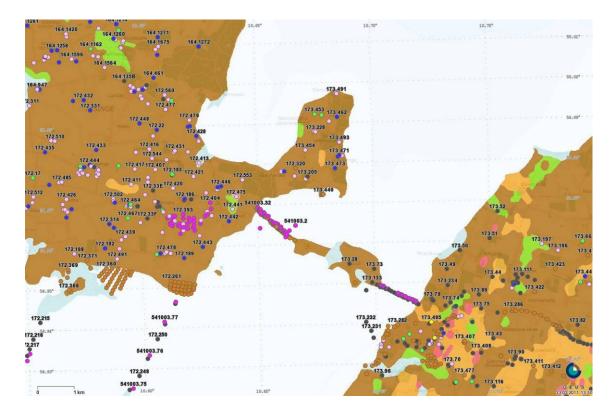
Figure 46. Map of the Quaternary surface deposits (From GEUS's Homepage. After Pedersen, 1989). Legend: Brown: Clayey till, Red brown: Sandy till, Red and orange: Melt-water sand and gravel, Green: Holocene freshwater deposits, Blue: Holocene marine deposits. Legend for boreholes: See fig. 47.

The area is mainly covered by clayey till with a few occurrences of sandy till. No surface exposures are available (Fig. 46).

The Quaternary deposits in the surface layers in the area mainly consist of clayey tills (Figs. 46 and 53). Towards the east, the clayey tills are silty, sandy, olive grey and calcareous from the ground surface and down to 30 m below. Towards the west, the clayey tills have the same characters but are only few m thick. Towards the north, clayey tills are slightly silty, sandy, yellow brown and non-calcareous down to 2 m. Toward the north and northeast, coarse-grained meltwater sand and gravel are found above olive grey calcareous clayey till down to 28 below ground surface.

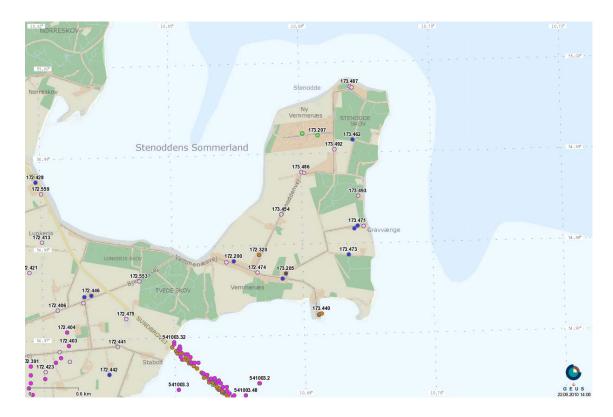
Figure 48. Detailed map with borehole locations on Vemmenæs. Legend see fig. 47.

The target is Eocene/Paleocene clays but only 3 boreholes within the area reach these clays (Figs. 47 and 48). Very few samples have been collected and described lithological. No sample has been dated on microfossils. A map with borehole locations from the adjacent Bjerreby area is on fig. 49 as the deposits have been used as reference. An example of a borehole log is found in fig. 50.

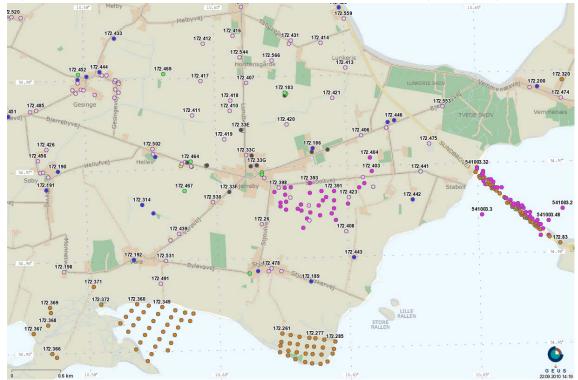
Figure 49. Borehole locations from the Bjerreby area. Legend: See fig. 47.

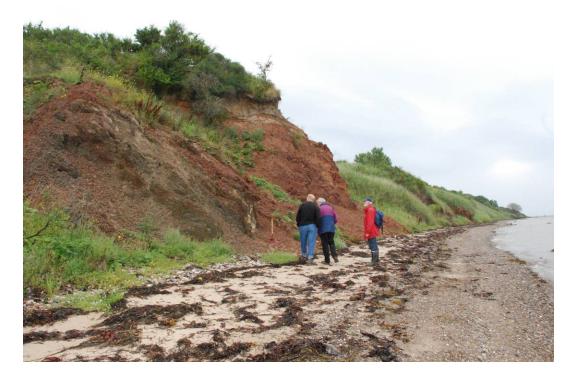
Figure 52. Section from the Albæk Hoved cliff, Juelsminde, Jylland. Red and green plastic clays comparable to the plastic clays Holmehus Formation.

Paleogene clays occur between 2 and 25 m below ground surface at Vemmenæs. Towards the south, the layers consists of fine-grained to silty olive grey and olive green clays containing volcanic ash layers. The clays are non-calcareous and are at least 17 m thick. Towards the east, the clay is fine-grained, green and olive green calcareous or non-calcareous. A faint lamination seems to occur and here the thickness is at least 18 m. It is difficult to include the deposits into formal units but the clays could belong to the Paleocene Holmehus Formation (Fig. 52).

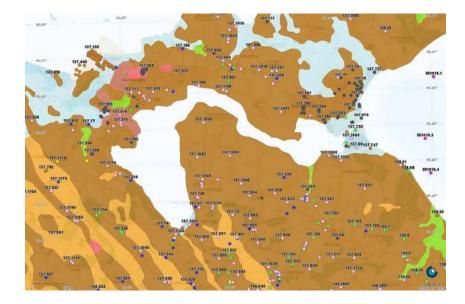
Figure 66. Map of the Quaternary surface deposits (From GEUS's Homepage. After Pedersen, 1989). Legend: Brown: Clayey till, red brown: Sandy till, red and orange: Melt-water sand and gravel, green: Holocene freshwater deposits, blue: Holocene marine deposits. Legend for boreholes: See fig. 67.

The area is mainly covered by clayey till with a few occurrences of sandy till. No surface exposures are available (Fig. 66).

The Quaternary deposits in surface layers in the area mainly consist of clayey tills (Figs. 66 and 70). The boreholes contain up to 28 m thick layers of clayey tills which are sandy, silty, olive grey and calcareous.

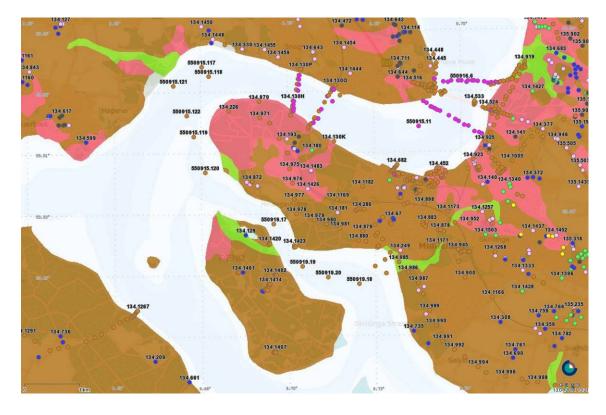
Figure 81. Map of the Quaternary surface deposits (From GEUS Homepage. After Pedersen, 1989). Legend: Brown: Clayey till, Red brown: Sandy till, Red and orange: Meltwater sand and gravel, Green: Holocene freshwater deposits, Blue. Holocene marine deposits, White: Pre-Quaternary deposits. Legend for boreholes: See fig. 82.

The area is mainly covered by clayey till with a few occurrences of sandy till. Outcrops are known from the cliff area at the Lillebælt Bridge, at the Øxenrade cliff at Middelfart and from the opposite side of Lillebælt, at Hagenør and Børup (Fig. 81).

The Quaternary deposits in surface layers in the area mainly consist of sandy deposits (Figs. 81 and 87).

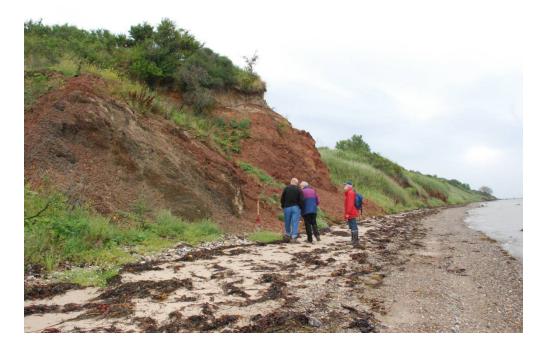
Figure 86. Section from the Albæk Hoved cliff, Juelsminde, Jylland. Red and green plastic clay from the Lillebælt Clay Formation and the Røsnæs Clay Formation.

The Late Oligocene deposits rest on 32 m Eocene Søvind Marl Formation of sticky calcareous clay, 35 m grey plastic clay from the Eocene Lillebælt Clay Formation, 14 m red plastic clay from the Eocene Røsnæs Clay Formation, 10 m clay with volcanic ash from the Eocene Ølst Formation, 37 m fine-grained clay with glauconite from the Paleocene Kerteminde Marl, and at last 6 m Bryozoan limestone with flint from the Danian (see DGU no. 134.226). Some of the sediment types can be seen in fig. 86.

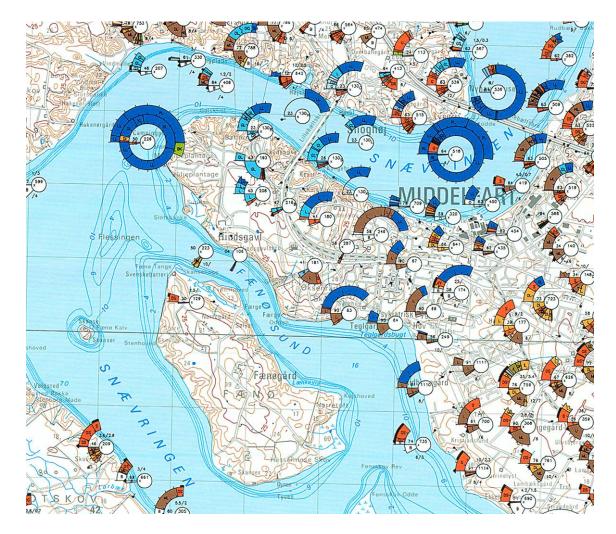
Figure 88. Part of the Geological Basic Data map 1213 II Fredericia showing borehole data from Hindsgavl, Fyn. Original Scale 1:50.000. Only data from one borehole were available on Fænø when the map was produced. Legend: See fig. 10 (From Grambo-Rasmussen, 1995).

No major fault line have been registered and mapped in the Hindsgavl-Fænø area. The Geological basic data map of the area demonstrates the positions of the Oligocene and Eocene deposits (Fig. 88). Further towards the southeast, outside the area, a 175 m deep valley in the pre-Quaternary deposits exists around Gamborg Fjord. It has been suggested that a local doming in the area has exposed Late Oligocene deposits.

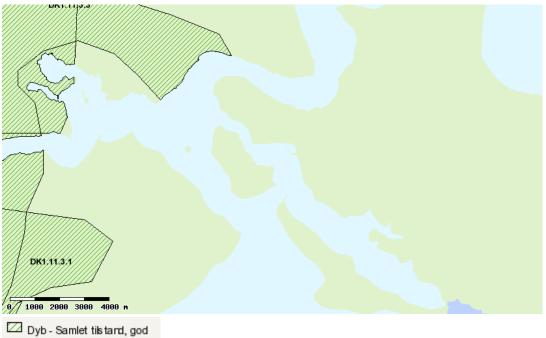
Dyb - Samlet tilstand, god

Figure 93. Deep groundwater bodies in Jylland west of Lillebælt (After Ministry of Environment, 2010).
