Survey report for vibrocore investigations, 2023

Geological screening for offshore wind farms,
the Danish Energy Agency

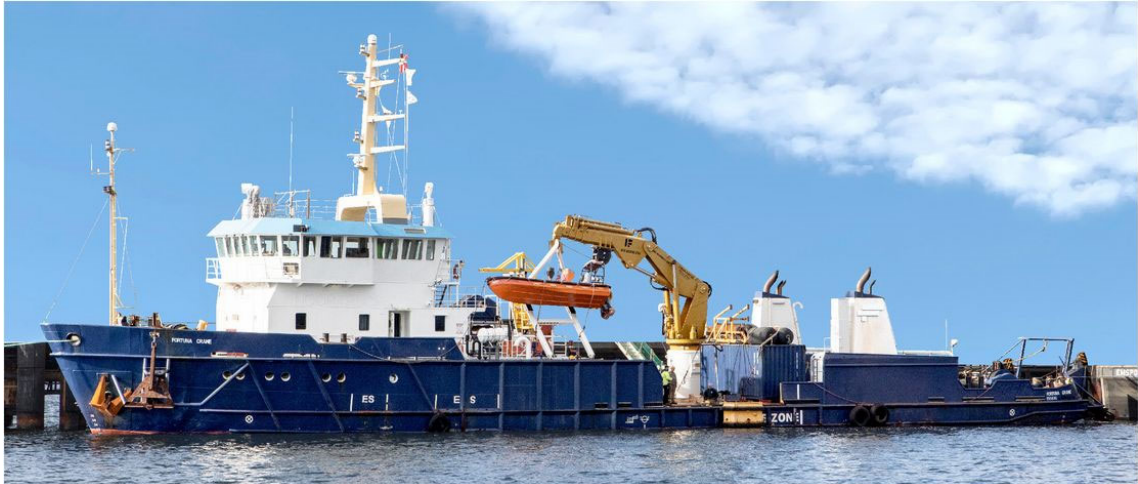
Figure 3.1 Survey vessel Fortuna Crane.

The ENS 2023 vibrocore and CPT survey was carried out using the survey vessel Fortuna Crane (Figure 3.1) provided by Foga Consult ApS.

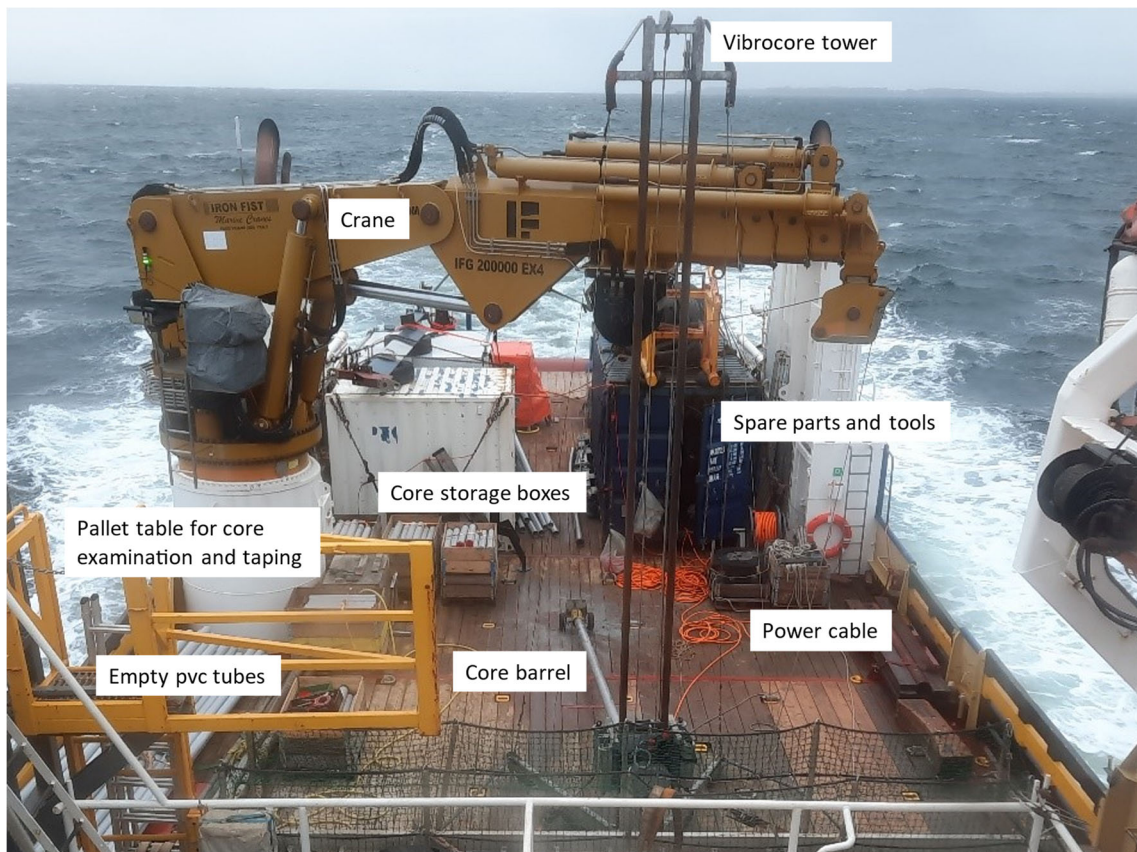
Figure 5.2 Deck arrangement of Fortuna Crane during vibrocore operations, looking aft from the bridge. Port side is to the right and starboard is to the left. The crane is mounted on the starboard side, but the vibrocrorer (centre of deck) is deployed over the port side.

The drilling crew prepared, deployed, operated, and recovered the vibrocore instrument (Figure 5.2). After the vibrocorer was back on deck, the 6 m long plastic core sleeve was extracted from inside the metal core barrel and cut into 1 m segments for storage and handling. GEUS geologists labeled the core segments with site-identifying codes and logged the lithology at the top of every core segment as well as any sediment in the core-catcher at the tip of the core barrel, to get an indication of the geology at the deepest penetration point.

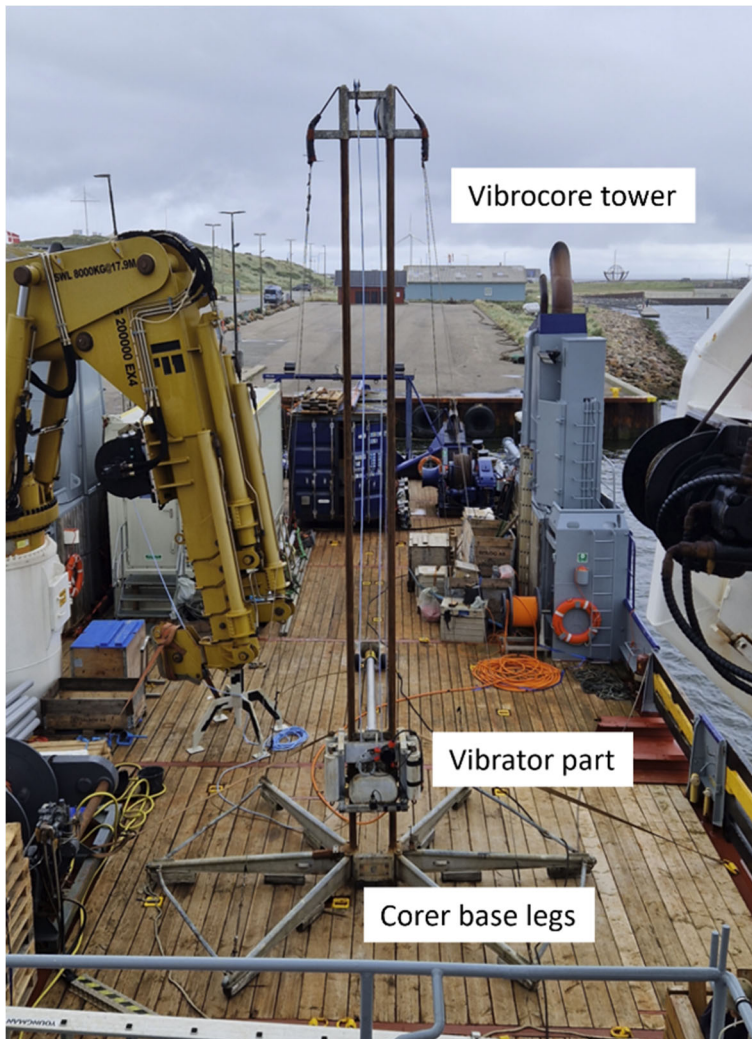
Figure 5.3 Vibrocore instrument used for sediment sampling. The vibrator part can be seen as the grey unit above the hexagonal foundation close to the deck.

In Figure 5.3 below, the vibrocore instrument is shown in more detail. The vibrator part is the grey box just above the hexagonal foundation close to the deck. When loading, the vibrator unit is raised to the top of the tower, and a pvc tube is inserted into the steel core barrel before it is raised to vertical position. Then the crane is used for deploying the vibrocrorer into the water and lowering it to the seabed where the core barrel and pvc tube is vibrated into the subsurface. When no more penetration is possible, the barrel and pvc tube is pulled back again, and the vibrocore unit retrieved back on deck and unloaded.

The vibrocrorer contains an echo-sounder unit and a current-measuring unit. The echo-sounder unit measures the approximate distance from the vibrocore unit to the seabed, and the current-measuring unit measures the induced amperes within the vibrator part as a proxy for the amount of pressure the vibrocrorer uses to penetrate the subsurface.

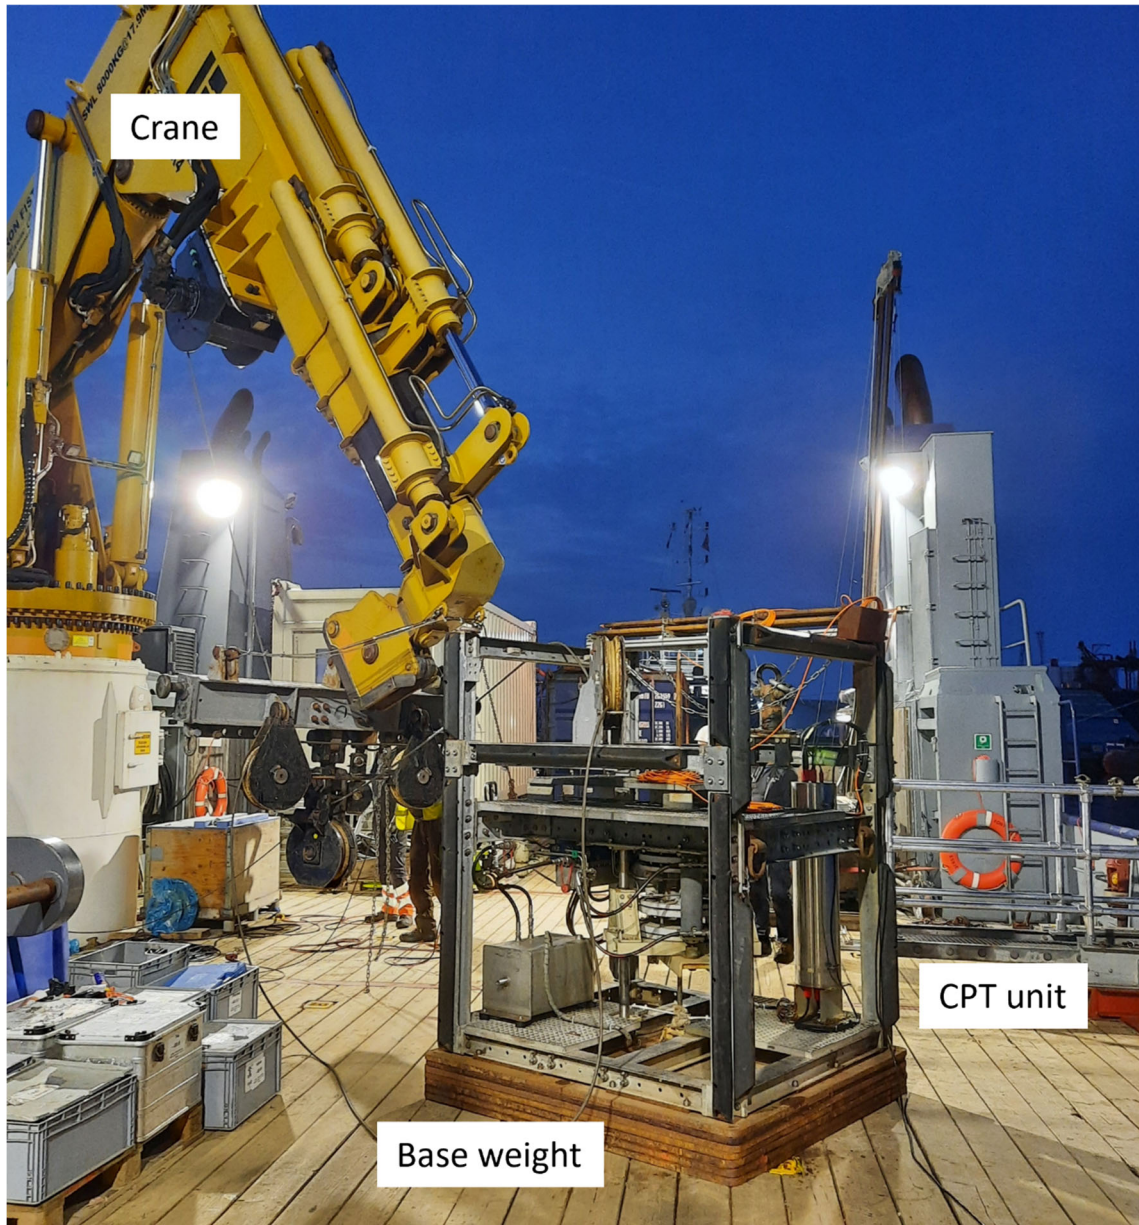
Figure 5.4 The GOST CPT unit on the deck of Fortuna Crane.

The CPT crew prepared, deployed, operated and recovered the CPT unit (Figure 5.4).
