Survey report for marine raw material mapping for the Danish Environmental Protection Agency 2022

Inner Danish waters and the Baltic Sea around Bornholm

Lara F. Pérez, Eric J. Haase, Luna H. Winther,
Niels Nørgaard-Pedersen, Nicklas Christensen,
Sigurd B. Andersen, Lars-Georg Rödel &
Thomas Vangkilde-Pedersen

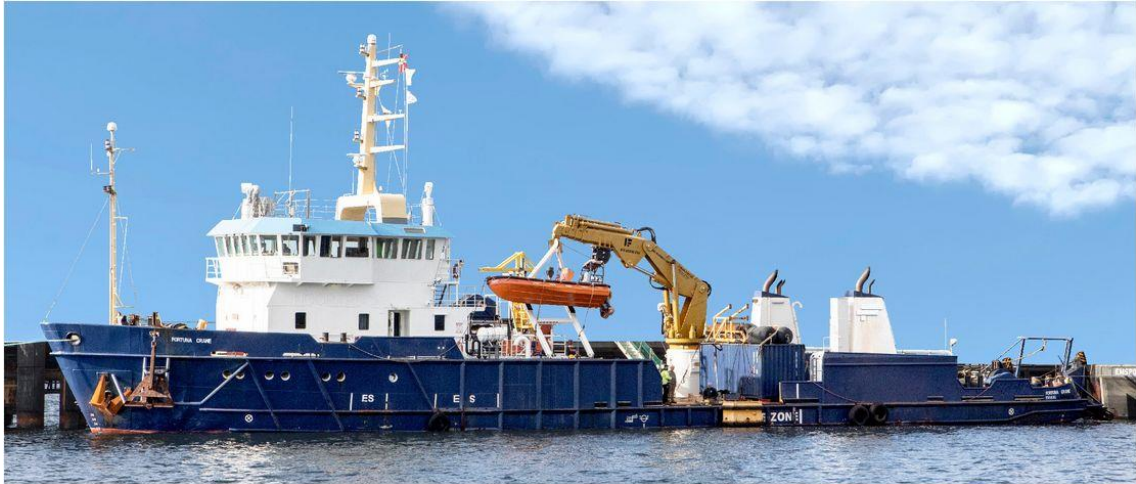
Figure 3. Survey vessel Fortuna Crane.

The MST 2022 survey was carried out using the survey vessel Fortuna Crane (Figure 3) provided by Foga Consult ApS.

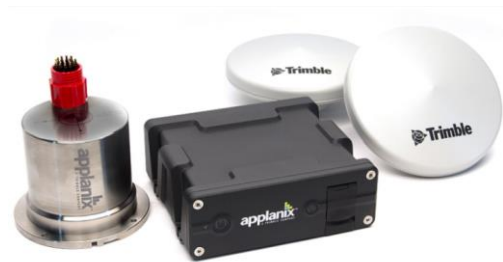
Figure 5. Applanix POS MV with GPS antennas and Inertial Motion Unit.

The GPS antennas for the Applanix PosMV positioning and motion sensor system (Figure 5) for the geophysical mapping was located on the roof of GEUS' survey container on the stern deck of Fortuna Crane (Figure 4) and the Inertial Motion Sensor (IMU) unit was placed directly on the EdgeTech multibeam/side scan and Innomar sub-bottom profiler units. The Applanix PosMV merges position data from the Global Navigation Satellite System (GNSS) and NTRIP RTK corrections with angular rate and acceleration data from the IMU, together with heading from the GNSS Azimuth Measurement System (GAMS) to produce a robust and accurate full six degrees-of-freedom position and orientation solution. The positioning and motion sensor data were distributed to the respective acquisition software using HyPack64 2022 software.

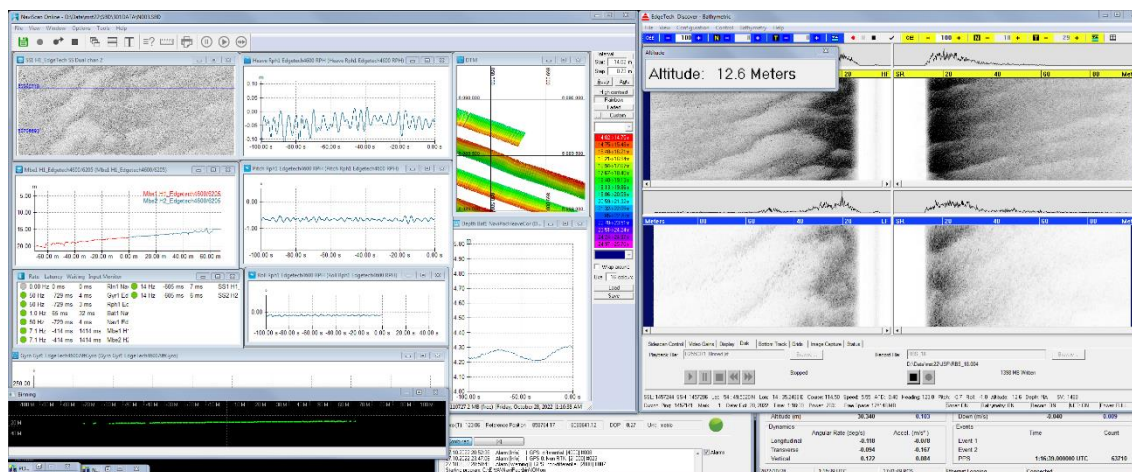
Figure 7. Screenshot of the general EdgeTech settings during the MST 2022 survey.

The EdgeTech 6205 was mounted on a pole in the starboard side of the ship. The sensors of the EdgeTech were located 3,25 m under the water line. The combined multibeam and side scan sonar EdgeTech operates on two channels: one low frequency (LF) and one high frequency (HF). The recording range was 100 m to each side, i.e. a total width of 200 m (Table 5, Figure 7).

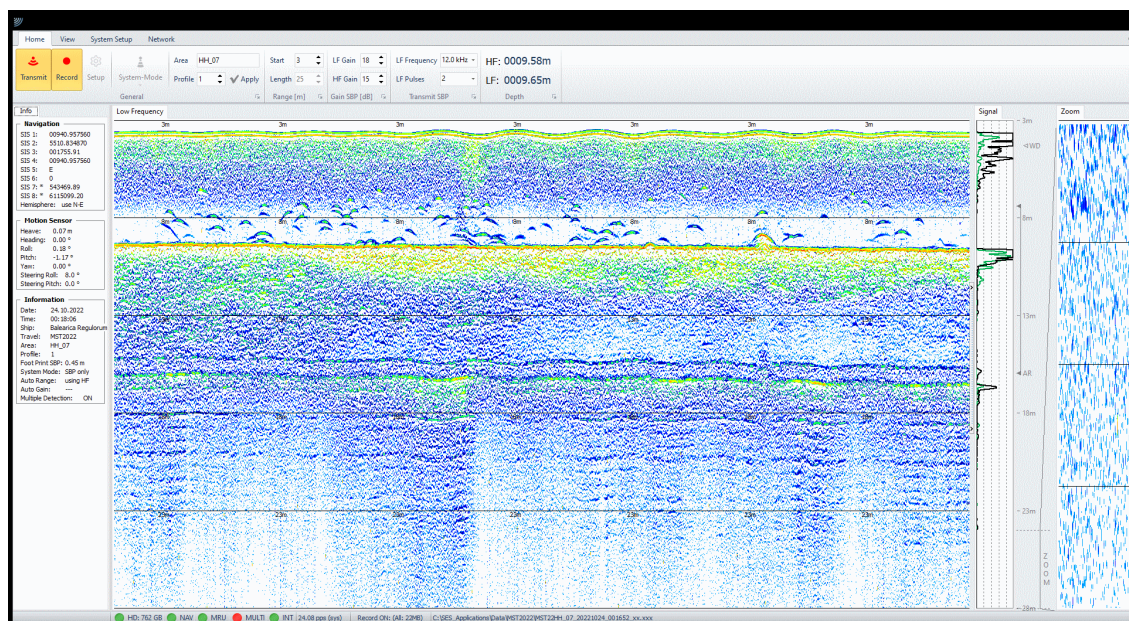
Figure 11. Screenshot of the general sub-bottom profiler settings during the MST 2022 survey.

The Innomar SES 2000 sub-bottom profiler was mounted on the starboard pole above the EdgeTech and 2,95 m under the water line. The recording window was set to 25 m and the trigger interval was synchronized with the multibeam, thus it changed with depth. The penetration of the Innomar record varied within the areas, but on average it was 5-10 m under the seafloor. Table 6 and Figure 11 summarize the sub-bottom profiler settings.

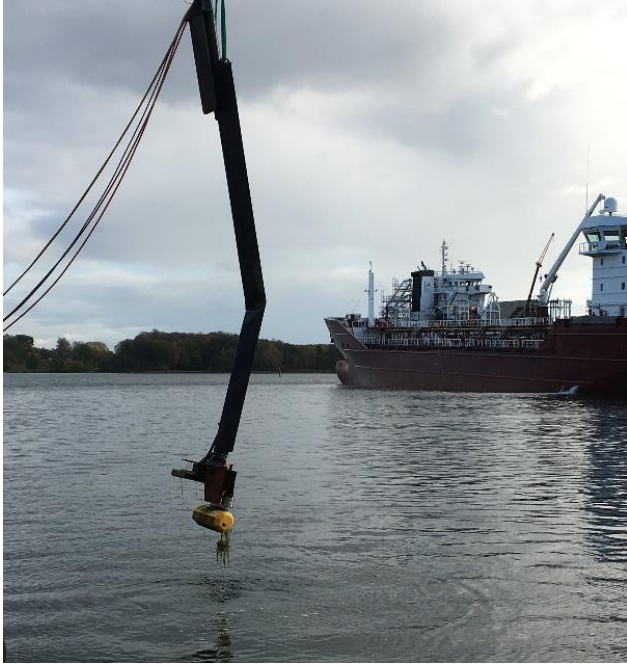
Figure 13. Pole where the EdgeTech and Innomar are mounted after running aground.

The ship was able to get off the ground again, but the pole hosting geophysical equipment was bent (Figure 13). A video inspection in the water showed, that the EdgeTech and Innomar transducers were potentially damaged and partly under the ship due to the bending of the pole. Thus, it was not possible to pull up the pole without further damage on the equipment. Hence, Fortuna Crane headed to Svendborg harbor keeping a slow speed of about 3-4 knots. Once in the harbor, the pole was detached from the ship and lifted. An assessment of the equipment showed that the fiber glass housing of the EdgeTech (Figure 14) was damaged, while the Innomar was in good condition.

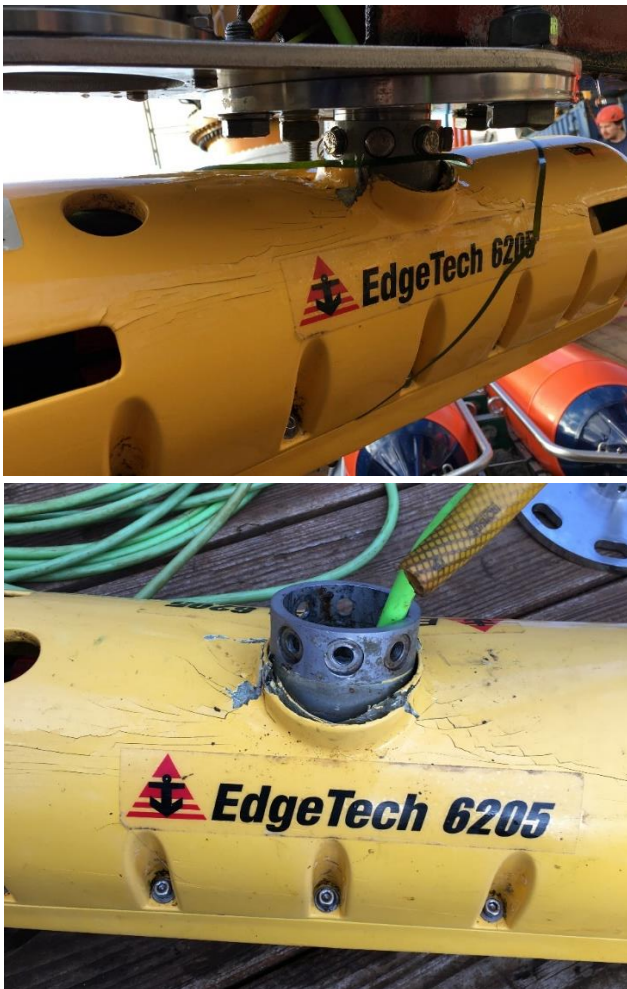
Figure 14. Damage of the fiber glass housing of the EdgeTech.

The pole and the housing of the EdgeTech were repaired at Svendborg shipyard and returned on October 25. EdgeTech and Innomar sensors and transducers were tested while leaving Svendborg harbor at 15:00 (UTC) on October 25 and the test showed normal response and no further damage of the equipment. Thus, the survey activities were resumed.

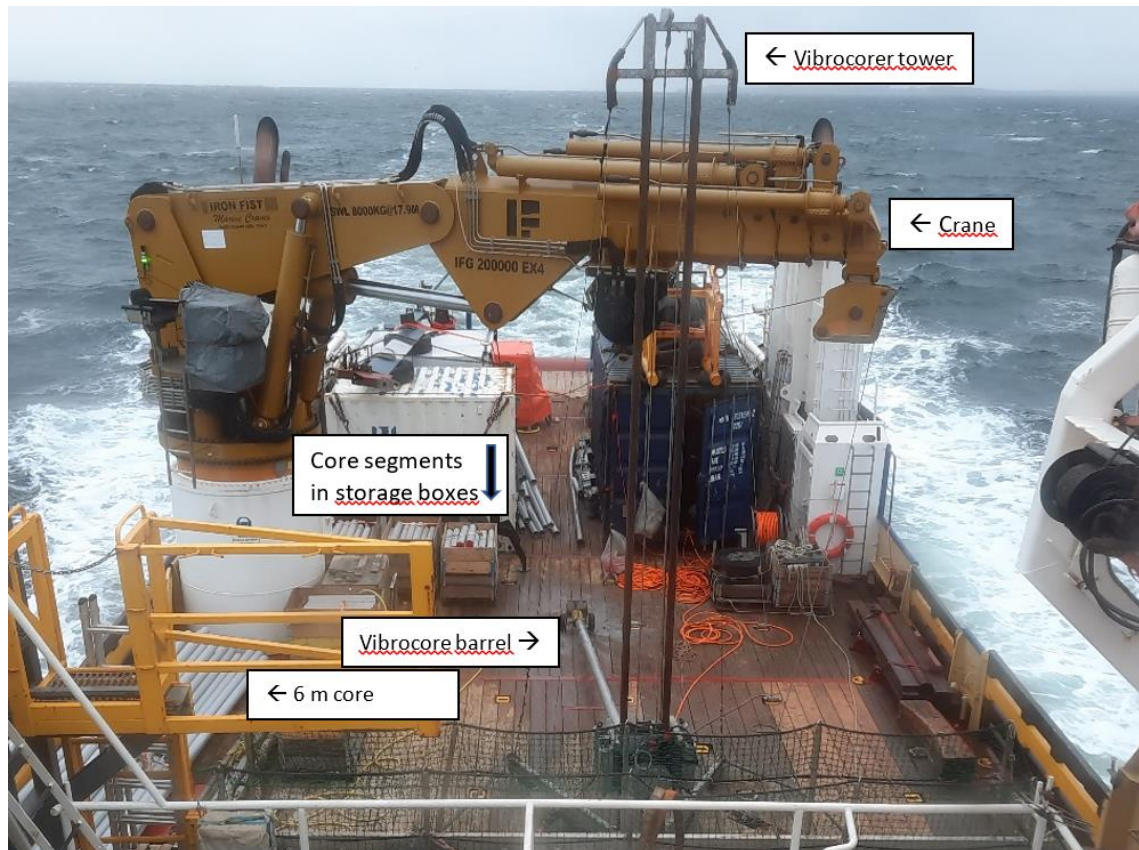
Figure 33. The image shows the deck arrangement of Fortuna Crane during vibrocore operations, looking aft from the bridge. Port is to the right and starboard is to the left. The crane is mounted on the starboard side, but always deployed the Vibrocore (centre of deck) over the port side of the ship.

The drilling crew prepared, deployed, operated and recovered the vibrocore instrument (Figure 33). After the Vibrocorer was back on deck, the 6 m long plastic core sleeve was extracted from inside the metal core barrel and cut into 1 m segments for storage and handling. GEUS geologists labeled the core segments with site-identifying codes and logged the lithology at
